URS Alaska, LLC  
700 G Street, Suite 500  
Anchorage, AK 99501  
ph 907.562.3366  
fx 907.562.1297  
www.urscorp.com

**Summary Memo on an Invasive Species Initial Assessment  
of the *Endeavour – Spirit of Independence*, Kachemak Bay,  
September 10-11, 2012, for Buccaneer Alaska, LLC.**

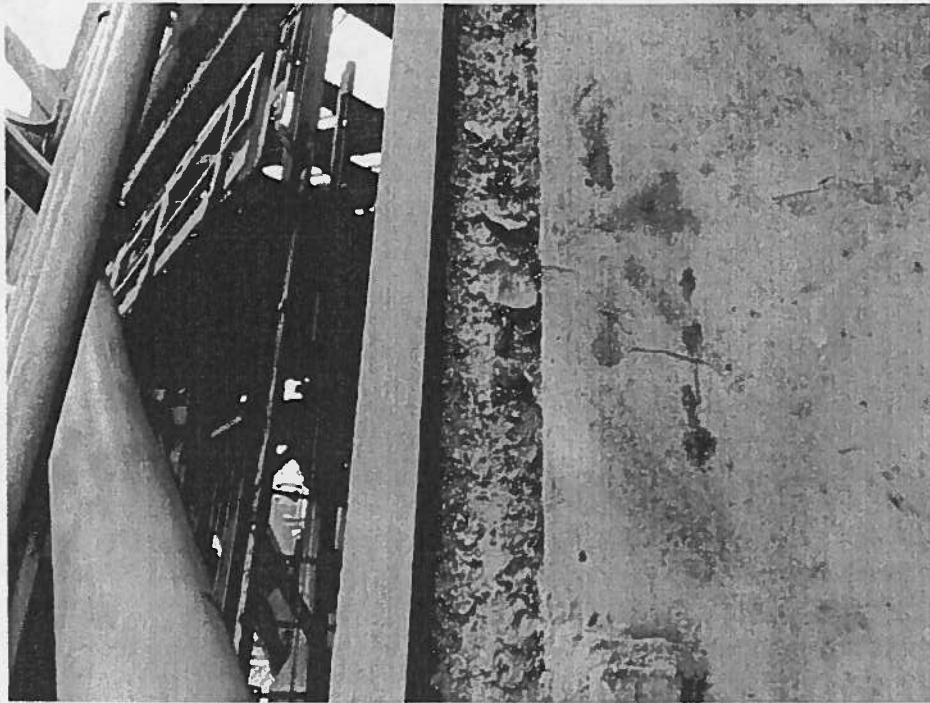
Remnant shell material and whole shells on the legs are primarily confined to a narrow 4-inch space between the leg chord and the jacking guide for the leg (Photo 1-3). The jacking movement doesn't appear to scrape these shells off in the process of raising and lowers the legs. The shell or shell crusts were found in the narrow, 4-inch gap on most of the chords (corner structures) of each of the three legs. Most of the shells in the narrow gap were covered with a thin coat of gray paint, which likely happened during the painting of the legs and their supports while it was in dry dock this past year. Remnants of oyster shell were also noted on the spud can support members and catwalks to the spud can manhole and on the lower portion of the jacking guide (seen through an inspection port) (Photo 4-7).

Photo 1. Old oyster shell on the bow leg (right) at the jacking guide slot (under gray paint). Operation of the jacking mechanism doesn't remove the old shells.

- Loose shell debris should be removed for all areas near the legs.
- The spud cans, supporting structures and catwalks should be scraped and painted at the same time as the other parts of the legs to minimize the risk of introducing non-indigenous species.
- The 4-inch gap near the jacking guides should be cleaned of old shell material and monitored for any build up after the drilling season.
- Leg structure should be cleaned of attached marine biota after the rig has completed its drilling season each year to minimize potential for transport of non-indigenous species.

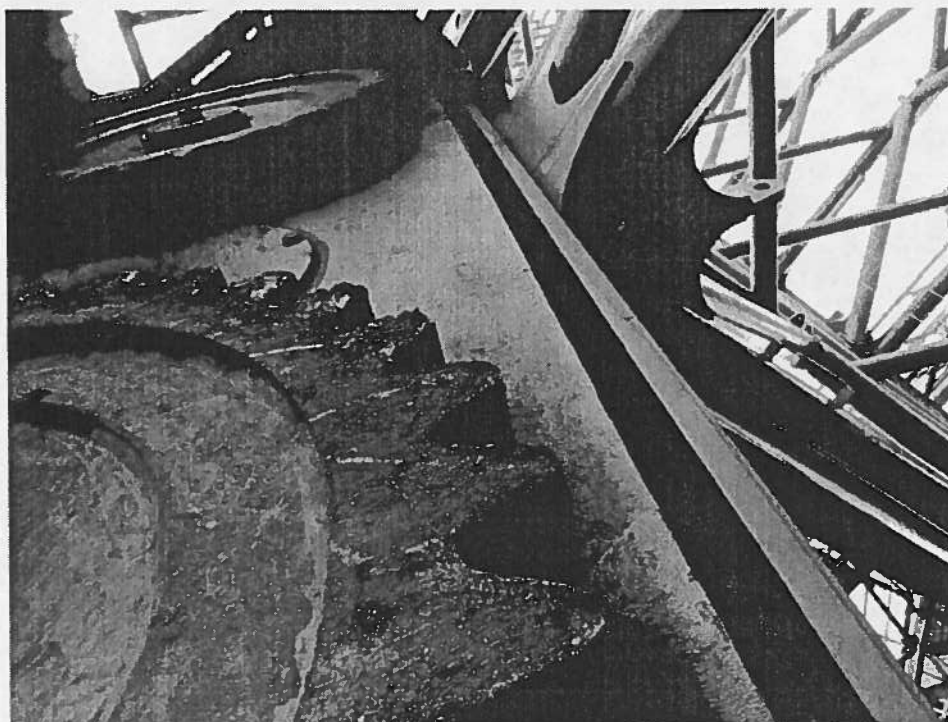
Photo 3. Old shells encrusted on the Bow Leg in the slot by the jacking guide. Shells extend up to the next deck level.

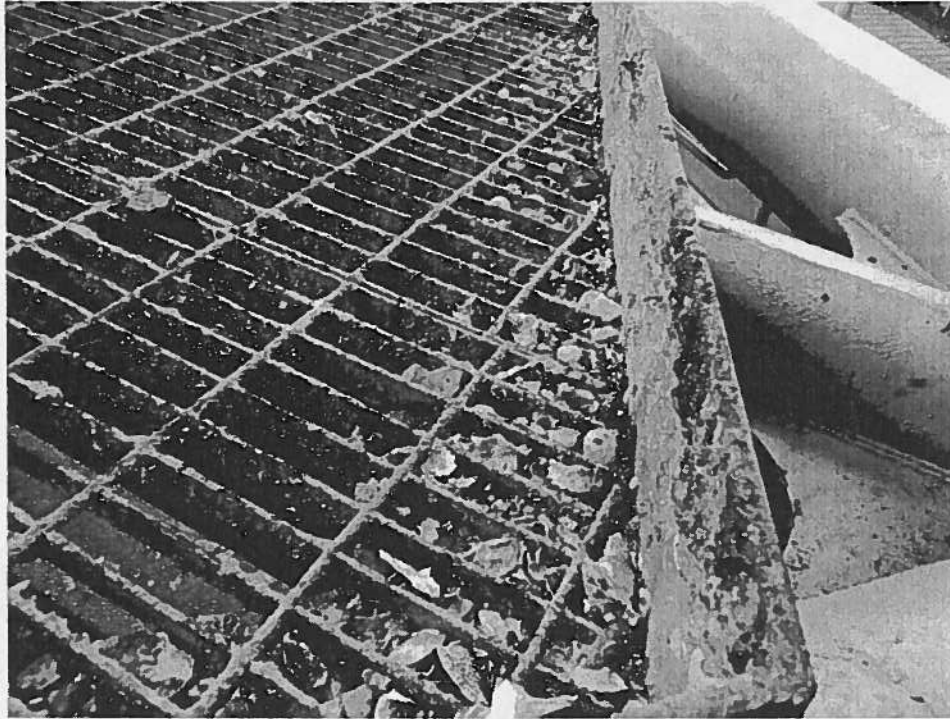
Loose shell debris was found in several areas around the leg such as decks, stairways, cracks and crevices and catwalks. Much of this scattered shell debris appears to have come from the scraping and cleaning of the legs and supports prior to being painted this past year.

Photo 5. Shell debris on the catwalk out to the manhole on top of the spud can. Debris likely collected from cleaning the legs of encrusting marine biota prior to painting the legs.

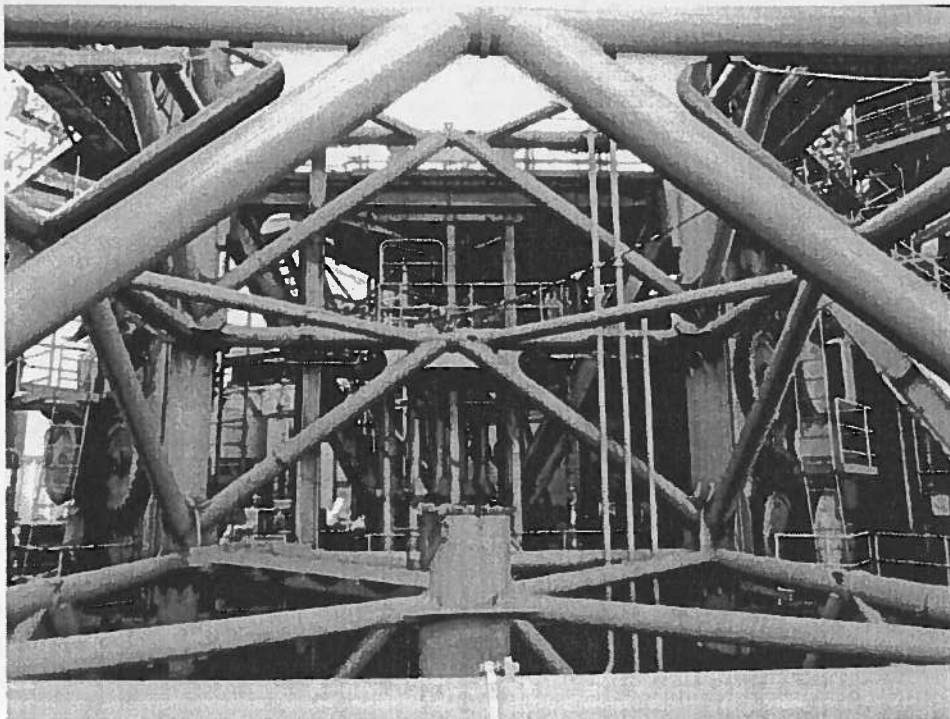
Photo 6. Cable stretched across bow leg (center of photo) with encrusting marine organisms. This cable was likely underwater when the rig was cold-stacked.

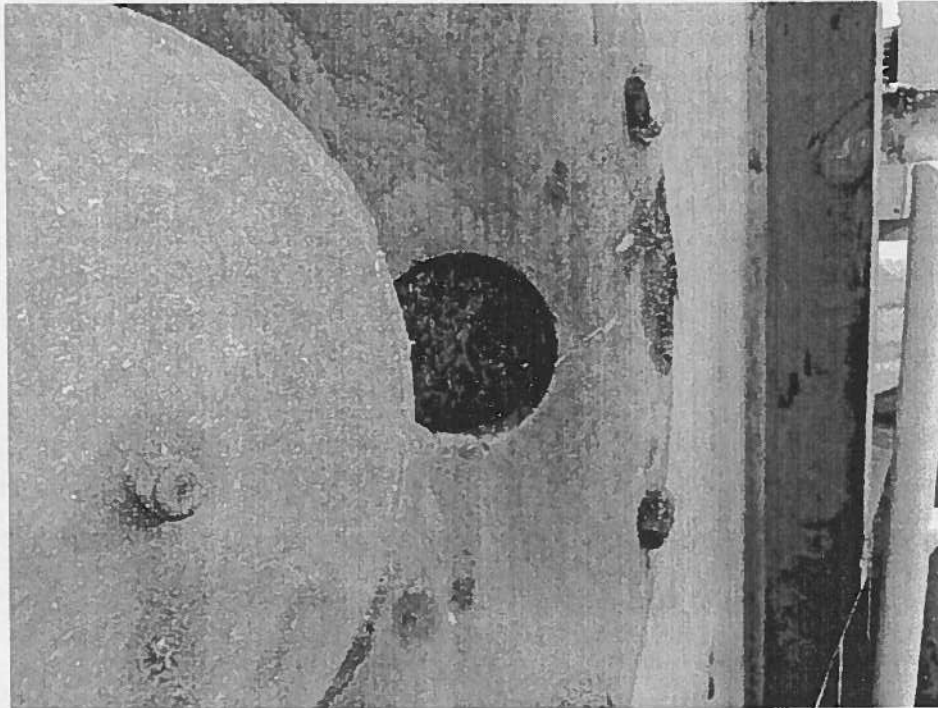
Photo 7. Old oyster shells on the inside the lower portion of the leg guide on D chord of the Starboard leg. Shells attached to this structure can only be seen through this opening when the legs are raised.

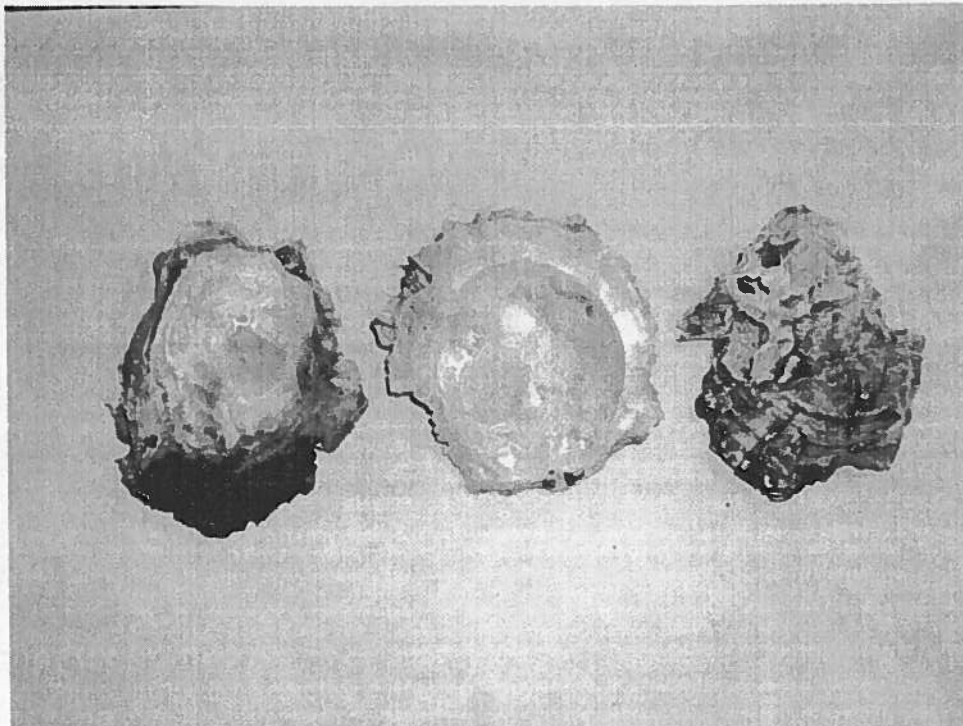
Shells in this 4-inch gap were primarily oyster (several species) with barnacles the second most common shell (Photo 8-12). Barnacle shells were both attached to metal surfaces and other shells. The starboard leg had more barnacles and less oyster shells. None of the shells examined supported any live animals,

Photo 8. Old oyster shells (unidentified) from the Bow Leg guide slots.

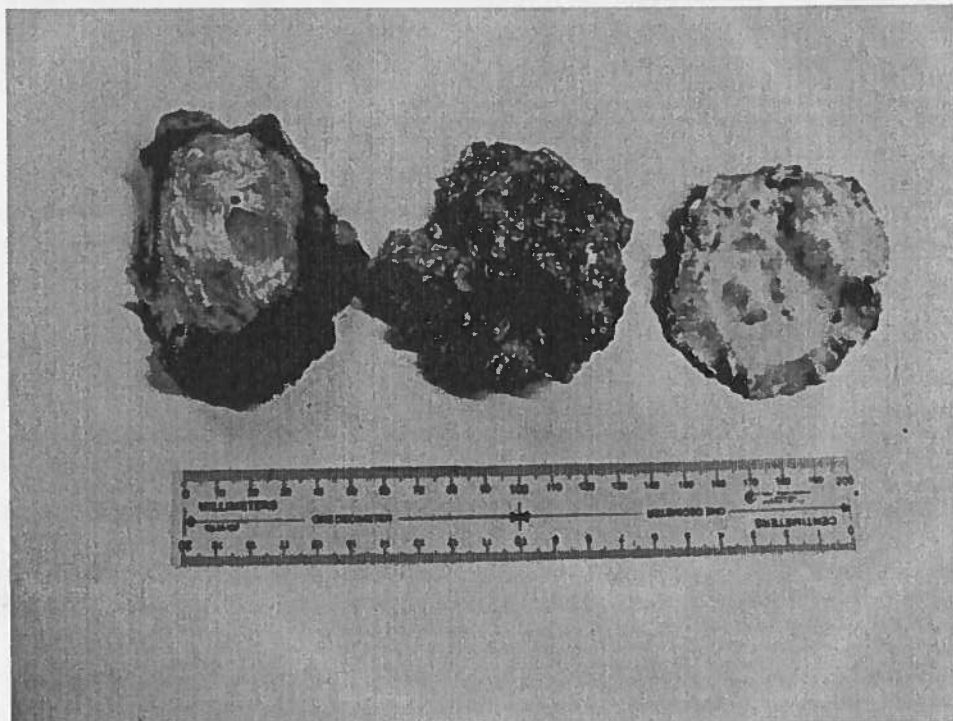
Photo 11. Right valves of typical oyster shell (unidentified) from the guide slot of bow leg.

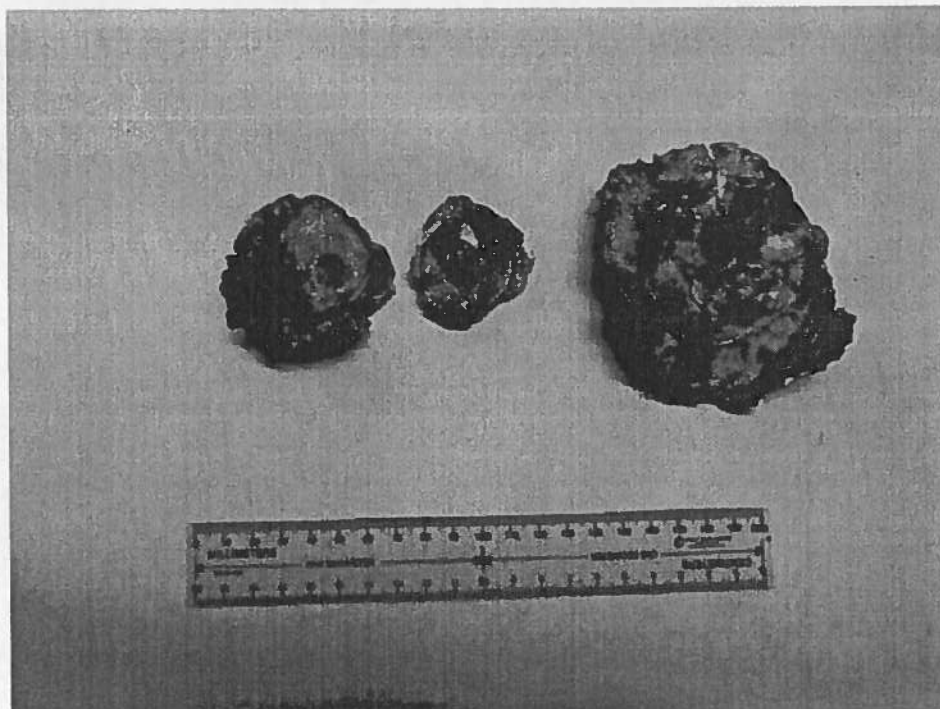
Photo 12. Right valves of oyster shells that have fallen from the legs. Oysters been dead for an extended period and shells are deteriorating.

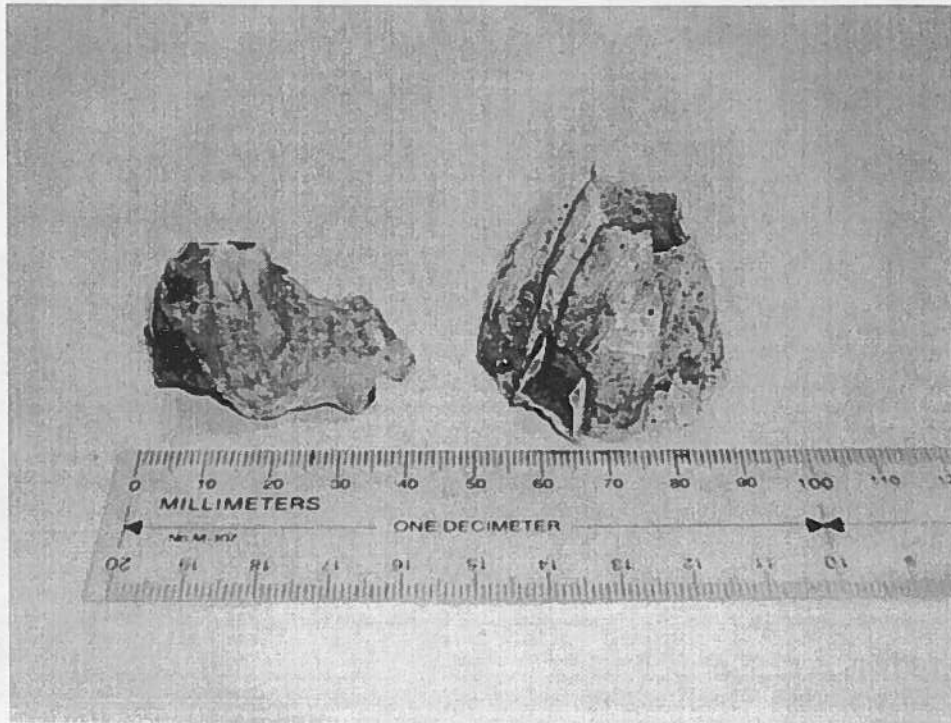
Photo 13. Old barnacle shells that had become detached from the legs.

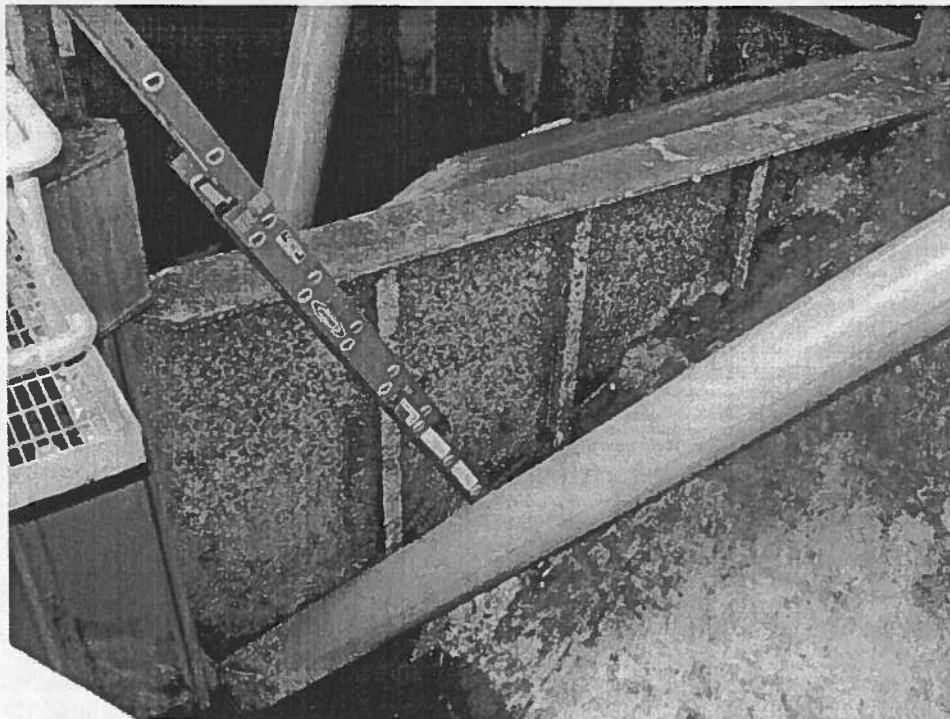
No living organisms were found in the encrusted marine film that was sampled from the spud can support member (Photos 14-17). Examination under a microscope found the mat to consist mostly of a dried calcareous tube worm cases, juvenile mussels, and a few juvenile clams (Photos 18-19). The mat was held together by the byssal threads of the mussels. Some of the juvenile mussels had some desiccated tissue still in the shell, suggesting they were likely alive when the rig went into dry dock. There were also dead fly larvae (maggots) entangled in the mat, which likely feed on the mussels and worms after they died.

Photo 14. Encrusted marine organisms (grayish film) on spud can support member just above the water level on the Bow Leg.

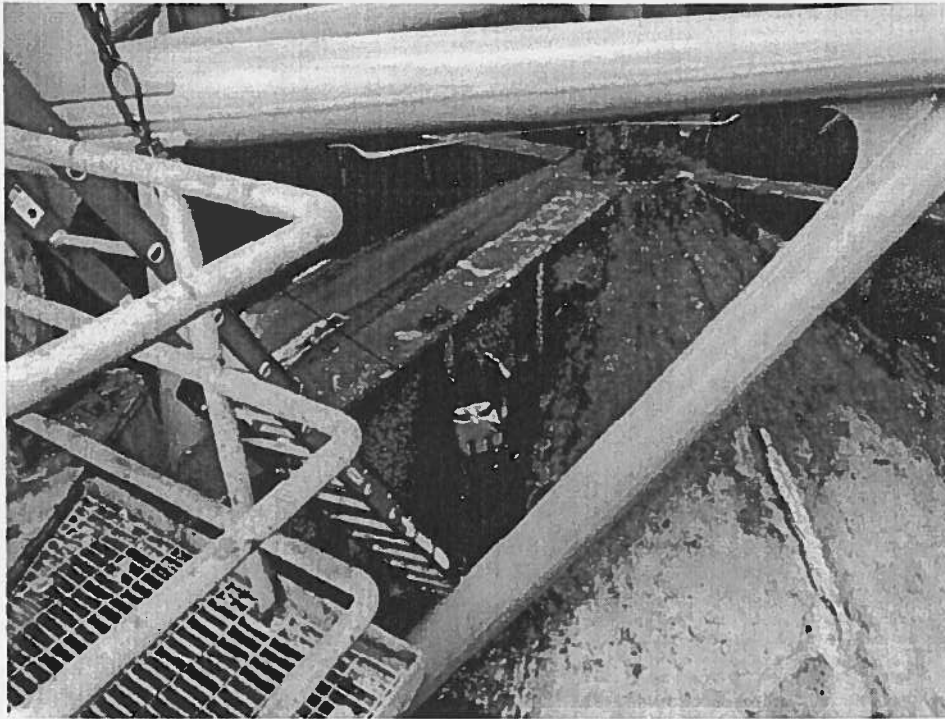
Photo 15. Worker preparing to take sample from vertical surface. Shell debris on the grate in the lower left.

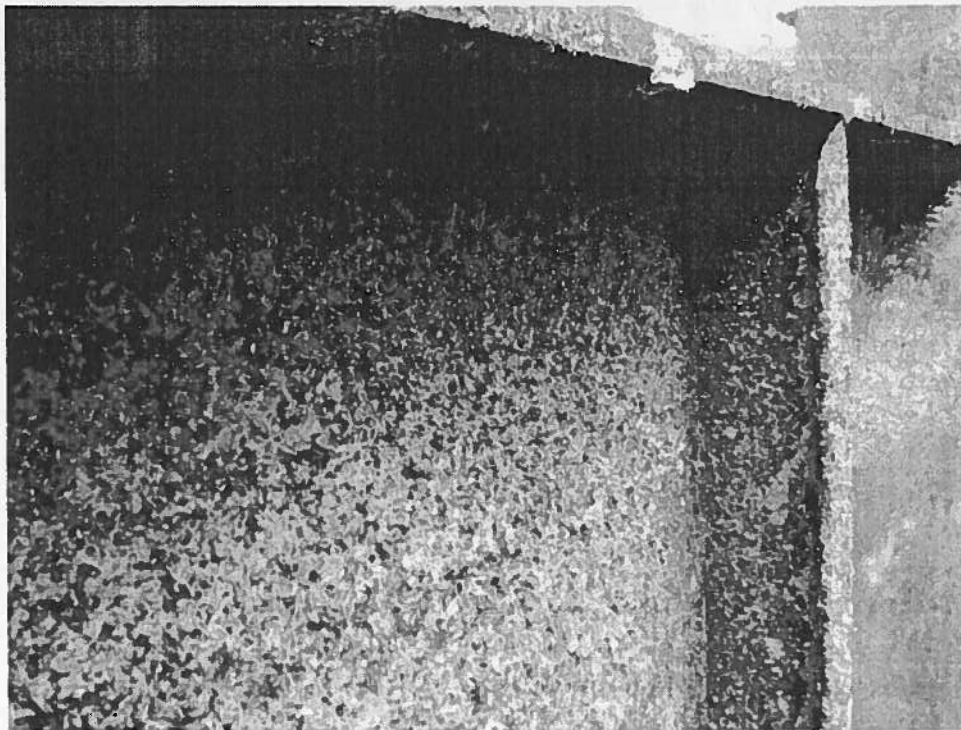
Photo 16. Close up of encrusted juvenile mussels and calcareous worm tubes on the spud can structural support member.
