Airborne Thermal Infrared Remote Sensing Anchor River Basin, Alaska

Confluence of South Fork Anchor River and Beaver Creek, Kenai Peninsula, Alaska

Data Acquisition: June 30, 2010
Report Date: September 17, 2010

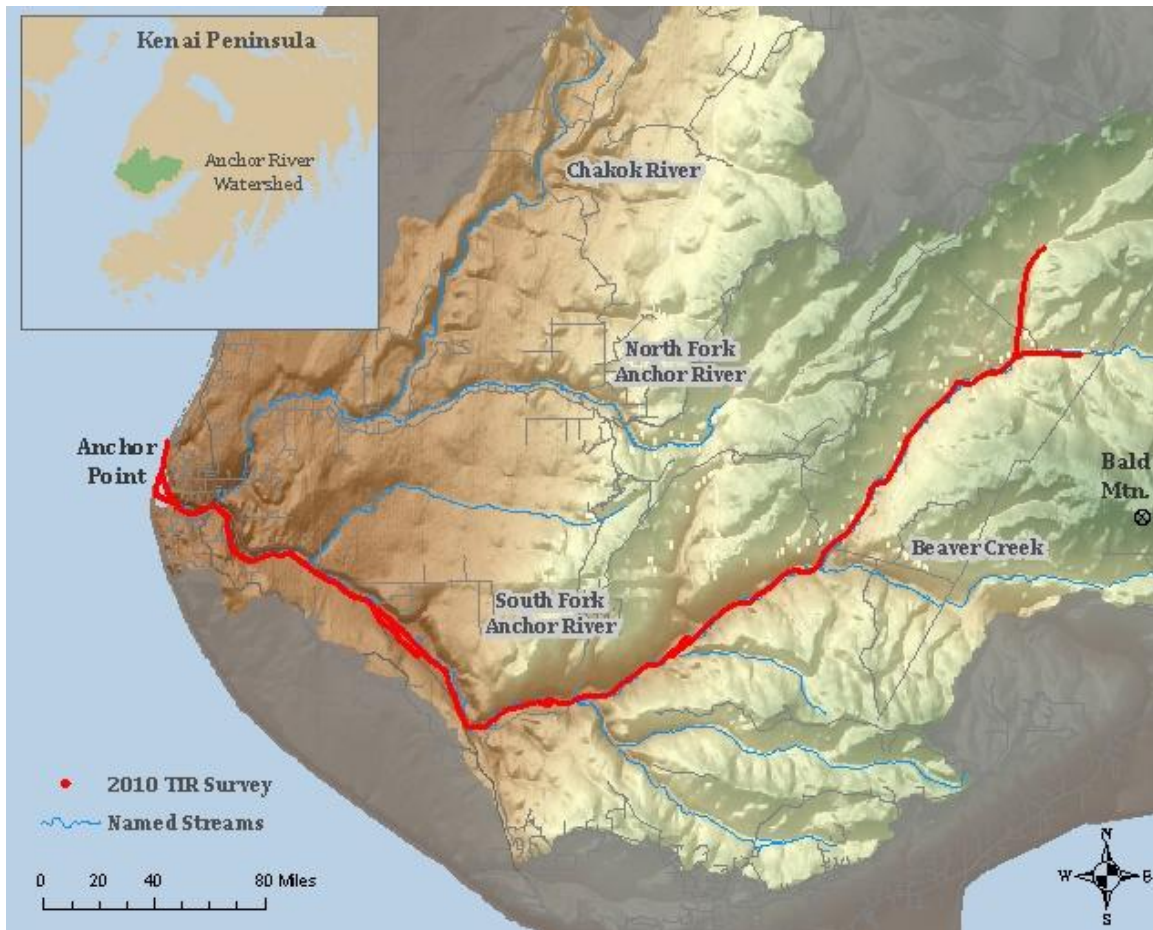
Figure 1 – An airborne thermal infrared survey was conducted on June 30, 2010 in the Anchor River Basin.

In 2010, Cook Inletkeeper contracted with Watershed Sciences, Inc. to provide airborne thermal infrared (TIR) imagery for the Anchor River and South Fork Anchor River on the Kenai Peninsula. The survey extended from the mouth in Anchor Point, AK upstream for thirty-four miles to a location just below Bald Mountain (*Figure 1*).

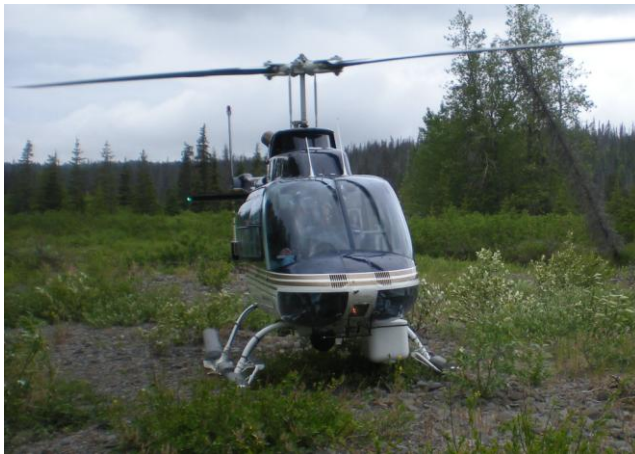
Figure 2 – Bell Jet Ranger equipped with a thermal infrared radiometer and high resolution digital camera. The sensors are contained in a composite fiber enclosure attached to the underside of the helicopter and flown longitudinally along the stream channel.

Images were collected with a FLIR system's SC6000 sensor (8-9.2 μ m) mounted on the underside of a Bell Jet Ranger Helicopter (*Figure 2*). The SC6000 is a calibrated radiometer with internal non-uniformity correction and drift compensation. General specifications of the thermal infrared sensor are listed in Table 1.

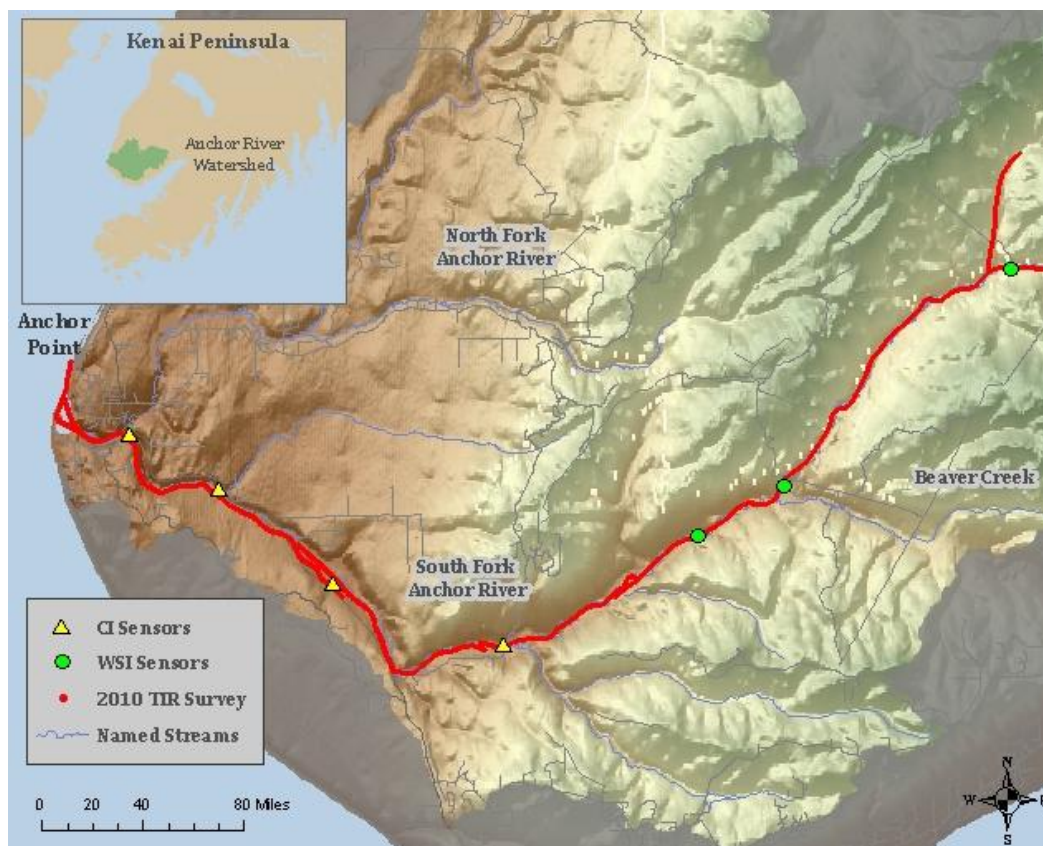
Figure 4 – Location of Cook Inletkeeper temperature sensors and sensors deployed by Watershed Sciences.

Cook Inletkeeper provided data from four in-stream data loggers that were deployed during the survey and Watershed Sciences deployed three additional sensors in the upper reaches of the river. All seven sensors (Onset HoboPro and HoboPro V2) were used to calibrate and verify the TIR data. The data logger locations are illustrated in Figure 4.

Table 4 – Comparison of radiant temperatures derived from the TIR images and kinetic temperatures from in-stream sensors. Sensor locations can be seen in Figure 4.

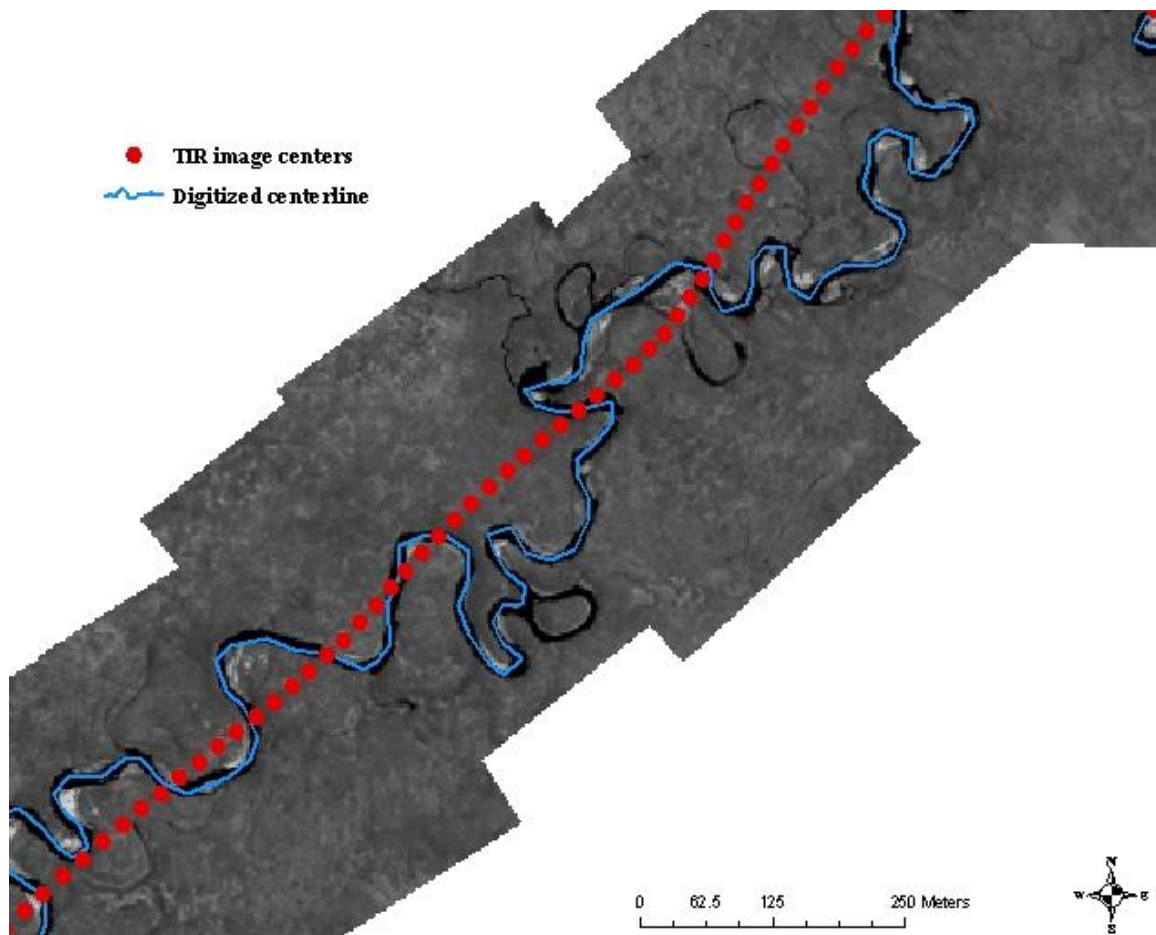
Figure 6 – Due to the highly sinuous nature of the South Fork Anchor River along certain reaches, it is difficult to apply an exact river mile to the TIR image points. Care should be used when referencing the river miles outside the scope of this report.

Due to the highly sinuous and dynamic nature of the South Fork Anchor River, river miles are approximate and based on a stream centerline digitized from the final thermal mosaics at a scale of 1:5000 (Figure 6). The ‘River Mile 0’ measure from the River Mile shapefile file found at the Kenai Peninsula Borough GIS website² was used as the starting location for the route.

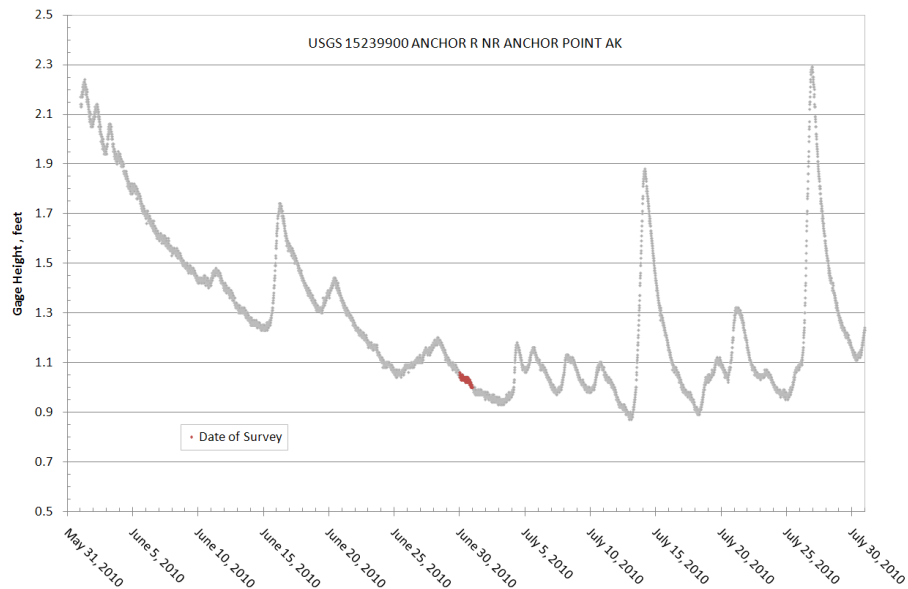
Figure 7- Stream flow graph for USGS gage '15239900-Anchor R NR Anchor Point AK' from May 31, 2010 to July 30, 2010.

During the time of the survey, one active USGS monitoring site was active near the intersection of Sterling Highway and Norman Lowell Road; however, temperature and precipitation data was unavailable for the monitoring site. The gage height graph for the time period before and after the survey can be seen in Figure 7³. Data from seasonal in-stream thermographs will be needed to assess how water temperatures on the day of the flight compare to average and maximum summer temperatures.

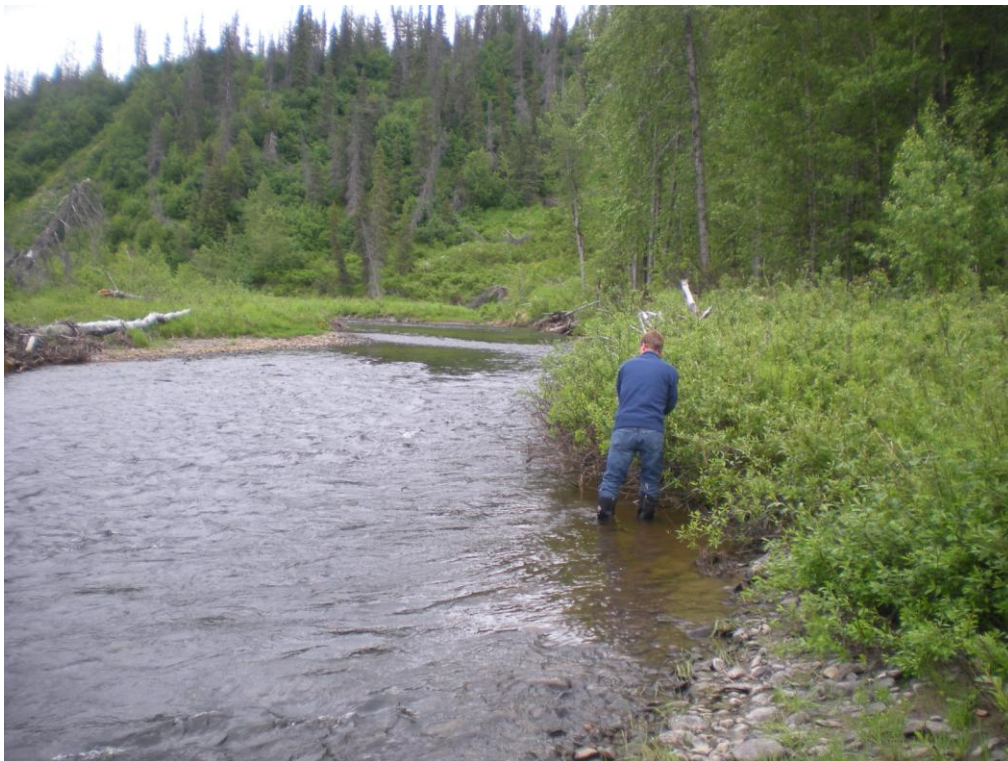
Figure 8- Watershed Sciences, Inc. deploying an in-stream data logger in the upper reaches of the South Fork Anchor River prior to the aerial TIR survey.

Seven in-stream data loggers were deployed in the South Fork Anchor River during the time frame of the flight (*Figure 8*). Table 4 summarizes a comparison between the kinetic temperatures recorded by the in-stream data loggers and the radiant temperatures derived from the TIR images. The differences between radiant and kinetic temperatures were consistent with other airborne TIR surveys conducted in the Pacific Northwest and within the target accuracy of $\pm 0.5^{\circ}\text{C}$.

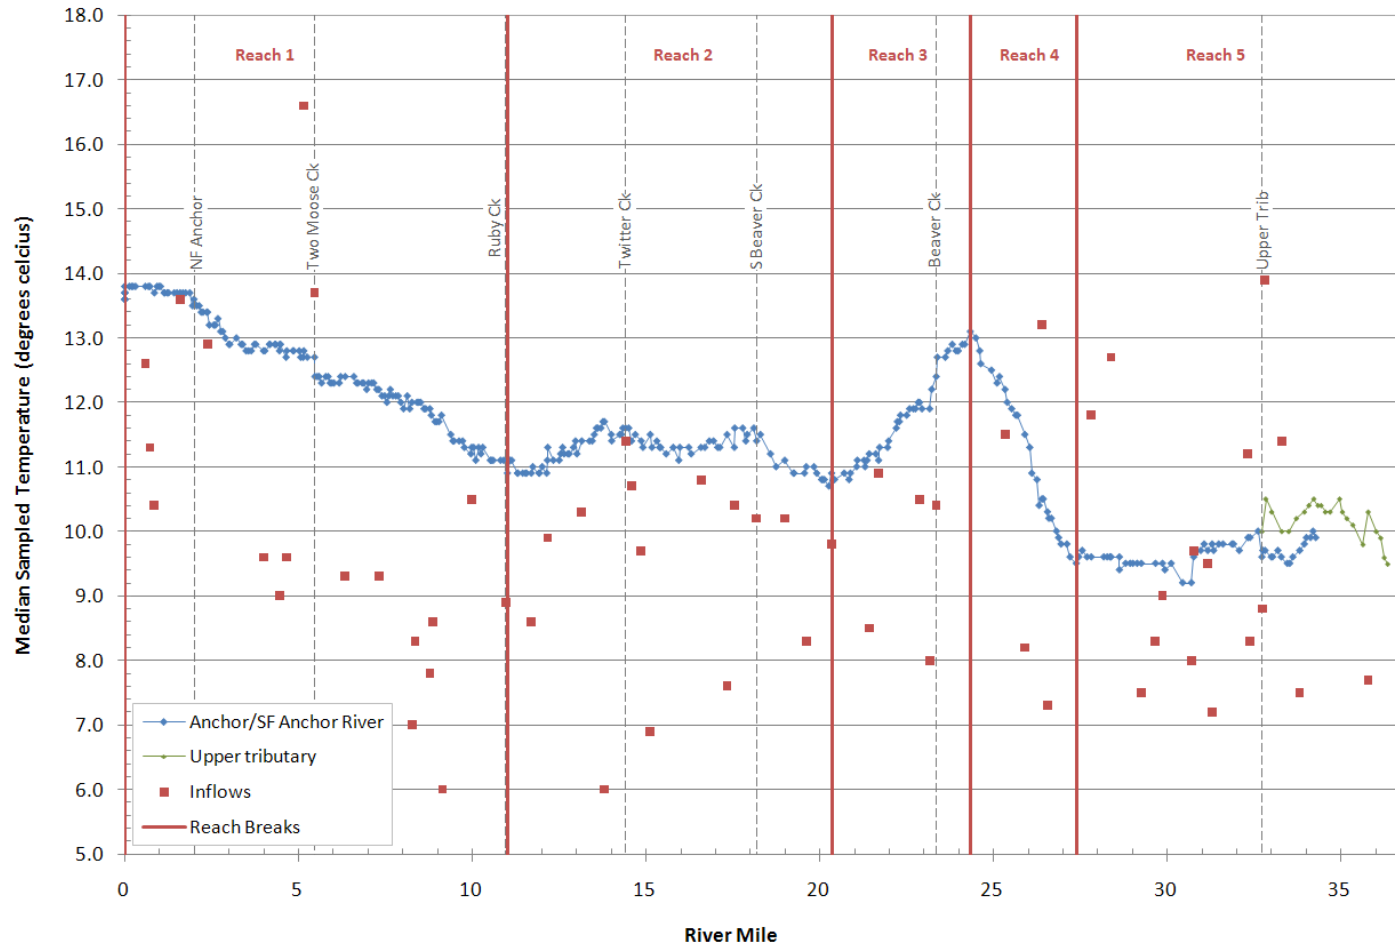
Figure 10 - Median channel temperatures plotted versus river mile for the Anchor and South Fork Anchor River. The locations of detected surface inflows are illustrated on the profile and listed in Table 5. The 'Reach Breaks' delineate the major thermal trends seen along the river.

Median channel temperatures were plotted versus river mile for the Anchor and South Fork Anchor Rivers (*Figures 9 and 10*). Tributaries, springs, and seeps sampled during the analysis are included on the longitudinal profile to provide additional context for interpreting spatial temperature patterns. Springs and seeps are generally differentiated by size and temperature; a feature is considered a spring when it has a defined source and is distinctly cooler than the surrounding waters. Features are called seeps when they are less defined spatially and in temperature; they most commonly occur on the edges of the river banks. If there was any doubt about the source of a feature, they were noted with a ‘?’ in the sampled shapefile. These locations should be verified in the field to confirm the presence of groundwater.

At the watershed scale, three types of thermal trends can typically be seen in a longitudinal profile: increasing temperatures, stable temperature plateaus, and decreasing temperatures. On a warm summer day, radiant water temperatures would be expected to increase as the river flows downstream in the absence of any external inflows. Reaches with stable temperatures or decreasing temperatures indicate zones of groundwater influence or cool surface inflow. Subsurface contributions commonly appear in areas where there are changes in river morphology, geology or valley type. These groundwater interactions may result in detectable point sources (i.e. seeps and springs) or they may be more diffuse and only be apparent in the overall trends seen in the longitudinal profile.

The Anchor River's temperature profile shows five distinct temperature reaches, with smaller point source fluctuations within each reach. Beginning upstream, above river mile 27.38 to the end of the survey (Reach 5), the longitudinal profile shows stable temperatures hovering between 9-10°C. This type of thermal plateau typically indicates that daytime heating is being tempered by groundwater influences. Ten of the seventeen sampled inflows along this reach contribute cooler water to the mainstem negating any diurnal heating. This reach is also very sinuous and has a very low gradient which allows for increased groundwater interchange with the slow moving water (*Anchor Image 2*).

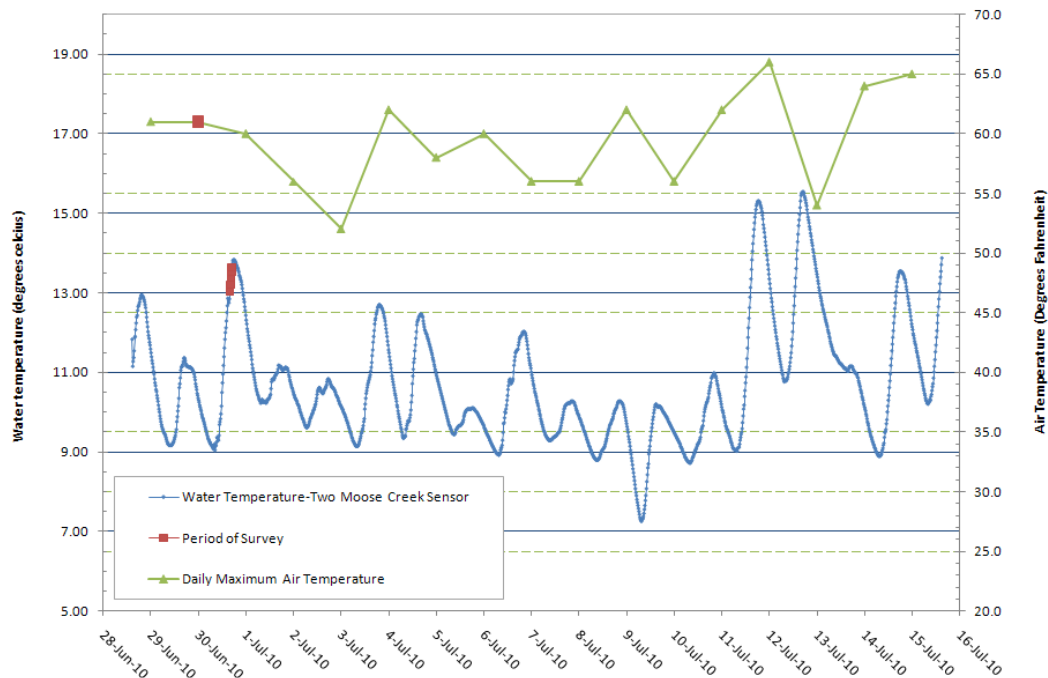
Figure 11 – Comparison of water temperatures recorded at the Two Moose Creek Sensor and daily maximum air temperatures in the weeks following the survey.

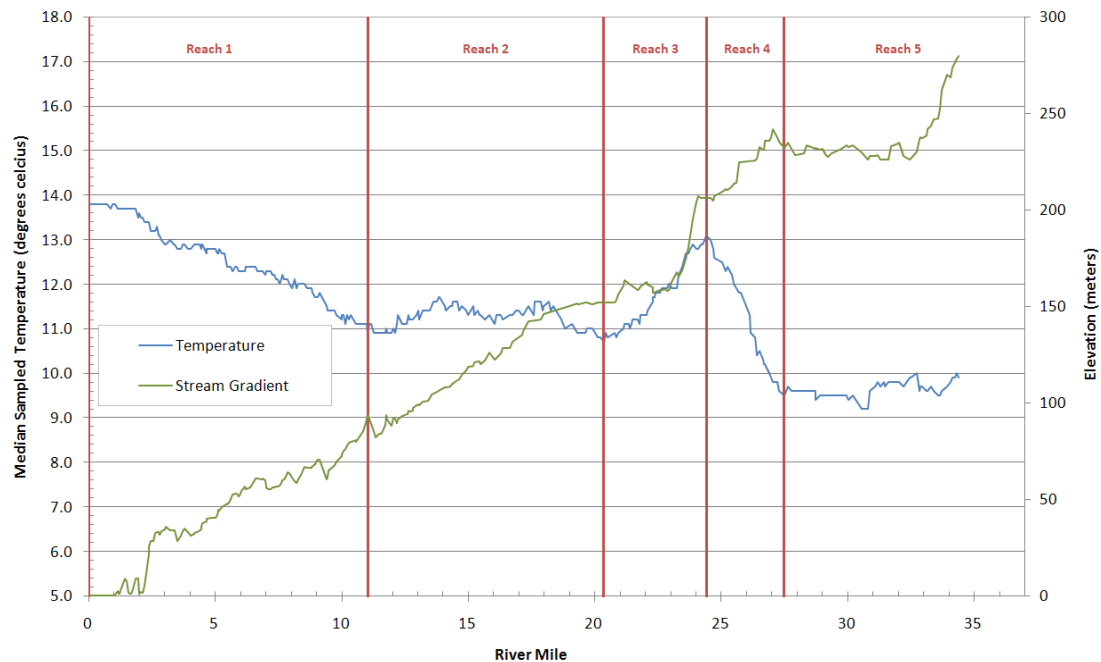
Figure 12- Thermal longitudinal profile as it relates to stream gradient. The transition in gradient seen between Reach 4 and 5 is a major contributing factor to the increase in temperatures seen in Reach 4. Stream gradient was coarsely calculated from the 30-meter Digital Elevation Model (DEM).

Below river mile 27.38 (Reach 4), the river straightens somewhat and the gradient increases greatly. This change in valley morphology results in decreased groundwater influence and increased temperatures (*Figure 12*). Only three cool water inflows were sampled in this reach, contributing only small volumes of water.
