Bartlett/Hohe Rehabilitation Project Water Quality Monitoring Report

May 2007

Prepared by Joel Cooper for

Cook Inletkeeper

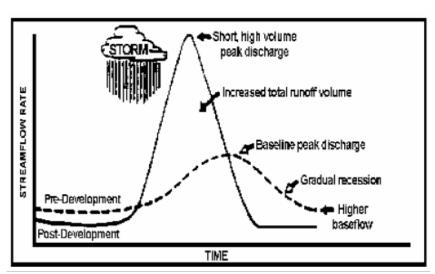
Impacts of urbanization on stream flow. (EPA 2000)

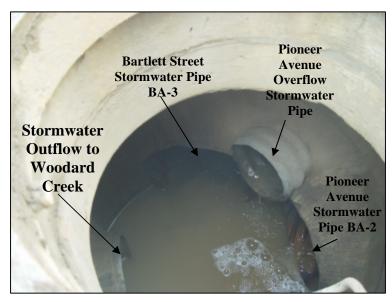
Looking down manhole at intersection of Bartlett Street and Pioneer Avenue where BA-2 and BA-3 samples were taken

assess the effectiveness of the Stormwater Management® StormFilter, samples were collected in the Bartlett stormwater pipe both above (BA-3u) and below (BA-3) the filter.

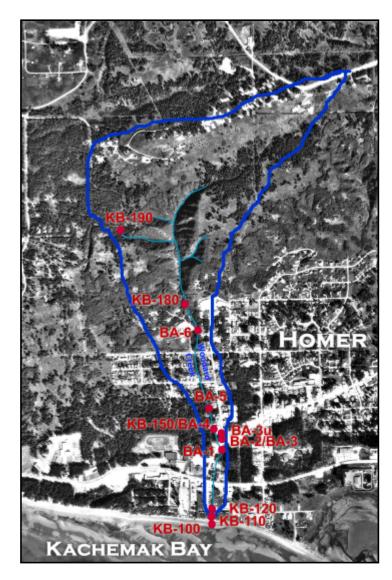
Figure 1: Project and CEMP monitoring sites in the Woodard Creek watershed.

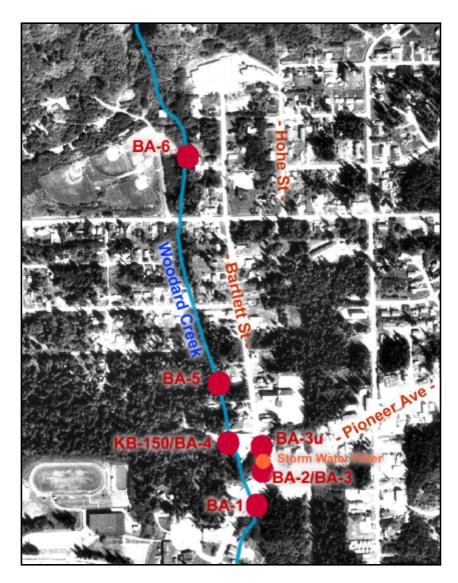
Figure 2: Project monitoring sites in Woodard Creek and the Bartlett Street Stormwater system.

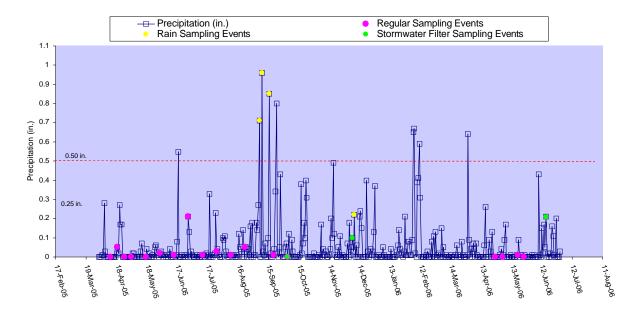
Figure 3: Daily precipitation for the Homer Airport (PAHO) weather station from 4/1/05 to 6/30/06 and when project samples were collected.

Rainfall during the project and when samples were collected is shown in Figure 3. Table 4 summarizes the rainfall for rain and stormwater sampling events.

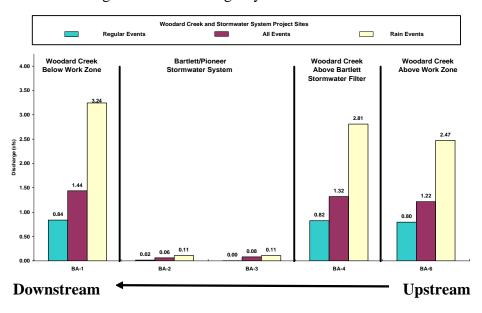
Figure 4: Mean Discharge for Sampling Events from 4/12/05 to 6/16/06 at Woodard Creek and Stormwater System Project Sites.

Calculated discharge readings ranged from 0.14 to 5.11 cfs at Woodard Creek monitoring sites. Figure 4 shows mean discharge values increasing as you move downstream at Woodard Creek

sites. The highest discharge readings were recorded on 9/16/05 when 0.82 inches of rain fell in a 24-hour period prior to sampling.

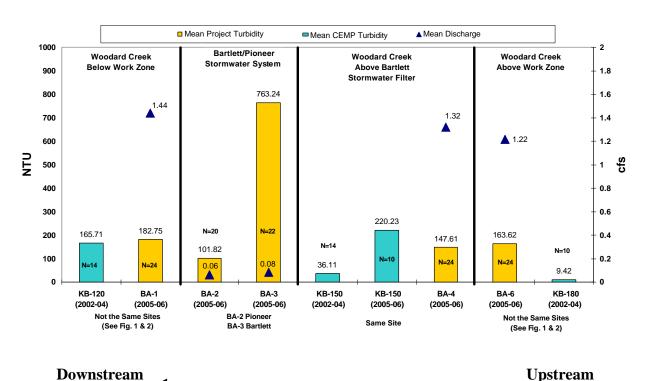
Figure 5: Mean turbidity and discharge data collected from 4/12/05 to 6/16/06 at Project sites and mean turbidity data from 10/01/02 to 5/18/06 at CEMP sites. Note: Data sets do not include the months Jan.-Mar.

Figure 5 compares Project mean turbidity data with CEMP mean turbidity data. This figure shows Project Woodard Creek sites have higher mean turbidity readings in 2005-06 than mean turbidity in 2002-04 at CEMP sites that are the same or in close proximity, and that mean turbidity is higher in the Bartlett Stormwater System than the Pioneer Stormwater System. BA-6 show increases of 154 NTUs in 2005-06 when compared to 2002-04 data for KB-180

(approximately 100 yards upstream). CEMP data for KB-150 show increases of 184 NTUs when comparing to 2002-04 data to 2005-06 data. Comparing KB-150 data for 2002-04 to BA-4 data for 2005-06 shows an increase of 111 NTUs. Mean turbidity differences in 2005-06 between CEMP data at KB-150 and project data at BA-4 is due to a CEMP sample collected on 4/30/06 (2119 NTU). Figure 5 also plots mean discharge for project sites showing high turbidity for relatively small flow rates.

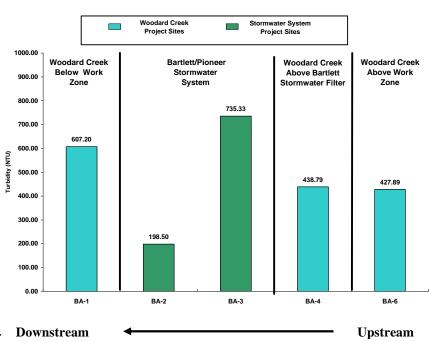
Figure 6: Mean rain event turbidity values at Woodard Creek and Stormwater System Project Sites.

Data collected during rain events shows turbidity increasing as you move downstream and that the Bartlett Street stormwater system has a significantly higher mean turbidity than the Pioneer Avenue stormwater system (Figure 6).

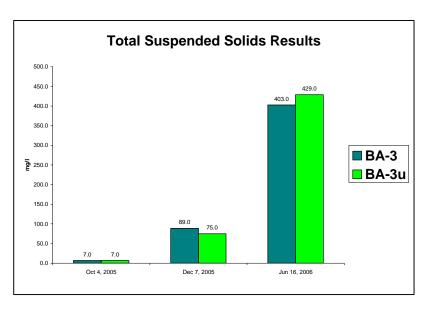
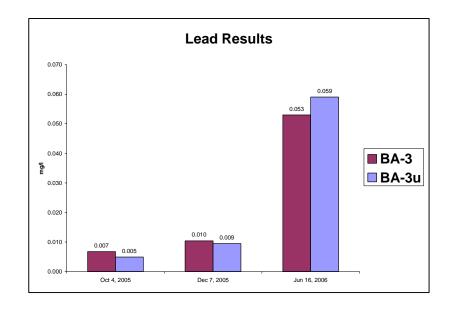
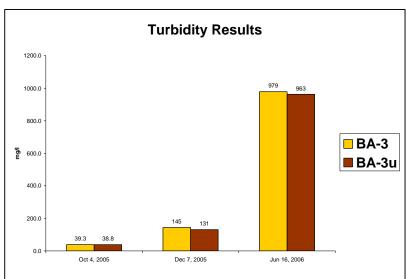
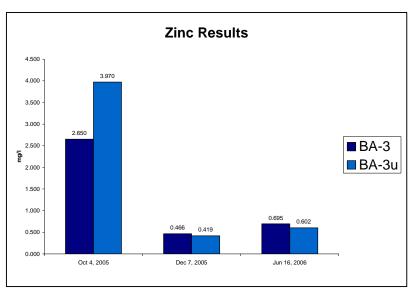
Figure 7: Total Suspended Solids, Turbidity, Lead, and Zinc results for samples collected above and below the Bartlett Street stormwater filter on 10/04/05, 12/07/05, and 06/16/06.
