# Citizens' Environmental Monitoring Program Baseline Water Quality Report

## Beaver Creek 2002-2010

Citizens' Environmental Monitoring Program  
Baseline Water Quality Reports  
2011: Beaver Creek

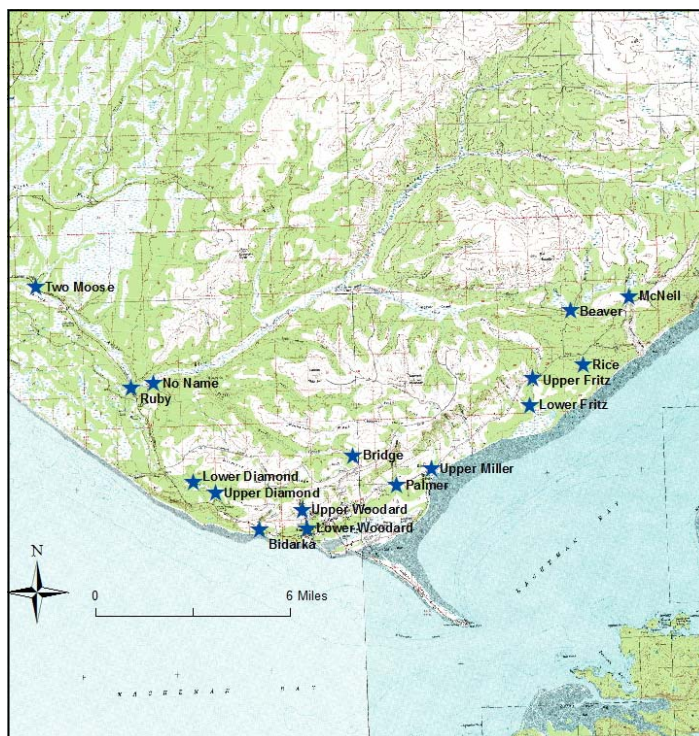
*All of the CEMP sites that will have baseline water quality datasets completed by 2014. Baseline reports will be developed as datasets are completed. A full baseline water quality library from the efforts of the Kachemak Bay and Anchor River CEMP is anticipated by 2015.*

visits, during the course of the year. Alternatively, a minimum of 80 site visits over the course of monitoring at a site may be used for a baseline dataset if other criteria are met. The map above shows the location of the sites that will have completed baseline datasets by 2014. Baseline reports for these sites will make up the baseline water quality library.

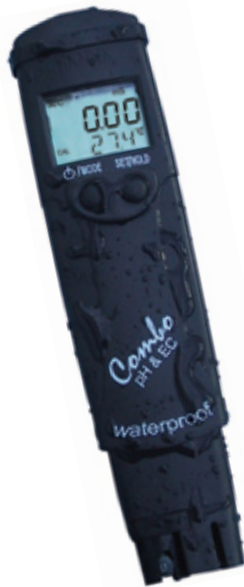
*CEMP monitors measures pH and specific conductance using waterproof Hanna combo meters. Monitors calibrate their meters before every sampling event. In addition, Inletkeeper's CEMP Coordinator collects all meters quarterly to clean and calibrate them in the laboratory. The meters automatically correct pH and conductivity values for the stream temperature.*

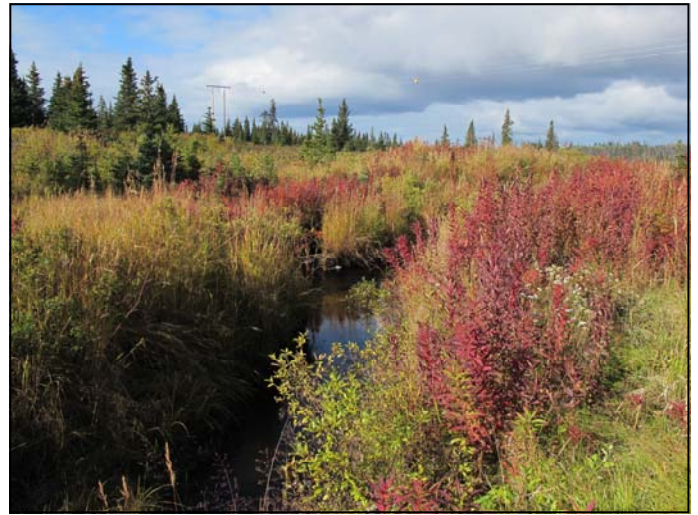
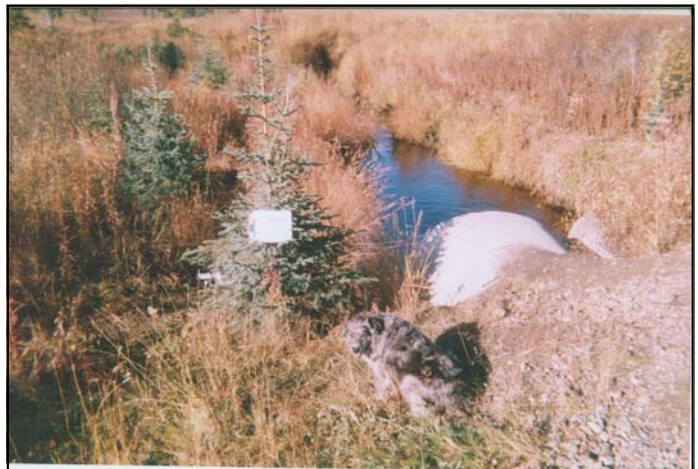
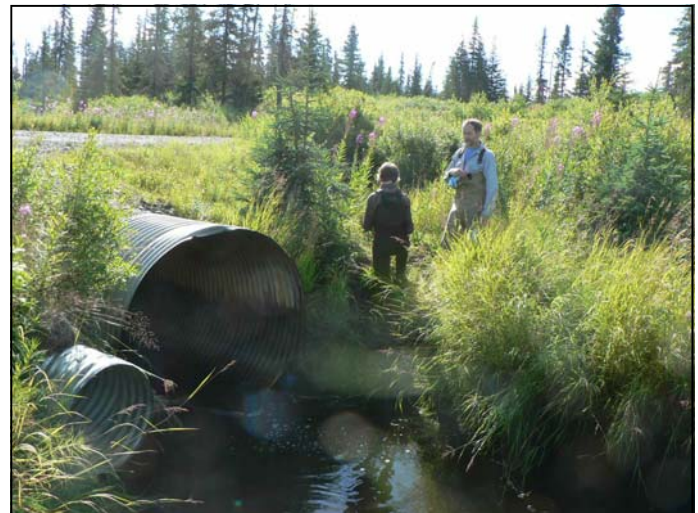
*Site photos from Upper Beaver Creek (AR-1090). Top: looking downstream, fall of 2010, Middle: looking downstream, fall of 2007, Bottom: looking upstream from below Bald Mountain Road during bioassessment in the summer of 2007.*

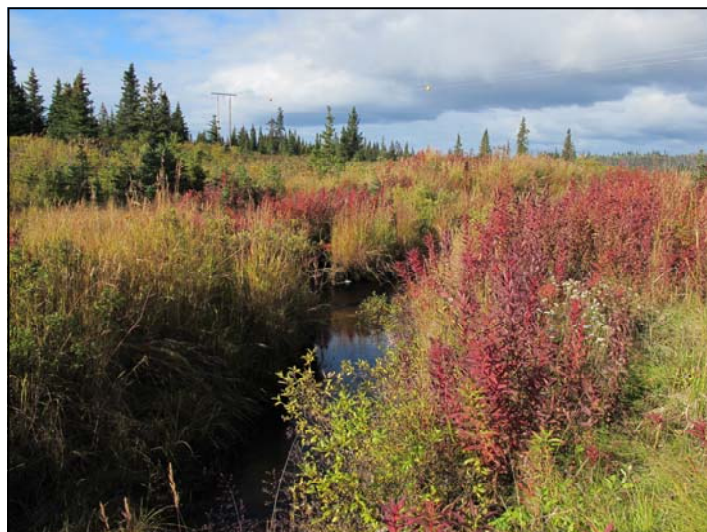
*Looking downstream from the Bald Mountain Road crossing at the Beaver Creek CEMP site. All water quality sampling was done downstream of the road crossing.*

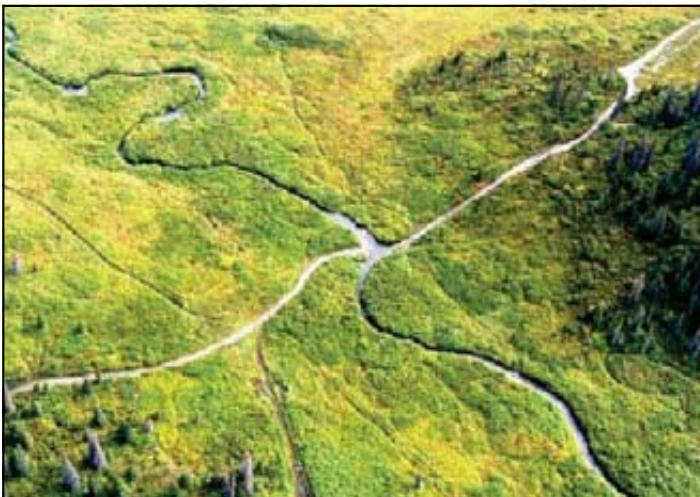
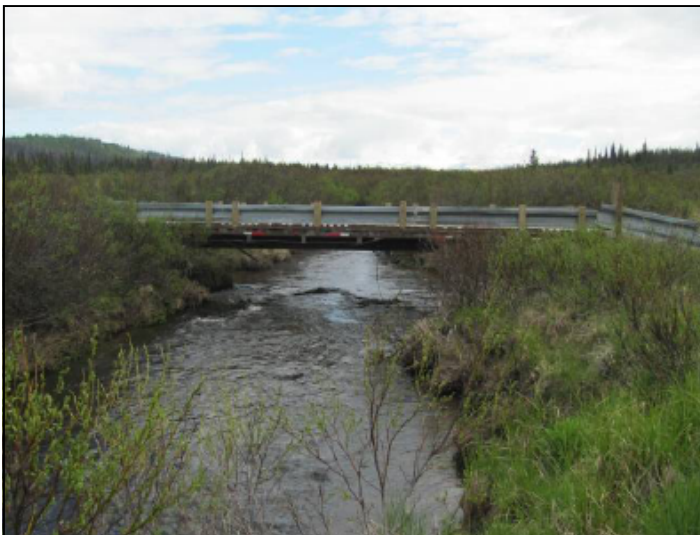
*Left: These pictures were included in the Homer Soil and Water Conservation District's Final Report (2010) on the Watermelon Trail bridge crossing project (ADEC ACWA Grant Project #: ACWA-10-14). The top photo shows the trail crossing Beaver Creek prior to the project. The bottom photo shows the final bridge, located about 60 feet upstream of the original crossing. Above: This map, provided by the Homer Soil and Water Conservation District (01/2011), shows the locations of reed canary grass on the South Fork of the Anchor River and on lower Beaver Creek.*

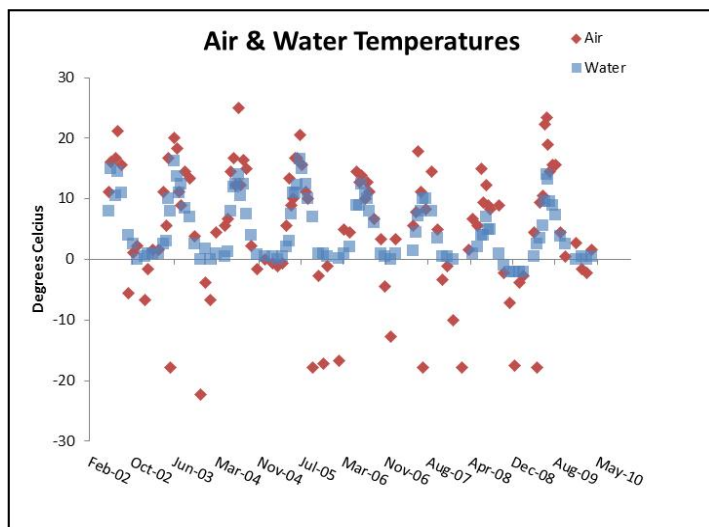
Top: All water (blue) and air (red) temperatures taken with the alcohol-filled thermometers by CEMP monitors during site visits at Beaver Creek from June 6, 2002 to March 29, 2010. Bottom: Average water (blue) and air (red) temperatures by month from CEMP site visits between 2002 and 2010.

There were 22 days in 2007 of temperatures exceeding the  $13^{\circ}\text{C}$  temperature water quality standard for fish spawning and egg and fry incubation, and 4 days when temperatures exceeded

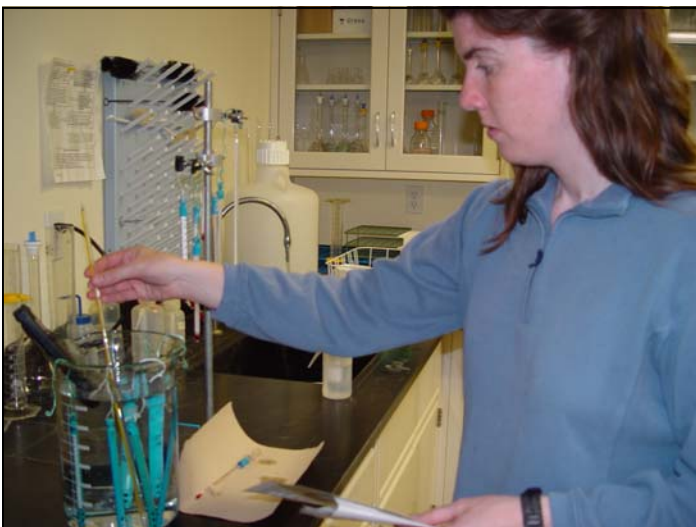
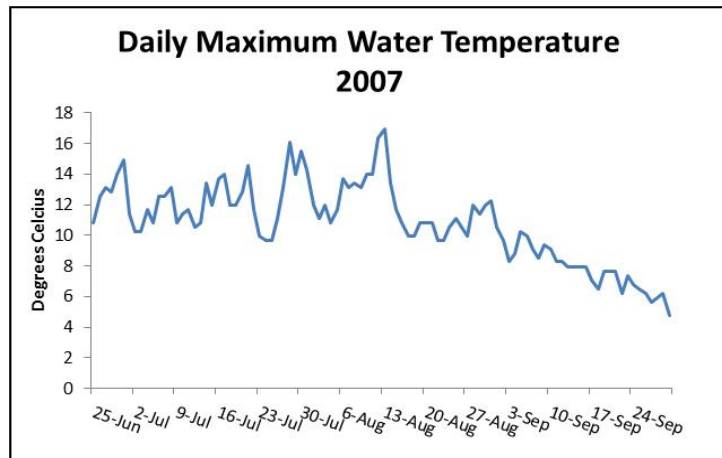
*Top: Daily maximum water temperatures measured at Beaver Creek during 2007 by the continuous data logger. Left: Air and water thermometers are checked for accuracy every year in the lab during CEMP recertification.*

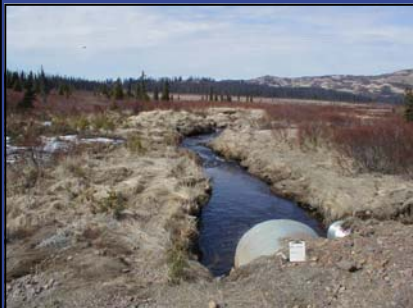
**August 27, 2006** New beaver dam 25 feet downstream has raised water level about 2 feet. Several dams are below this new one.

**May 13, 2007** 4 beaver lodges! Water about 1' higher than last year. Water backed up past culverts, road.

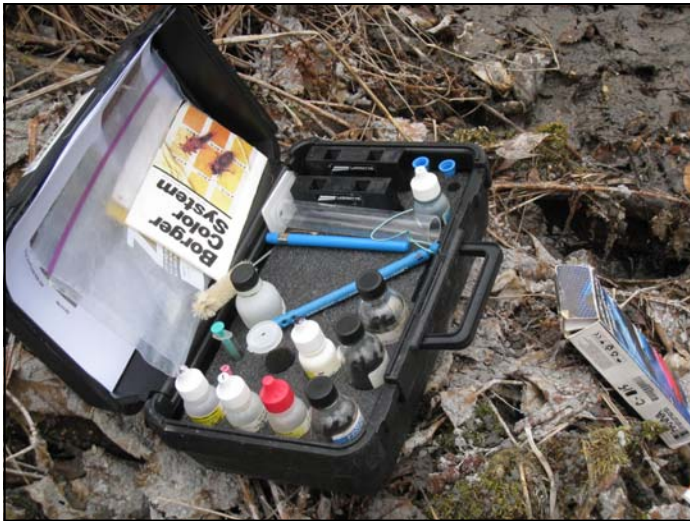
*CEMP monitors measure dissolved oxygen using the Winkler Titration. Most of the chemical reagents in their monitoring kits are for this test.*

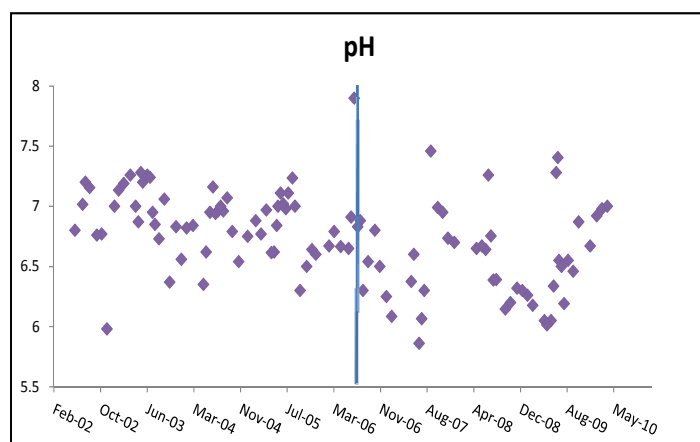
*Top: All pH taken by the Hanna Meter by CEMP monitors during site visits at Beaver Creek from June 6, 2002 to March 29, 2010. The vertical blue line indicates the date when CEMP monitors first observed changes in the stream from the beaver dam construction. Bottom: Average pH by month from CEMP site visits between 2002 and 2010.*

During the summer of 2006, beavers built a series of dams downstream of the CEMP monitoring site at Beaver Creek. Following the construction of these dams, the variability in pH increased and average pH levels have slightly decreased from 6.87 to 6.59 ( $p < 0.001$ ,  $t = 4.40$ ). The vertical blue line in the top figure shows when CEMP monitors first observed changes in the stream from the beaver dams.

There were 25 exceedences of the state water quality standard for pH at Beaver Creek. Twelve of these occurred between July, 2008 and June, 2009. There were 2 additional exceedences occurring in August and September of 2009. ❄

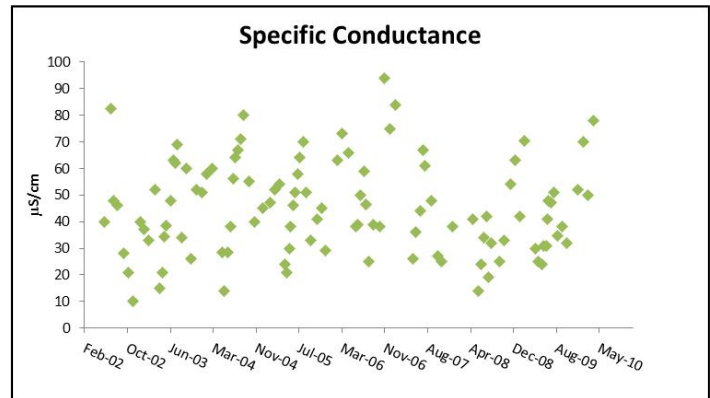
*Top: All specific conductance data ( $\mu\text{S}/\text{cm}$ ) were taken with a Hanna Meter (HI 98129) by CEMP monitors during site visits to Beaver Creek from June 6, 2002 to March 29, 2010. Bottom: Average specific conductance ( $\mu\text{S}/\text{cm}$ ) by month from CEMP site visits between 2002 and 2010.*

CEMP volunteers measured specific conductance during 107 site visits to Beaver Creek between 2002 and 2010. Average specific conductance was  $45 \mu\text{S}/\text{cm}$  and ranged from  $10 \mu\text{S}/\text{cm}$  –  $94 \mu\text{S}/\text{cm}$ . Throughout the year, specific conductance was higher during the winter and summer months and lower during April, May, and October. Heavy rains during these months may have diluted groundwater inputs to the stream, thereby lowering its specific conductance. This site is located just downstream of a small dirt road (Bald Mountain Road, off of Hutler Road, 11 miles east of Homer). While some runoff likely is produced during rain events, there is a minimal amount of impervious cover around and upstream from this Beaver Creek site, and specific conductance values are consequently low. 🌱

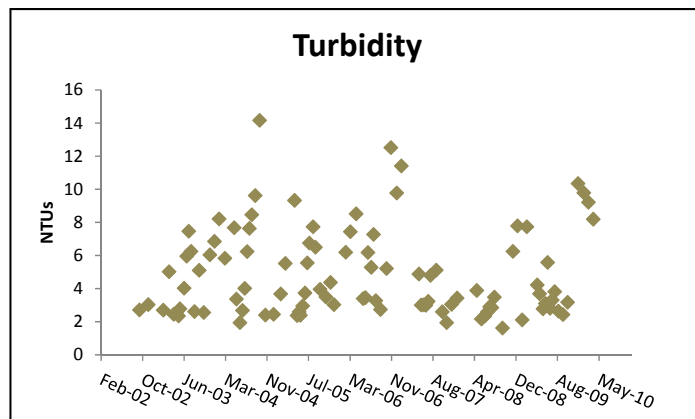
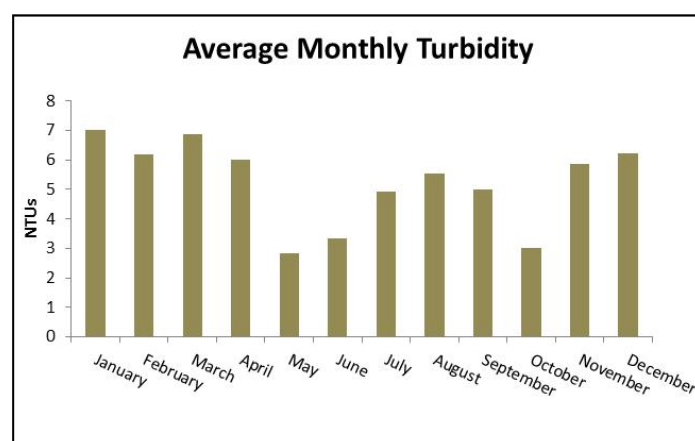
Top: All turbidity data (NTU) were collected by CEMP monitors during site visits to Beaver Creek from June 6, 2002 to March 29, 2010. Water samples for turbidity analysis are collected in the field and analyzed in the lab using a LaMotte Turbidimeter. Bottom: Average turbidity (NTU) by month from CEMP site visits between 2002 and 2010.

An example comes from the site visit comments, recorded on January 31, 2010 (Turbidity = 9.78 NTU): “Axed down 6”, water came up in the hole with lots of debris – don’t know if it was suspended in stream or if it was stirred up by water rushing into the hole...” ❄️

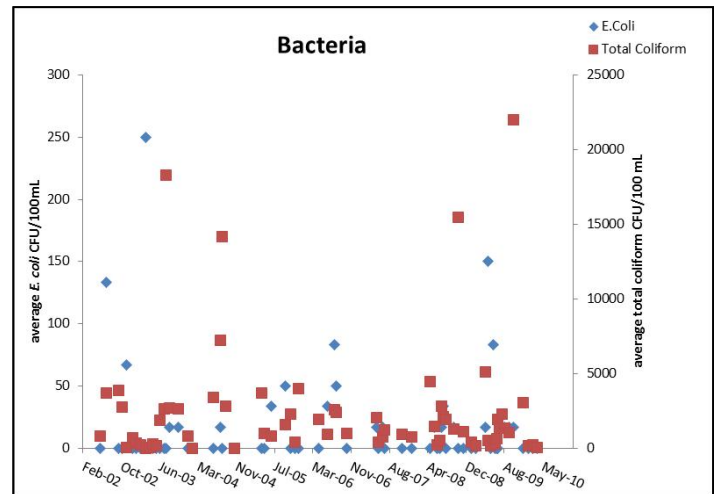
Top: Bacteria levels at Beaver Creek from June 6, 2002 to March 29, 2010. *E. coli* colonies are in blue, and total coliform colonies in red. Both data sets show the average colony forming units (CFU) per 100mL. Bottom: Water samples are mixed with a bacteria-growing medium and incubated on a petri dish for 48 hours. Different types of bacteria show up as different colors, providing counts of total coliform and *E. coli* colonies.

CEMP monitors collected water samples for bacteria testing that were successfully plated and incubated during 69 site visits. Bacteria levels have been low throughout the years of sampling at Beaver Creek. Total coliform colonies were generally below 5,000/100mL. Four sampling events had total coliform numbers near or above 15,000/100mL (August 9, 2003 and 2004, and October 26, 2008 and 2009). Total coliforms include fecal and *E. coli* coliform bacteria. They are present in soils and surface waters and don't necessarily indicate pollution. Higher total coliforms counts are often found during periods of wet weather. *E. Coli* colonies were present in 39% of the samples (n = 27). The average number of colonies was 47/100mL. The highest *E. coli* colony count was 250/100mL on March 30, 2003. There was no discernable change in *E. coli* levels following the establishment of beaver dams downstream of the site in 2006. No changes were noted in water temperature, either, indicating that the influence from downstream dams

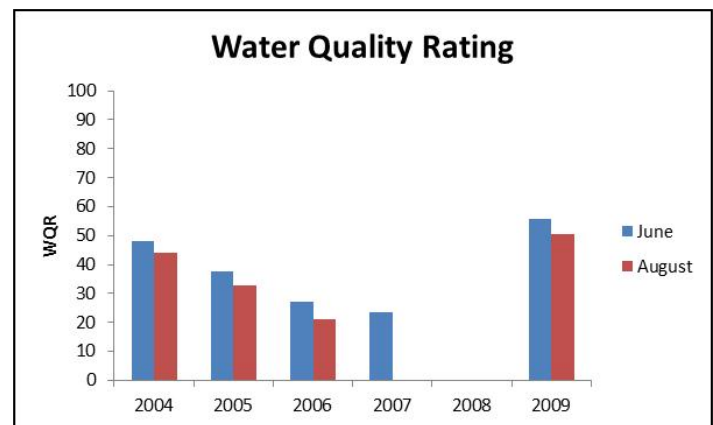
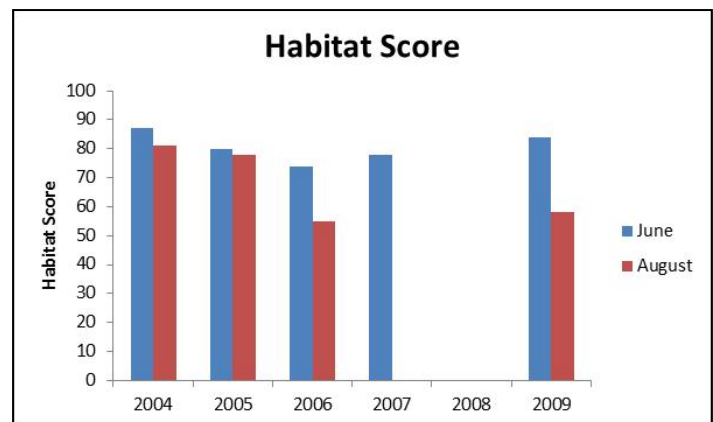
*Bioassessment indices used to assess the macroinvertebrate community and water quality at Beaver Creek from 2004—2009 in June (blue) and again in August (red). Top: EPT Richness shows the number of taxa classified as Ephemeroptera (mayflies), Plecoptera (stoneflies), or Trichoptera (caddisflies) during sampling. Middle: The Water Quality Rating is on a scale of 0-100. This metric is calculated using several parameters (see text). Bottom: The Habitat Score is on a scale of 0-100 and rates 10 components of stream habitat for macroinvertebrates.*

EPT Richness and WQR both declined from 2004-2007 at Beaver Creek. In 2009, water had receded from the beaver dam construction and both indices were at their highest since sampling began in 2004. The lowest EPT Richness and WQR scores occurred in 2006 and 2007. Beaver dams tend to slow the flow of water, increasing sedimentation and decreasing available habitat for aquatic insects.

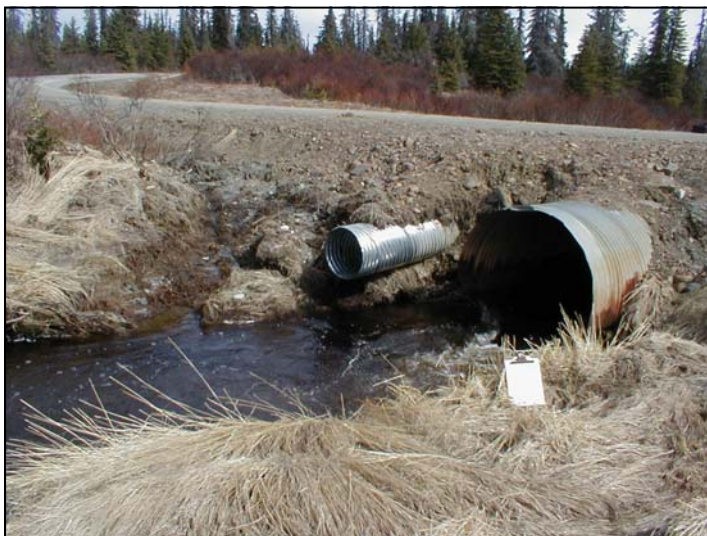
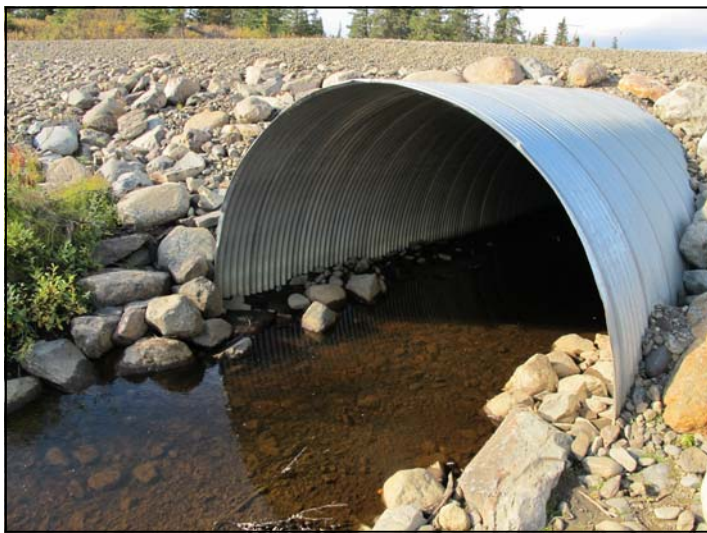
*Beaver Creek, passing under Bald Mountain Rd. The old culvert pipes (top) were replaced in the summer of 2009 with one larger culvert arch to improve water flow during high water events (bottom).*

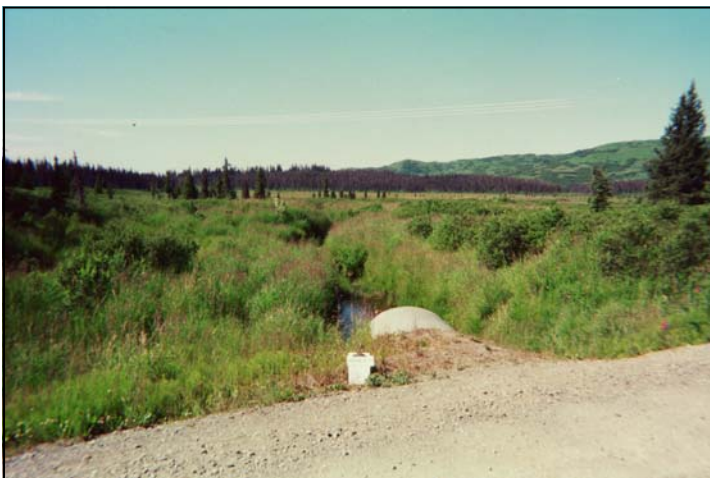
*Left: CEMP sampling site AR-1090, upper Beaver Creek, during the first year of sampling. This picture was taken in August of 2002.*

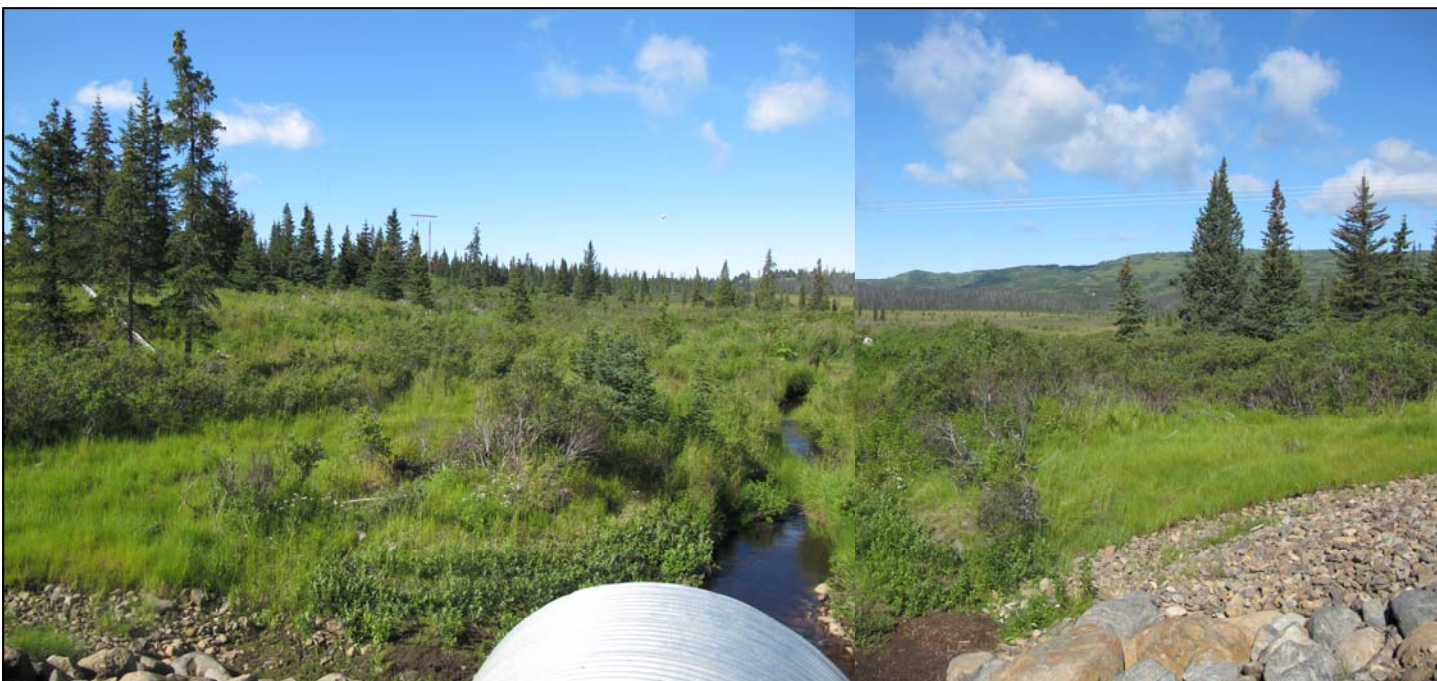
*Bottom: Two photos stitched together. Together these pictures provide a wider perspective of the riparian zone that was included in the Stream Walk assessment. These pictures were taken in August of 2010.*

- Do a Stream Walk every other year (in summer), starting in 2012, with a minimum of 4 photographs taken from established photo points. Incorporate a basic invasive species assessment in partnership with the Homer Soil & Water Conservation District.
- Do a GIS analysis when new satellite images become available to Inletkeeper staff to assess

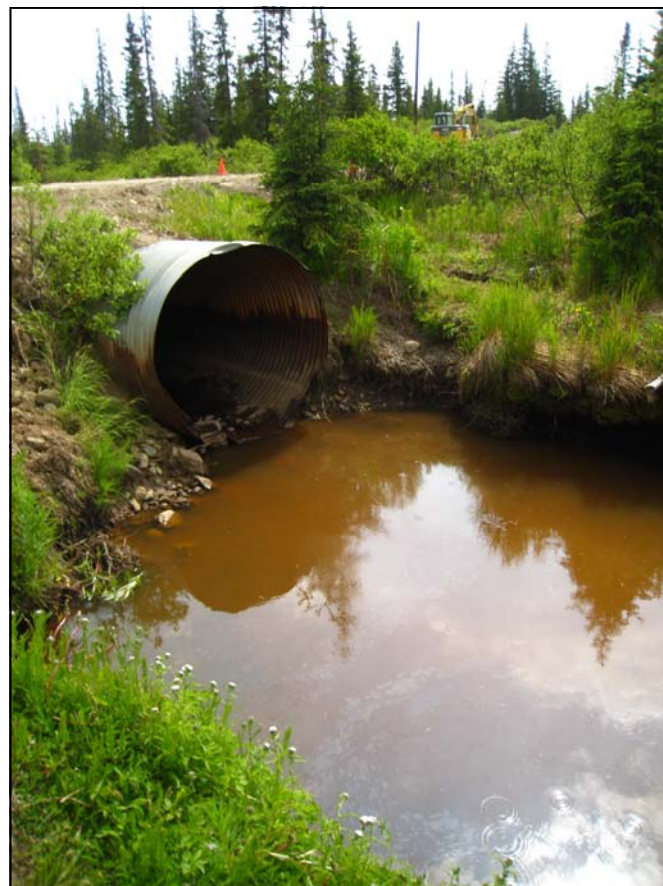
*Inletkeeper staff and volunteers maintained a visible presence during the culvert replacement project at the upper Beaver Creek site during the summer of 2009. Baseline water quality reports for CEMP sites provide a foundation for the protection of water quality in our watersheds.*
