Citizens' Environmental Monitoring Program Baseline Water Quality Report

Bidarka Creek 1996—2010

Citizens' Environmental Monitoring Program
Baseline Water Quality Reports
2011: Bidarka Creek

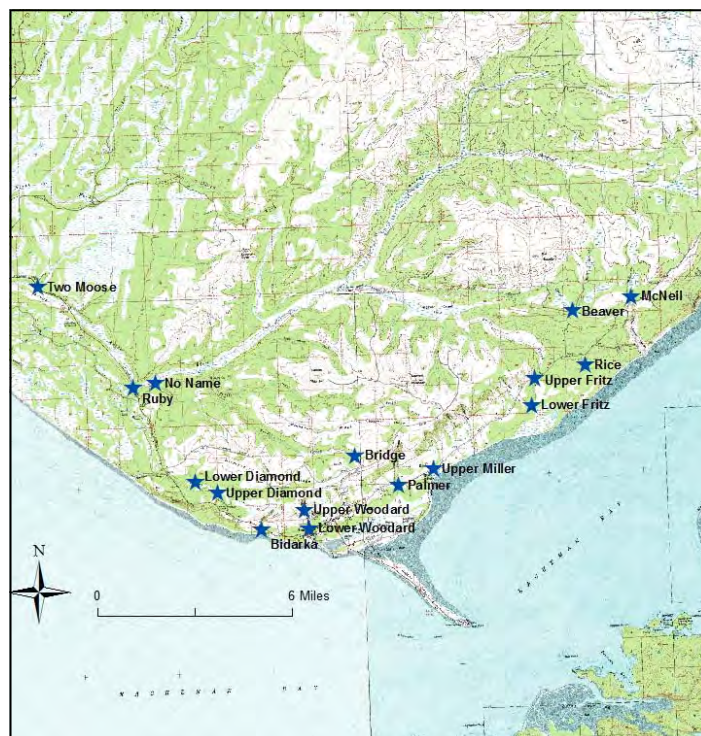
All of the CEMP sites that will have baseline water quality datasets completed by 2014. Baseline reports will be developed as datasets are completed. A full baseline water quality library from the efforts of the Kachemak Bay and Anchor River CEMP is anticipated by 2015.

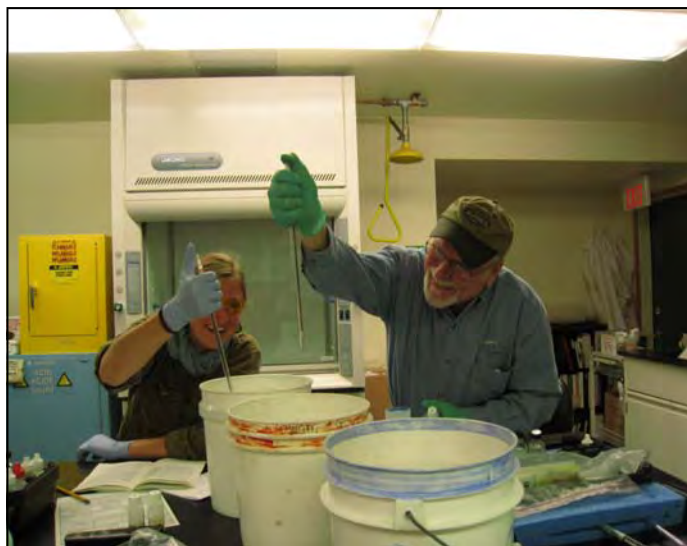
Volunteers learn how to follow protocols for collecting water quality data in the Inletkeeper lab during Phase II of CEMP training.

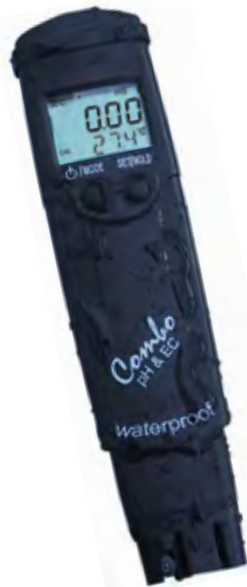
CEMP monitors measures pH and specific conductance using waterproof Hanna combo meters. Monitors calibrate their meters before every sampling event. In addition, Inletkeeper's CEMP Coordinator collects all meters quarterly to clean and calibrate them in the laboratory. The meters automatically correct pH and conductivity values for the stream temperature.

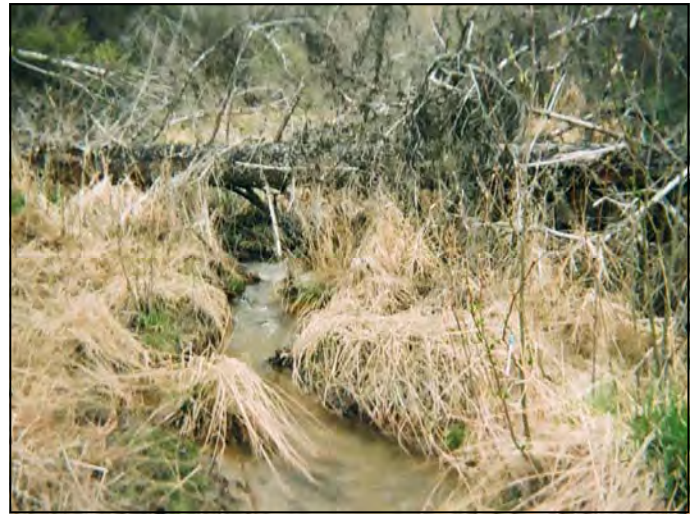
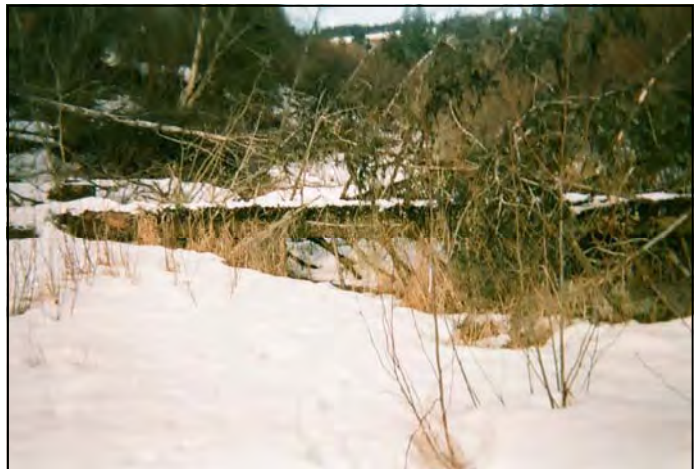
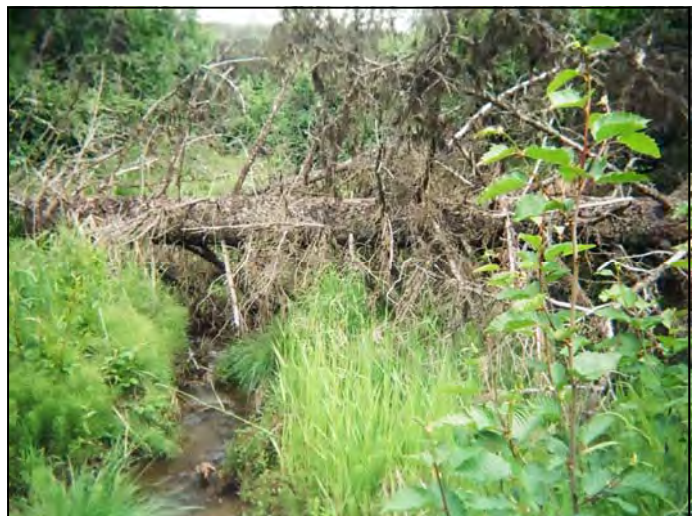
Site photos from Bidarka Creek Top: looking upstream, fall of 2006, Middle: looking upstream, winter of 2007, Bottom: looking upstream, summer 2007.

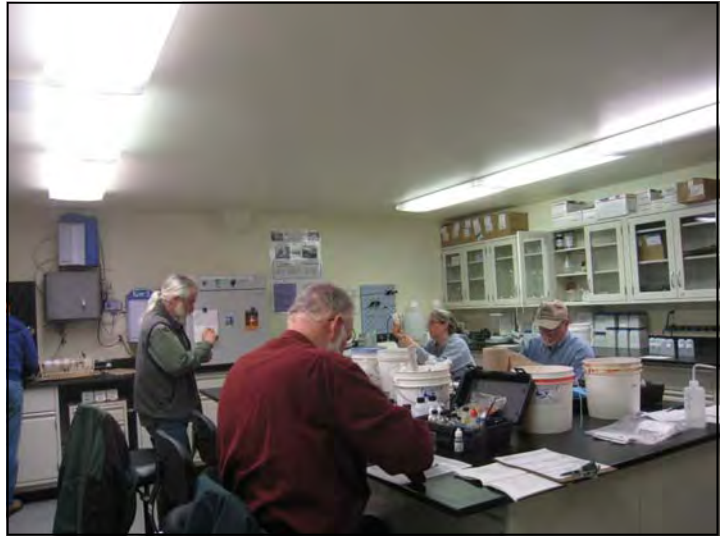
Right: CEMP monitors go through a 3-day training to become certified for water quality sampling at Cook Inletkeeper's laboratory in Homer.

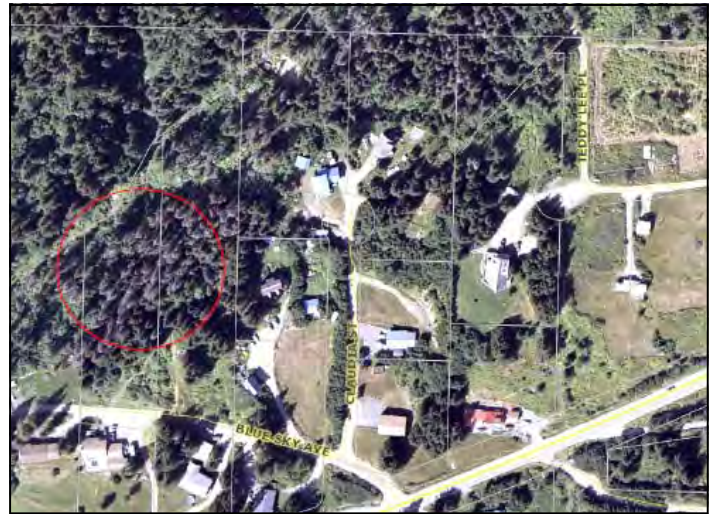
From the Kenai Peninsula Borough Parcel Viewer (accessed 09/21/2011). Dead standing spruce, common in the treed areas of the watershed, can be seen in the red circle.

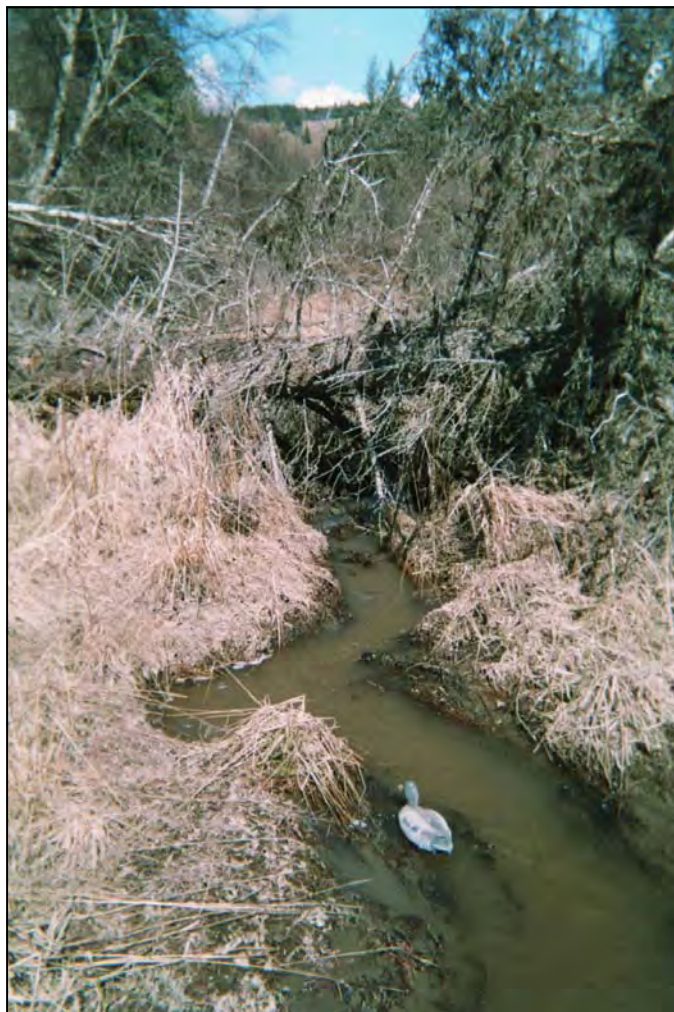
Above: A site photo taken at Bidarka Creek in the fall of 2006 shows a mallard duck in the stream. Bottom left: As a small system, Bidarka Creek would often freeze solid during the winter months at the CEMP sampling site. This picture was taken in the winter of 2008, looking upstream from the sampling location.

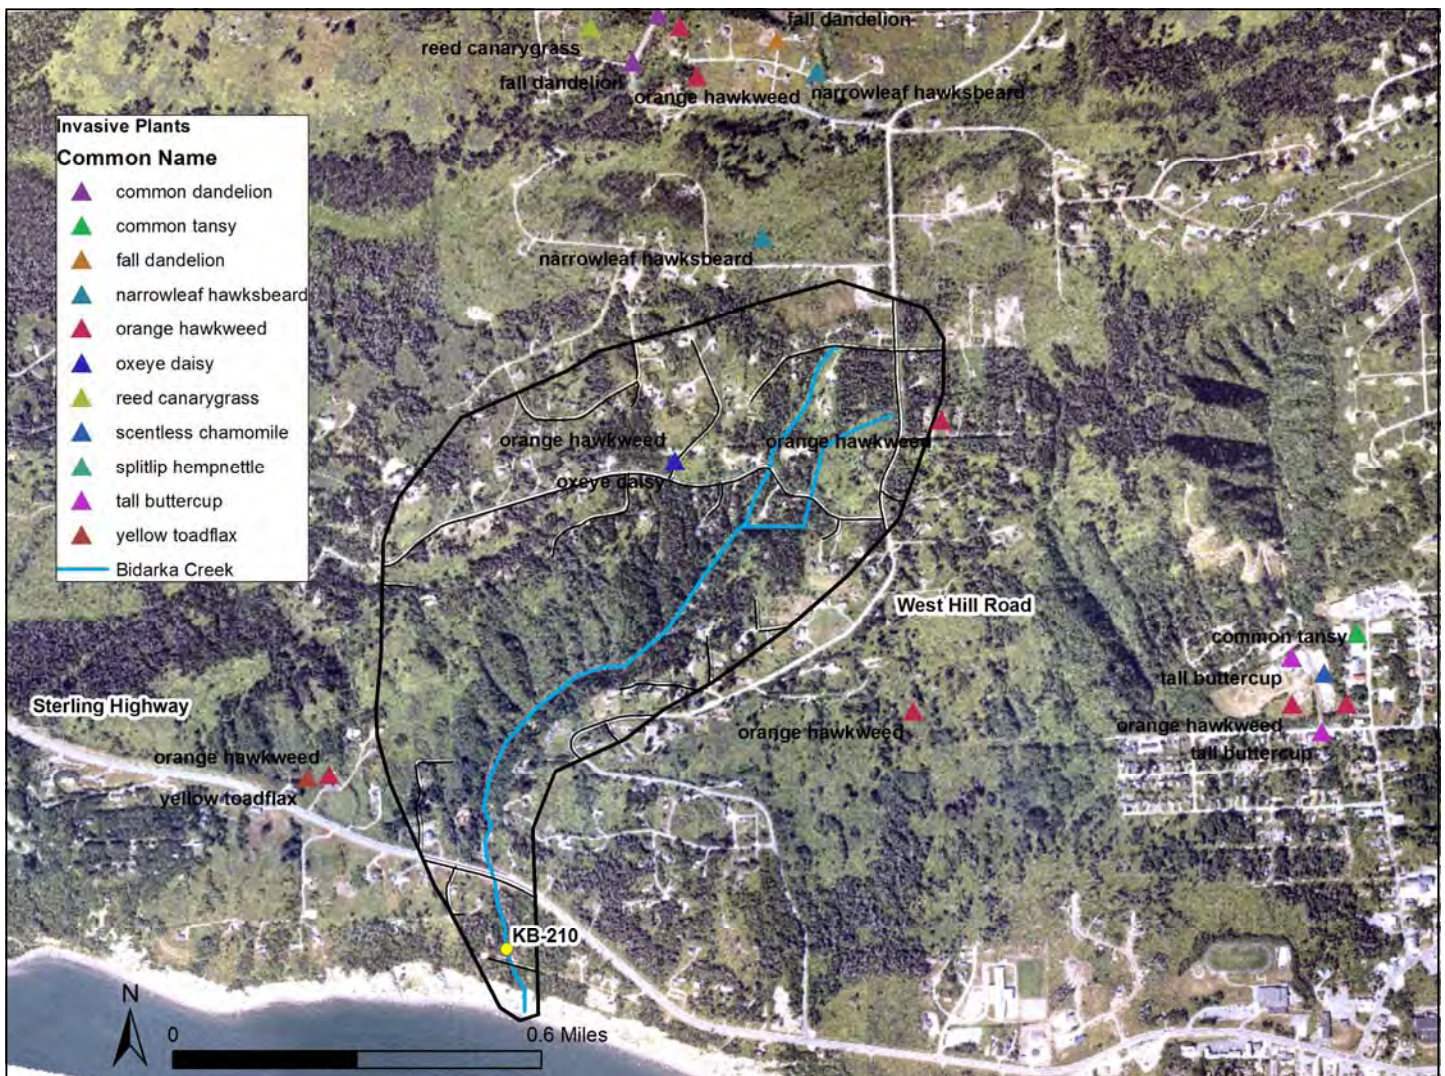
Basemap: Kenai Peninsula Borough fixed wing aerial imagery, 2003. Invasive species data from the AKEPIC Data Portal, accessed September 2011: <http://aknhp.uaa.alaska.edu/maps/akepic/>.

Orange hawkweed and oxeye daisy are documented to occur within the Bidarka Creek watershed. These common invasive plants are found throughout neighborhoods in Homer, and can be seen on lands surrounding Bidarka Creek. Reed canarygrass, an aggressive invasive that can fill in stream beds and destroy habitat for fish and other aquatic organisms, has been documented north of Bidarka Creek, in the Diamond Creek watershed. No invasive species were seen during the habitat assessment at CEMP site KB-210 in August 2010, however landowners in the water-

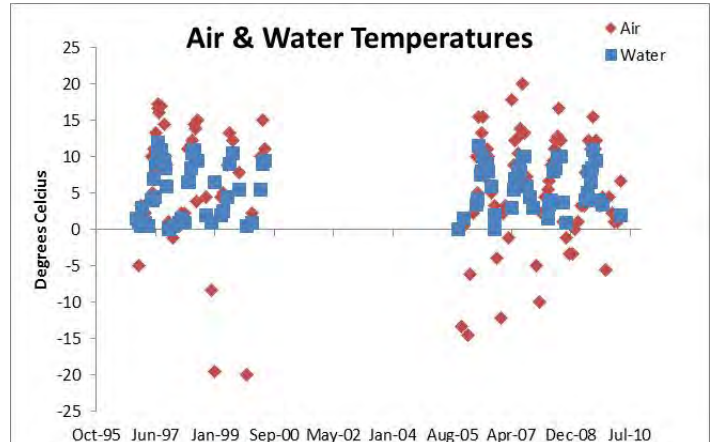
Top: All water (blue) and air (red) temperatures taken with the alcohol-filled thermometers by CEMP monitors during site visits at Bidarka Creek from 1996 to 2010. Bottom: Average water (blue) and air (red) temperatures by month from CEMP site visits between 1996 and 2010.

Air temperature was recorded at 117 site visits to Bidarka Creek. Average air temperature was 5.9°C (43°F). Air temperature ranged from -20°C (-4°F) to 20°C (68°F). Air temperature was lowest during the winter months of November (-4.0°C), December (-6.1°C) and January (-4.3°C) and warmest during June (12.0°C), July (13.1°C) and August (13.4°C). ❄

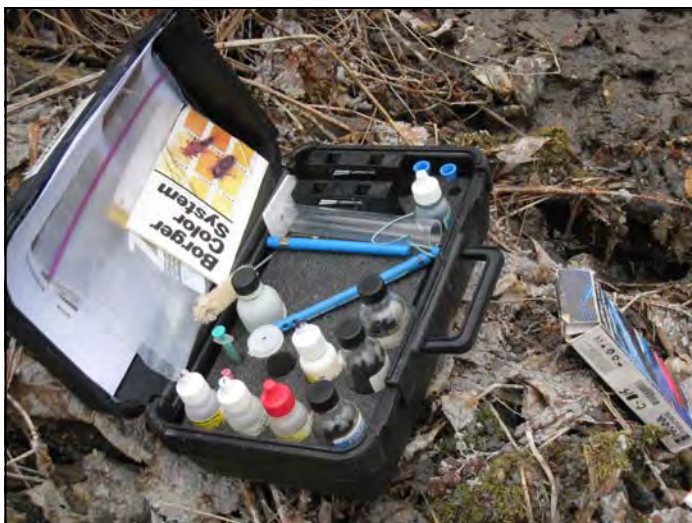
CEMP monitors measure dissolved oxygen using the Winkler Titration. Most of the chemical reagents in their monitoring kits are for this test.

CEMP monitors the levels of dissolved oxygen (DO) in our streams. Oxygen is needed by fish and other aquatic organisms to live. We measure DO using a chemical titration, and express it as a concentration of milligrams of oxygen per liter of

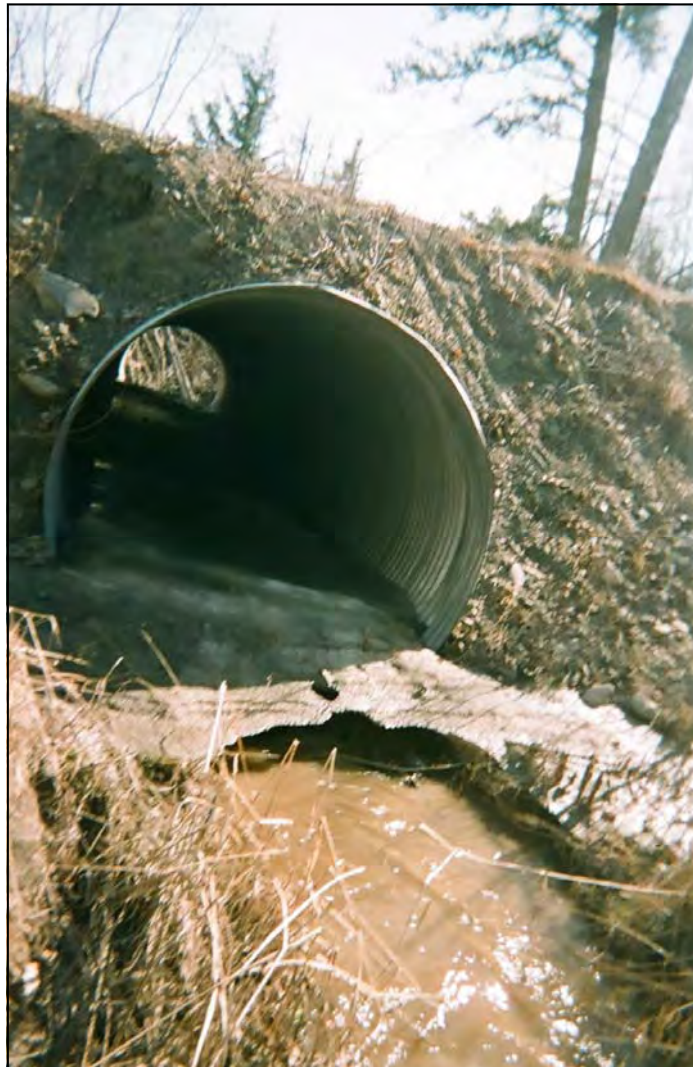
Bidarka Creek was often frozen under ice until March, with increased turbidity in April. This picture was taken at Bidarka Creek in the fall of 2007. Saltwater Drive runs above the culvert.

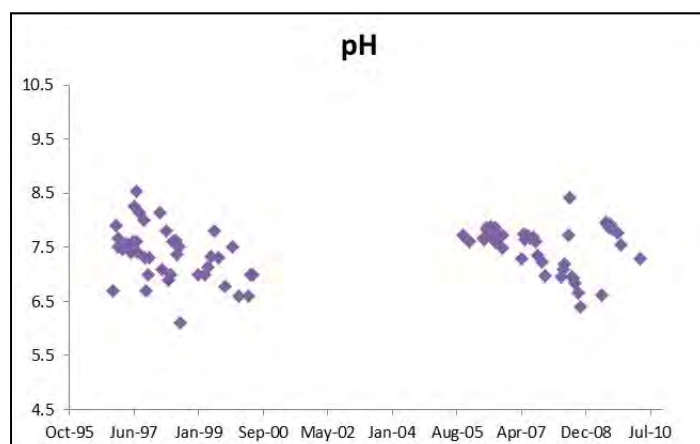
Top: All pH taken by the Hanna Meter by CEMP monitors during site visits at Bidarka Creek from 1996 to 2010. Bottom: Average pH by month from CEMP site visits between 2002 and 2010.

pH averaged 7.4 at Bidarka Creek. The range of pH values was 6.1 (in August 1998) to 8.5 (in July 1997). Monthly averages fluctuated from 6.8 in November to 7.8 in July. Lower pH averages were in November and April – both are generally rainy months. Rain inputs can lower pH in streams, as the average pH of rain is slightly acidic at 5.5. pH exceeded the lower Alaska water quality standard of 6.5 twice, once in August 1998 (6.1) and again in October 2008 (6.4). These isolated incidents over the 8+ years of sampling do not point to any persistent concerns with pH in Bidarka Creek. 🌱

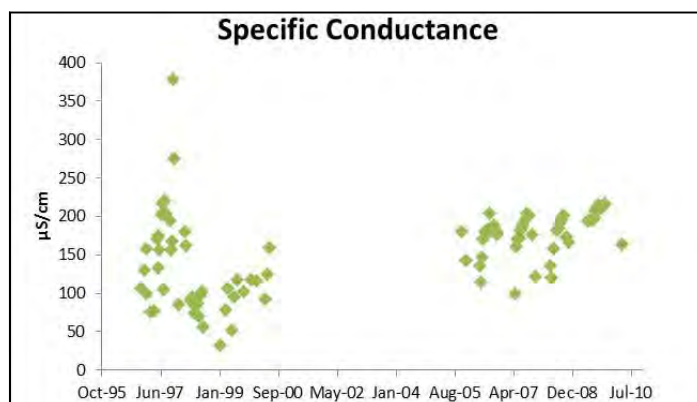
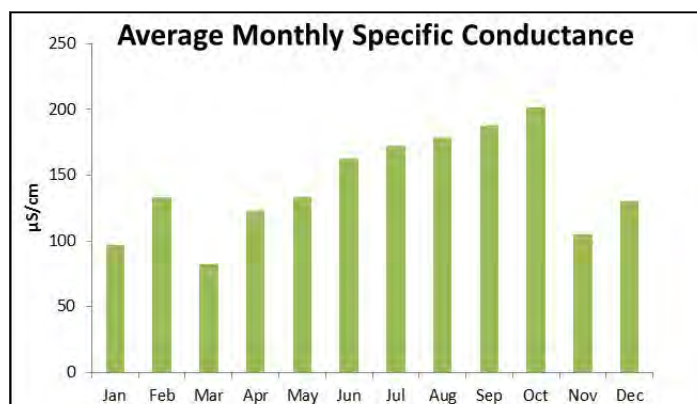
Top: All specific conductance data ($\mu\text{S}/\text{cm}$) were taken with a Hanna Meter (HI 98129) by CEMP monitors during site visits to Bidarka Creek from 1996 to 2010. Bottom: Average specific conductance ($\mu\text{S}/\text{cm}$) by month from CEMP site visits between 1996 and 2010.

CEMP volunteers measured specific conductance during 155 site visits to Bidarka Creek. Average specific conductance was $155 \mu\text{S}/\text{cm}$ and ranged from $33 \mu\text{S}/\text{cm}$ to $378 \mu\text{S}/\text{cm}$. The highest specific conductance levels measured at Bidarka Creek were in the fall of 1997. While we aren't sure what caused this brief spike in specific conductance, levels across all years are similar to other streams in the city of Homer and running off of the Homer bench (such as Woodard and Palmer Creeks). In contrast, CEMP sites that are in the Anchor River watershed have specific conductance levels consistently under $100 \mu\text{S}/\text{cm}$, and often less than $50 \mu\text{S}/\text{cm}$. On the Homer bench, it's likely that many of our streams are both heavily fed by ground and sub-surface water, which would increase the amount of dissolved ions and therefore the conductance of the surface water. Many of these streams also have some rural/urban interface, with more roads and other impervious surfaces which can affect the runoff entering the streams during rain events (which would otherwise act to depress specific conductance levels). The impervious cover analysis done by the Environmental Protection Agency (see page 16 of this report) estimates that approximately 8% of the Bidarka Creek watershed is impervious cover. A study in Anchorage creeks in-

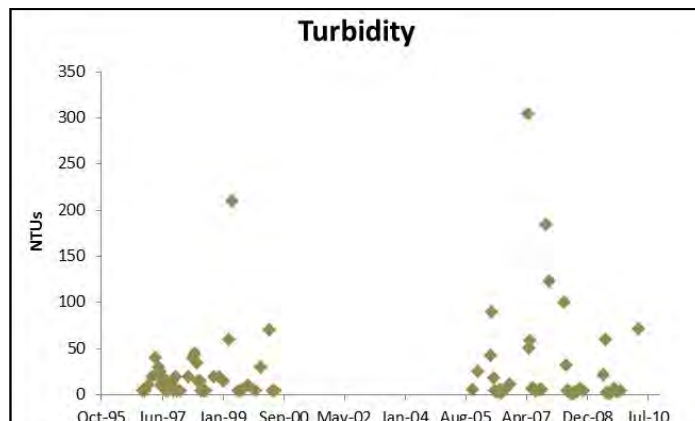
Top: All turbidity data (NTU) were collected by CEMP monitors during site visits to Bidarka Creek from 1996 to 2010. Water samples for turbidity analysis are collected in the field and analyzed in the lab using a LaMotte Turbidimeter. Bottom: Average turbidity (NTU) by month from CEMP site visits between 1996 and 2010.

CEMP monitors took turbidity samples during 90 site visits to Bidarka Creek. Turbidity was 25 NTUs on average over all years, with notably higher levels during the spring month of April, when the average turbidity was 129 NTUs. Spring break-up and runoff can dramatically increase the turbidity of streams, especially where there are roads and other disturbed habitats that may contribute to sedimentation during storm events. Minimum turbidity at Bidarka Creek from 8 years of sampling was 1.5; turbidity was under 5 NTUs during much of the summer months of June, July and August. 🌱

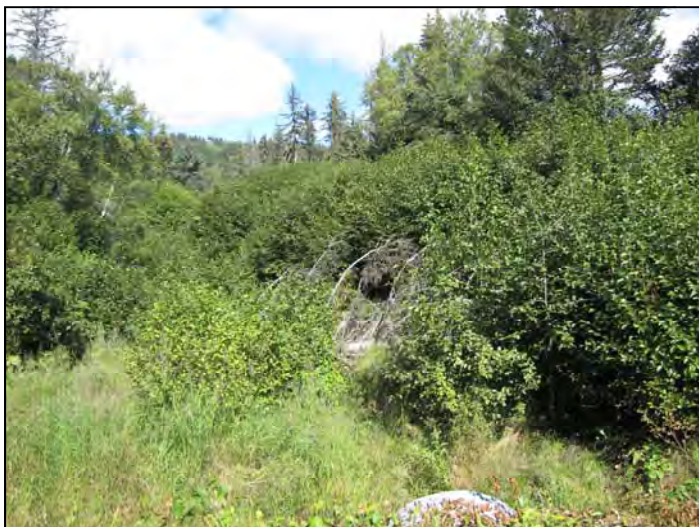
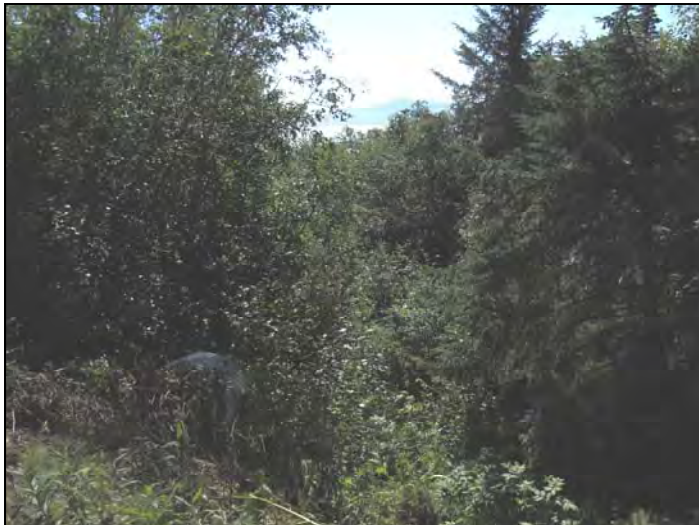
Top: Looking north from Saltwater Drive up Bidarka Creek. Bottom: Looking south from Saltwater Drive, down Bidarka Creek. The culvert can be seen just to the left in the picture. Both photographs were taken on August 19, 2010.

On August 19, 2010 Inletkeeper staff performed a habitat assessment over a 50-meter reach of Bidarka Creek. The downstream boundary of the reach began at the current CEMP site, just upstream of the culvert that passes under Saltwater Drive.

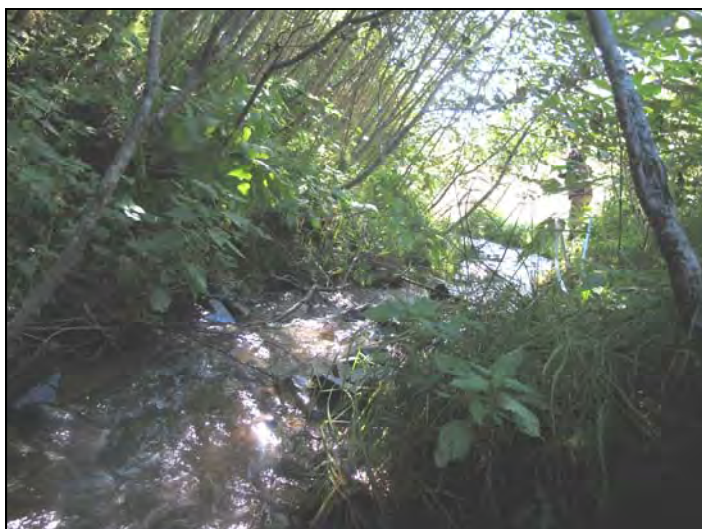
From the top of the 50-meter reach, looking down-stream/south.

The riparian zone surrounding the stream was composed of intact native vegetation for more than 60 feet on the right bank, and an average of 35 feet on the left bank. A private gravel driveway (approximately 10 feet wide) parallels this reach of Bidarka Creek along the left bank, about 35 feet to the east. There is another house off the right bank, greater than 60 feet away and in the

lower sections of the sampled reach. Stream bank stability was rated as primarily stable, with 5% of the left bank ranked as moderately stable. No erosion from human activity was noted, and no sections of man-made channels or erosion control were present. The vegetation within the 35 – 60 foot riparian zone consisted largely of small deciduous trees (less than 20 feet tall) such as alder (*Alnus tenuifolia*) and cottonwood (*Populus balsamifera*). Tall conifers (spruce, *Picea spp.*) covered approximately 15% of the left riparian area and less than 1% of the right riparian area. Tall deciduous trees (greater than 20 feet tall; cottonwood, alder, and birch *Betula kenaiica*) covered 10% of the riparian zone adjacent to both banks. The riparian zone adjacent to the right bank had less than 1% of short shrubs such as willow (*Salix spp.*), and approximately 40% grasses, ferns, and other short plants such as horsetails (*Equisetum arvense*) and ferns.

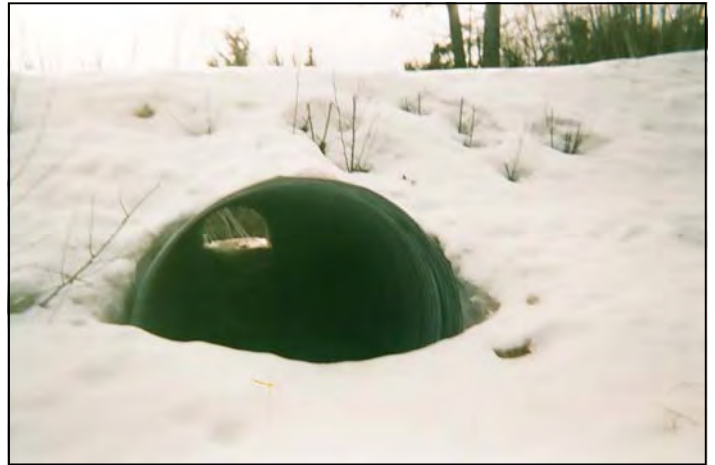
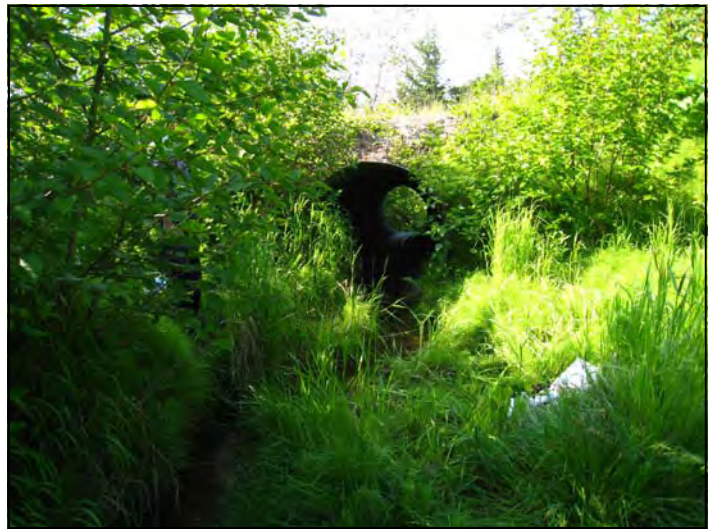
*Top: Looking downstream at Bidarka Creek and the Saltwater Drive culvert in December 2006.
Bottom: Looking downstream at Bidarka Creek and the Saltwater Drive culvert in June 2009.*
