East End Road Construction Project Water Quality Monitoring Report

May 2006

Cook Inletkeeper

Homer Soil & Water Conservation District,
Alaska Department of Transportation and Public Facilities, and
Quality Asphalt Paving Inc.

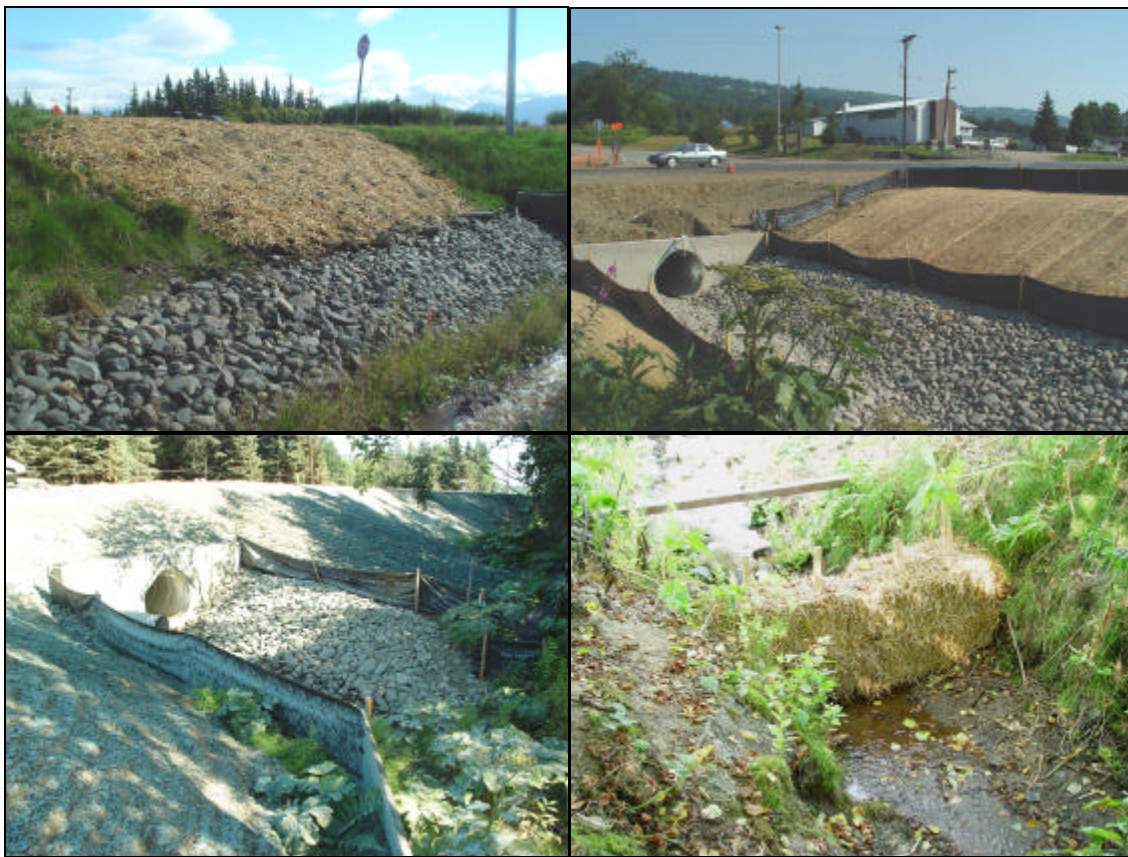
Figure 2. Examples of BMPs employed on the East End Road construction project. Upper left – straw mulching and rock-lined channel at the upstream site on Mariner Creek 9/6/05. Upper right - silt fence barriers, rolled erosion control products, and outlet protection at the downstream site on Mariner Creek 7/13/04. Lower right – straw bale barrier at the downstream site on Alder Creek 8/13/04. Lower left – seeding, silt fence barriers, and outlet protection at the downstream site on Mattox Creek 8/10/04.

Silt Fence Barriers consist of geosynthetic material placed in a manner that controls sheet flow from disturbed lands. Silt fences do not filter sediment out of runoff waters; instead they create a small containment system to allow for the deposition of suspended particles. Silt fences act as temporary containment structures to be used while construction activities occur (Fafield 2002).

Straw Bale Barriers are sediment containment structures useful in limiting pollution from runoff and sheet flow. These barriers obstruct the passage of water and reduce flow velocity allowing for the deposition of suspended particles. Straw bale barriers act as temporary containment structures to be used while construction activities occur (Fafield 2002).

Diversion ditches, Rock-lined Channels, Slope Drains, Outlet Protection, and Silt Basins are runoff control measures that reduce erosion and sediment transport associated with stormwater and roadway runoff. Diversion ditches intercept runoff from the construction area and transport it through the proper channels away from the work zone. Rock check dams were installed in some diversion ditches to slow runoff flows. The armoring of diversion ditches, stream channels, and culvert outlets with riprap and cobble helped to prevent the scouring and gully erosion during peak flows. Slope Drains used plastic pipe to collect and transport runoff from the roadway to silt basins at the toe of embankment slopes. These measures are temporary and permanent structures to be used during and after construction activities (Fafield 2002).

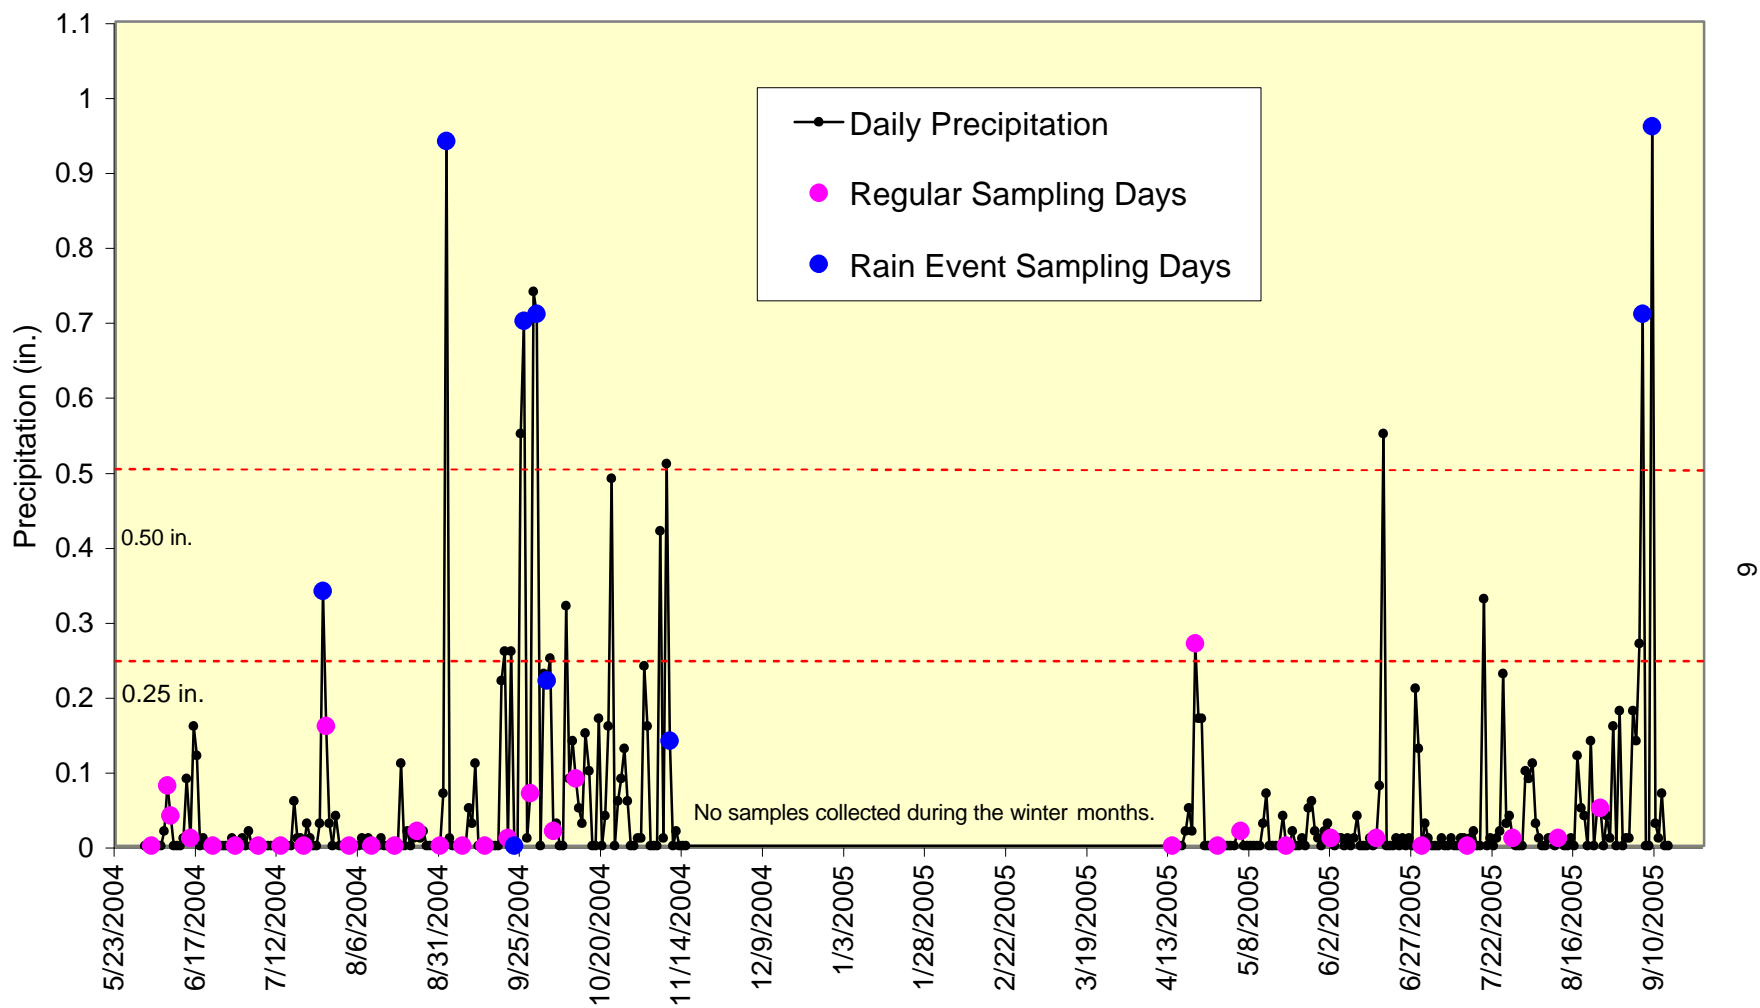
Figure 4. Daily precipitation for the Homer Airport (PAHO) weather station from 6/1/04 to 9/15/05.

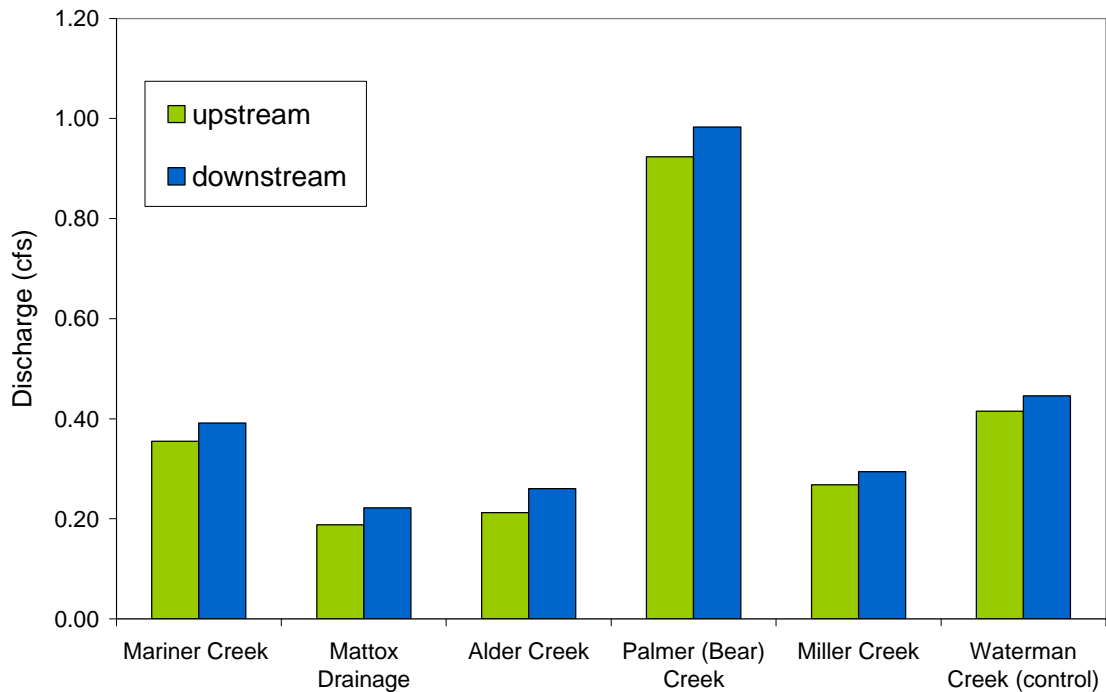
Palmer (Bear) Creek recorded the highest discharge readings of the streams monitored. Mean discharge for Palmer (Bear) Creek from 6/3/04 to 9/9/05 was 0.95 cfs. For the other five study streams, mean discharge from 6/3/04 to 9/9/05 was between 0.21 cfs and 0.44 cfs. During regular weekly and bi-weekly sampling, discharge on the five sample streams ranged between 0.09 cfs and 0.23 cfs. During rain events and spring break-up, discharge on these five streams ranged between 0.29 cfs and 1.61 cfs. All six streams registered a higher mean discharge at the downstream site.

Figure 5. Mean discharge from 6/3/04 to 9/9/05 for upstream and downstream sites on six streams crossing East End Road.

Palmer (Bear) Creek has the largest drainage area and, as expected, recorded the highest discharge readings of the six study streams. All six streams recorded lower discharge readings during regular weekly and bi-weekly sampling. Measurements recorded during weekly and bi-weekly sampling represent base flow conditions. All six study streams recorded higher discharge readings during rain event sampling and spring break-up conditions. Measurements taken during rain event sampling and spring break-up reflect the combination of base flow with event flow.

All of the study streams recorded higher discharge readings at the downstream site than at the upstream site. On most sections of East End Road there are drainage ditches that run parallel to the road. Diversion ditches intercept runoff and divert it to a stabilized area where it can be safely discharged (ADOTPF 2004). The upstream sampling sites were located above the roadside ditches and were not affected by ditch runoff. The amount of runoff after a storm is influenced by the ground's ability to absorb water (permeability). Roads and parking lots are considered 100% impervious, meaning these surfaces cannot absorb water (NOAA 2004). The increase in discharge from the upstream sites to the downstream sites could be attributed to storm runoff. This indicates that BMPs were effective in intercepting runoff and diverting it into the drainage system.

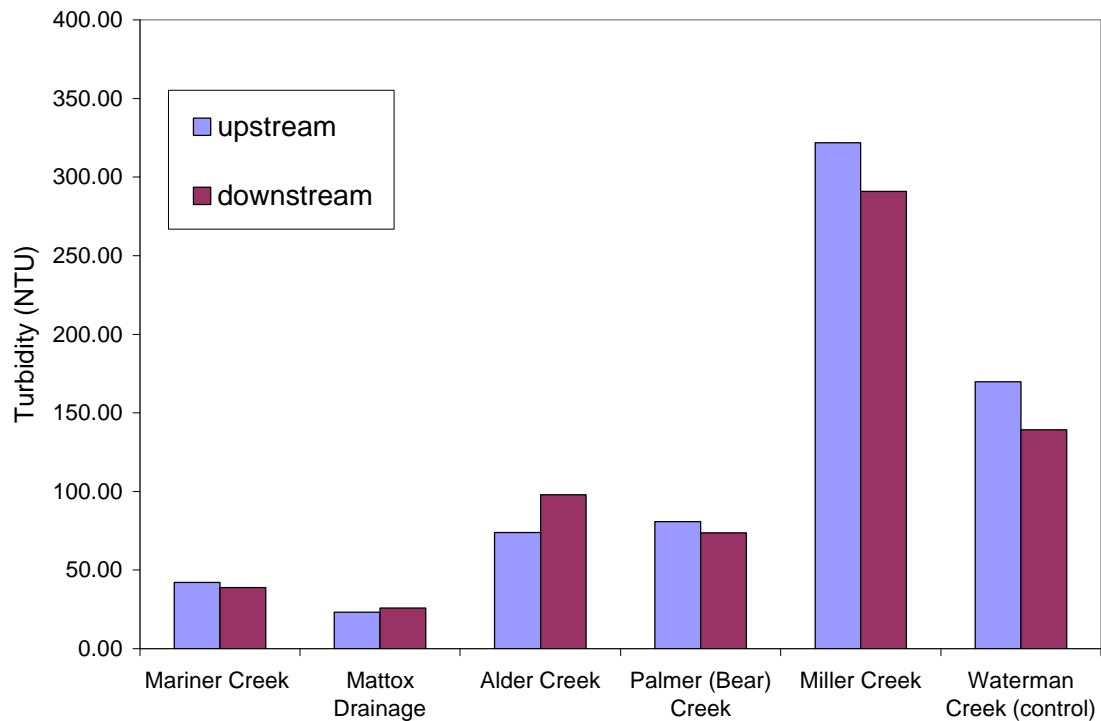
Miller Creek recorded the highest turbidity levels of the six streams that were monitored (Figure 6). Alder Creek was the only stream that displayed an increase in turbidity of more than 5 NTUs from the upstream site to the downstream site (Figure 6). All six study streams showed an increase in turbidity as discharge increased. Mariner Creek, Miller Creek, and Waterman Creek recorded lower turbidity levels at the downstream sites (Figure 7, 11, 12). Mattox Drainage and Palmer (Bear) Creek displayed similar turbidity to discharge relationships at both the upstream and downstream sites (Figure 8, 10). Alder Creek was the only stream that showed a larger increase in turbidity at the downstream site as discharge increased (Figure 9). All six study streams showed higher turbidity levels during rain events and spring break-up than during regular weekly and bi-weekly sampling.

Figure 6. Mean turbidity from 6/3/04 to 9/9/05 for upstream and downstream sites on six streams crossing East End Road.

To measure the effect of road building on the turbidity levels in the study streams, upstream and downstream measurements were compared. For comparative purposes when looking at ADEC water quality standards, upstream measurements represent the natural conditions for the six study streams on this project. Alder Creek was the only stream to display turbidity levels that did not meet the ADEC water quality standard, “may not have more than 10% increase in turbidity when the natural turbidity is more than 50 NTU” (ADEC 2003). Alder Creek experienced large scale reconstruction during the East End Road project. The roadway grade was raised approximately two meters with roadway widening and a separated pathway. Two culverts were replaced between the upstream and downstream monitoring sites on Alder Creek. One culvert passes under East End Road and the other culvert passes under Alder Lane. Also, the stream channel between the two culverts was lined with gabions (metal wire cages filled with rock). The increased turbidity at the downstream site on Alder Creek may have been due to disturbed soils from the construction zone entering the stream. Sediment could also have been transported to the stream by roadway runoff and sheet flow erosion. Another source of increased turbidity at the downstream site on Alder Creek may have been residue associated with the large volume of rock added to the stream channel. In terms of ADEC water quality standards, BMPs for soil stabilization and sediment control were highly effective on all sample streams except Alder Creek.

Four of the six study streams recorded higher mean turbidity levels at the upstream site than at the downstream site. The upstream/downstream decrease in turbidity may have resulted from the installation of temporary and long term sediment control BMPs. Waterman Creek, the control stream, also recorded higher turbidity readings at the upstream site. There were no temporary BMPs in place on Waterman Creek, but inlet and outlet protection using rubble and cobble was installed following the flooding in 2002. This indicates that without the use of temporary BMPs such as silt fences and straw bail barriers, sediment deposition still occurred in Waterman Creek upstream of East End Road.

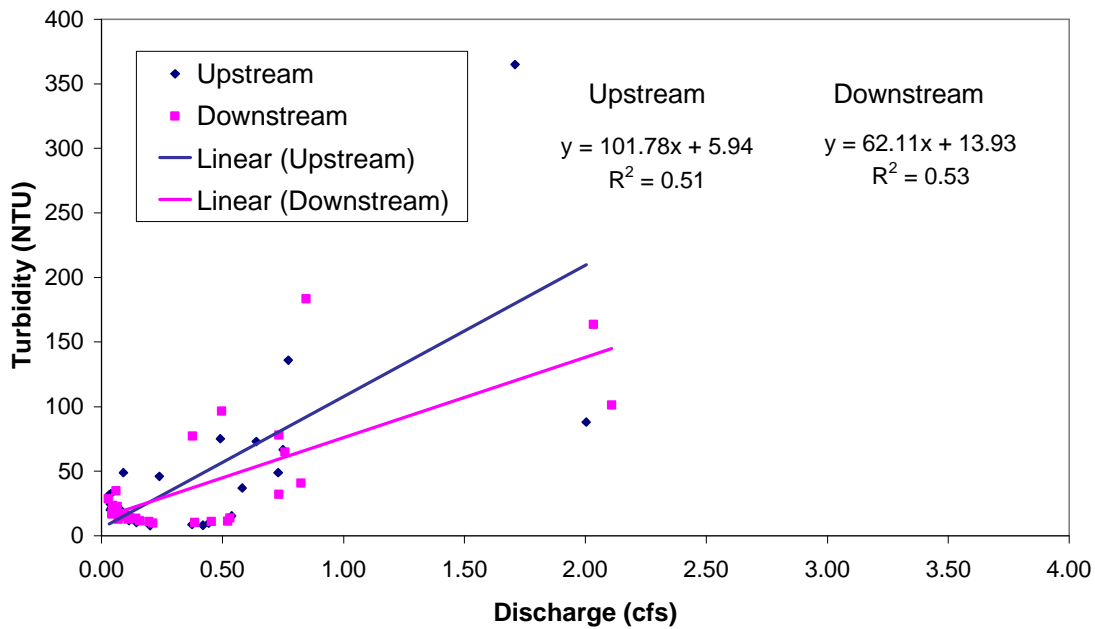
Figure 7. Relationships between discharge and turbidity at the upstream and downstream sites on Mariner Creek.

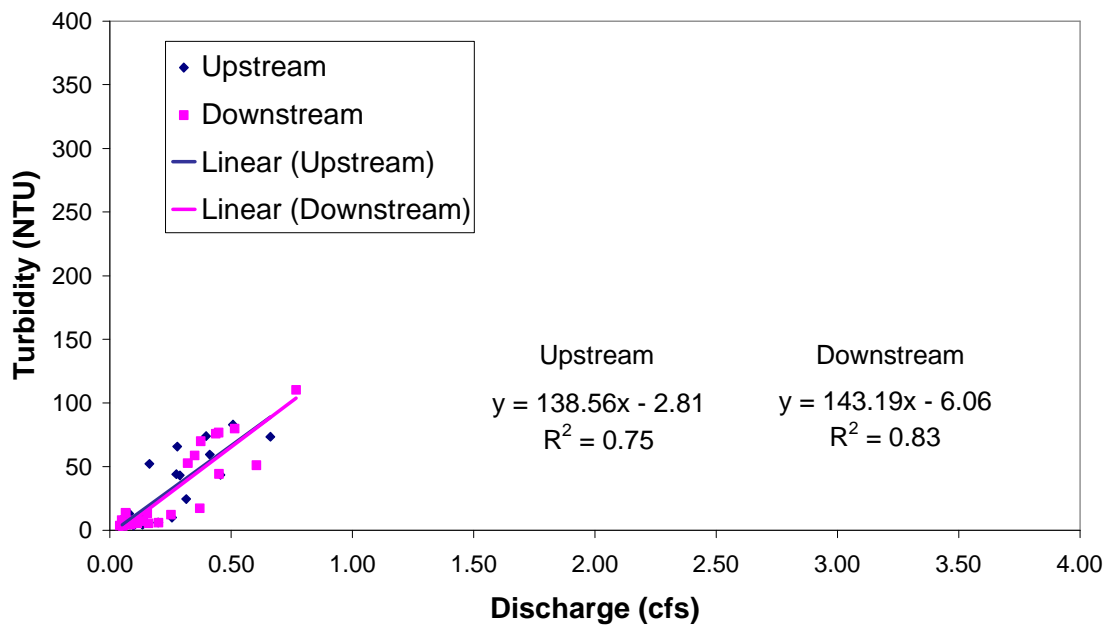
Figure 8. Relationships between discharge and turbidity at the upstream and downstream sites on Mattox Drainage.

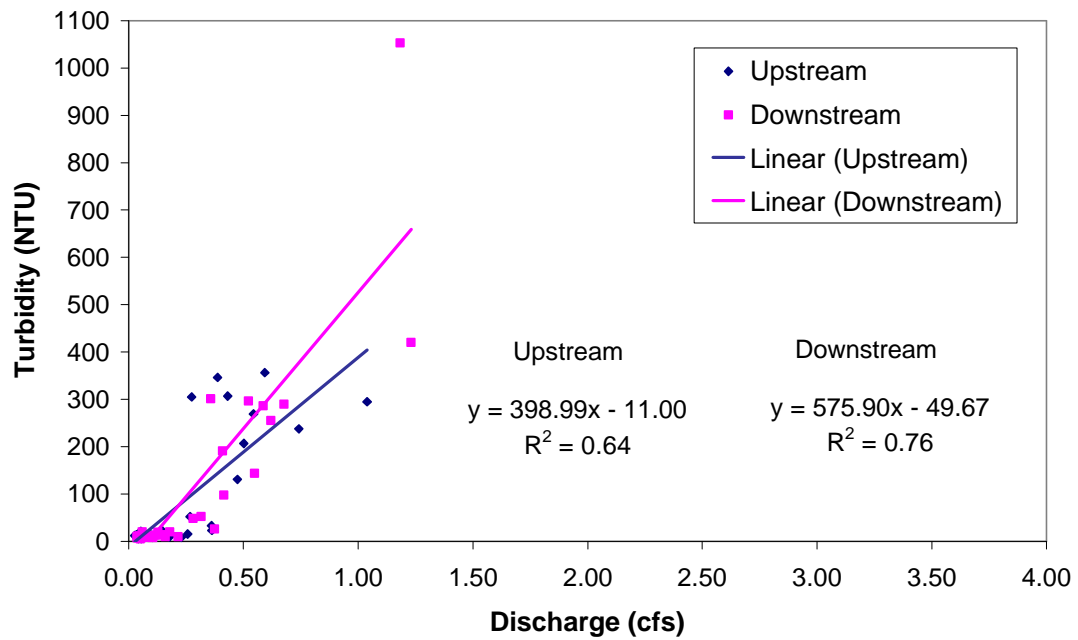
Figure 9. Relationships between discharge and turbidity at the upstream and downstream sites on Alder Creek.

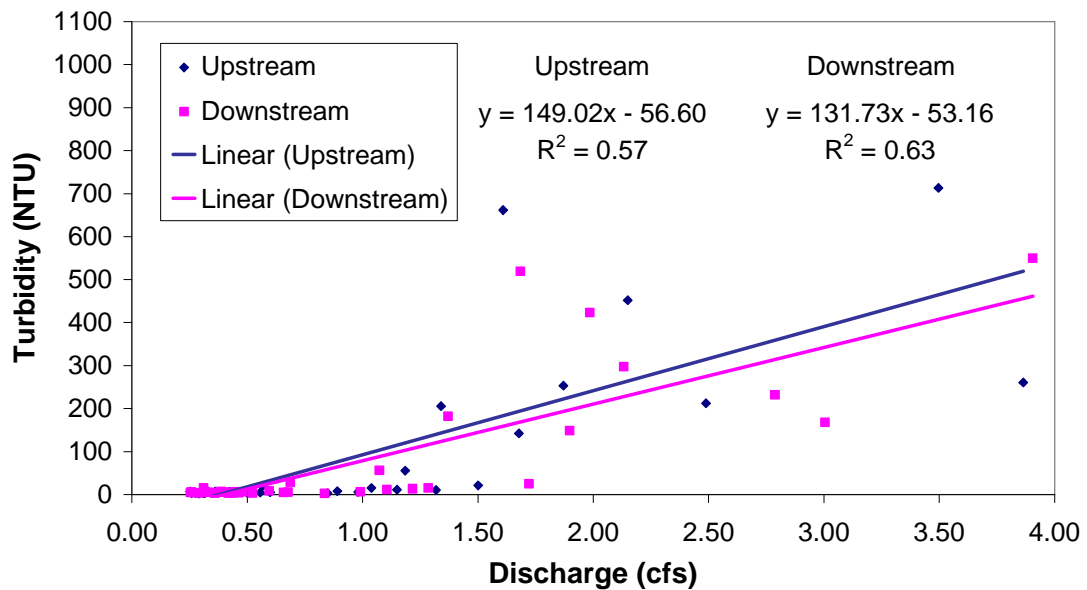
Figure 10. Relationships between discharge and turbidity at the upstream and downstream sites on Palmer (Bear) Creek.

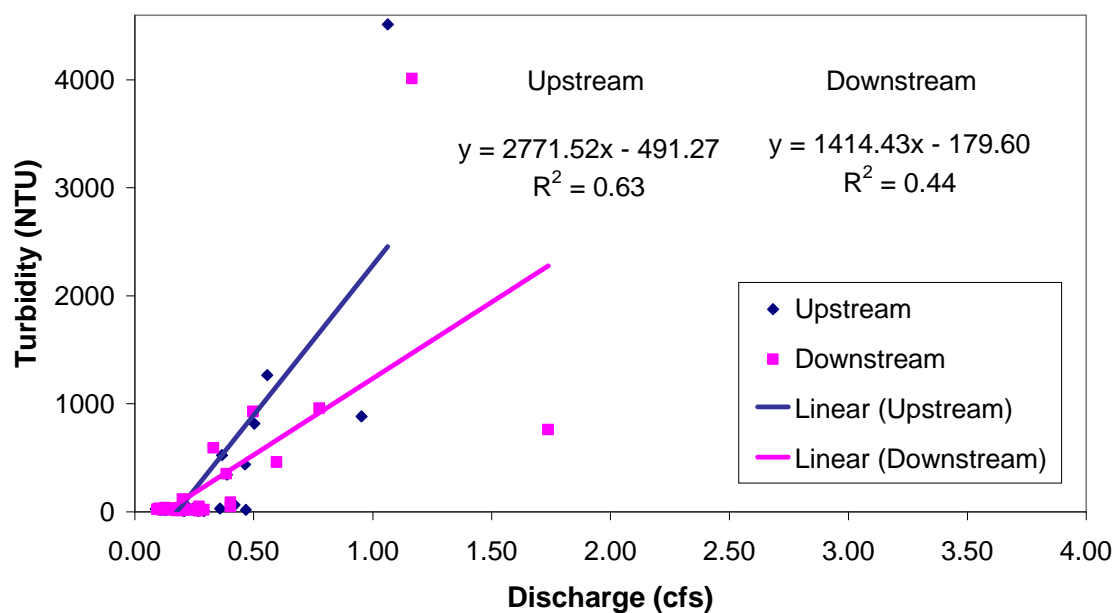
Figure 11. Relationships between discharge and turbidity at the upstream and downstream sites on Miller Creek.

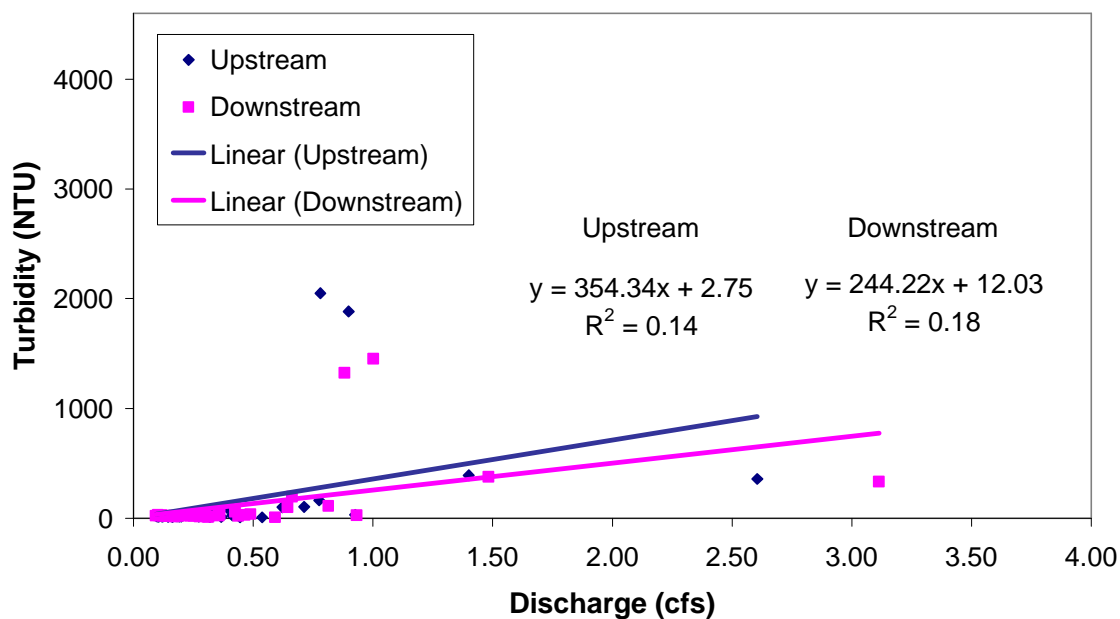
Figure 12. Relationships between discharge and turbidity at the upstream and downstream sites on Waterman Creek.

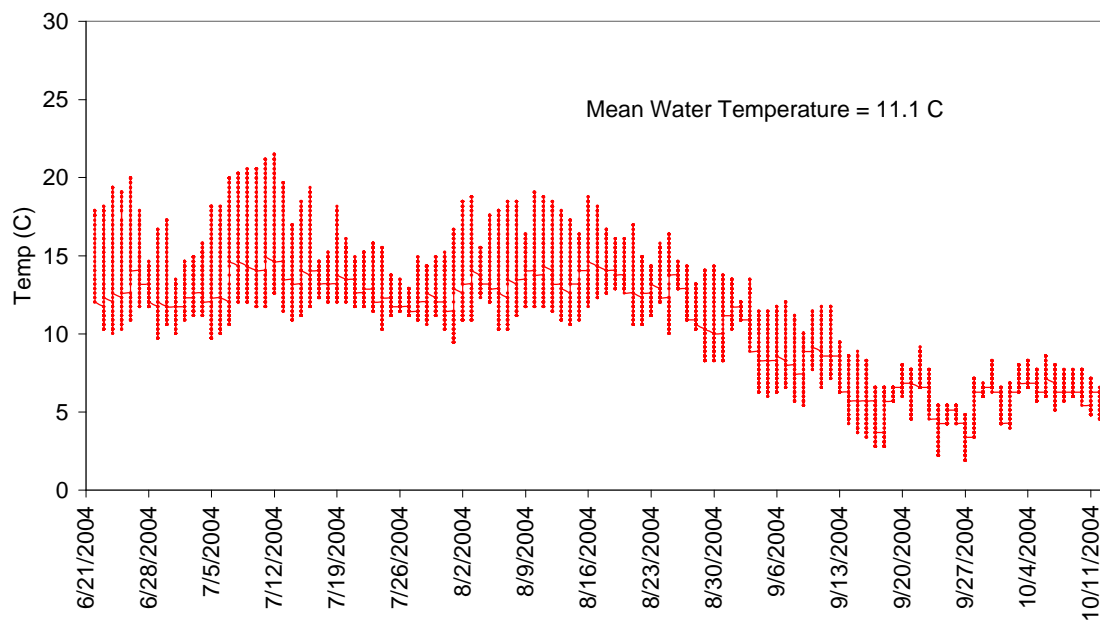
On the six study streams that were monitored from 6/3/04 to 9/9/05, mean water temperature ranged from 8.3° C to 11.9° C. Water temperature readings did not vary from upstream site to downstream site by more than 0.2° C on any of the study streams. The largest upstream/downstream gradient (0.2° C) was recorded in Alder Creek. Water temperature was recorded at both the upstream and downstream sites on Palmer (Bear) Creek every 15 minutes from 6/22/04 to 10/12/04. Mean daily water temperature in Palmer (Bear) Creek did not vary from upstream site to downstream site by more than 0.1° C. Mean daily water temperature on Palmer (Bear) Creek from 6/22/04 to 10/12/04 was 11.1° C at the upstream site (Figure 13) and 11.2° C at the downstream site.

Figure 13. Water temperature at the upstream site on Palmer (Bear) Creek recorded every 15 minutes from 6/22/04 to 10/12/04.

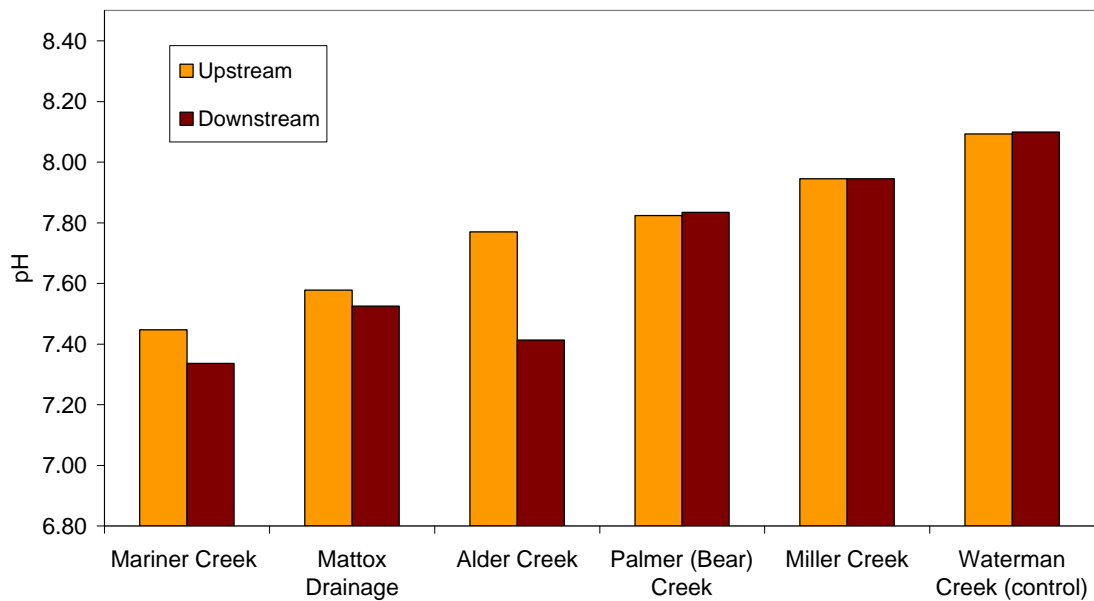
Mean pH values for the six study streams ranged between 7.34 and 8.10 (Figure 14). On four of the study streams including Mattox Drainage, Palmer (Bear) Creek, Miller Creek, and Waterman Creek, pH values did not vary by more than 0.05 from upstream site to downstream site. On Mariner Creek, mean pH was 7.45 at the upstream site and 7.34 at the downstream site. On Alder Creek, mean pH was 7.77 at the upstream site and 7.41 at the downstream site. pH values recorded in the six study streams did not exceed ADEC water quality standards for drinking water, agriculture, or contact recreation.

Figure 14. Mean pH values from 6/3/04 to 9/9/05 for six streams crossing East End Road.

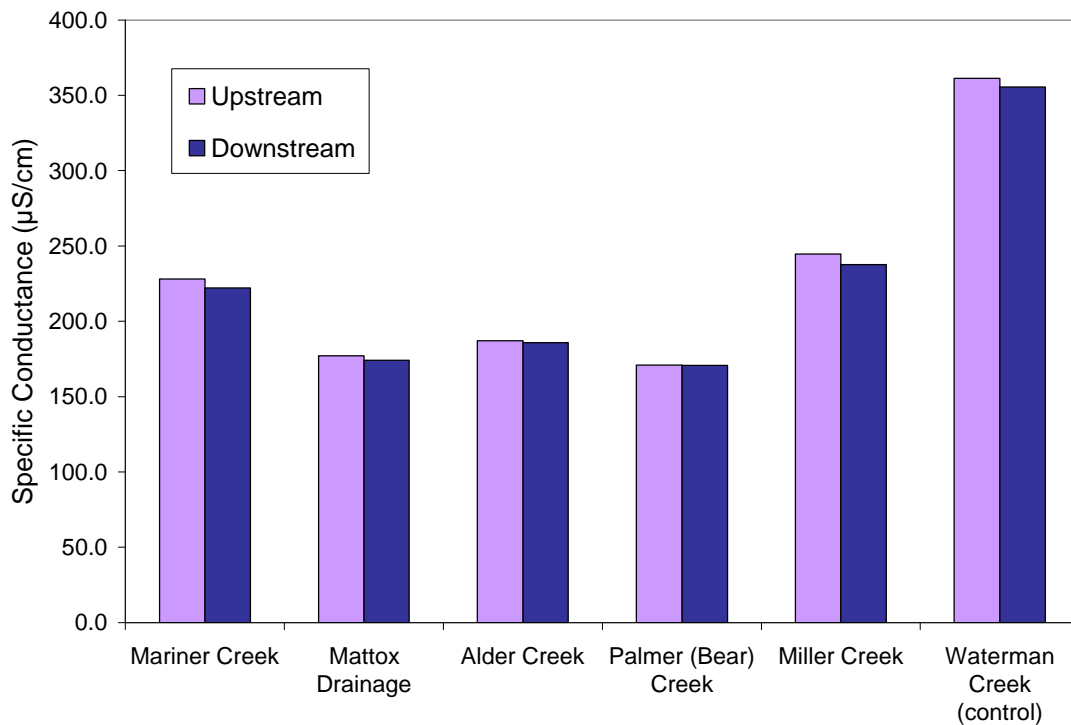
All six study streams recorded slightly higher specific conductance readings at the upstream site (Figure 12). The largest upstream/downstream gradient was 7.1 $\mu\text{S}/\text{cm}$ recorded in Miller Creek. All six study streams recorded lower specific conductance during rain event sampling than during regular weekly sampling.

Figure 15. Mean specific conductance from 6/3/04 to 9/9/05 on six streams crossing East End Road.

There were no significant upstream/downstream differences in specific conductance recorded in any of the streams monitored. All six study streams recorded slightly higher specific conductance readings at the upstream site. The largest upstream/downstream gradient was 7.1 $\mu\text{S}/\text{cm}$ recorded in Miller Creek. Conductivity is inversely correlated with discharge. As discharge increases, the concentration of dissolved solids decreases (Dingman 2002). The lower specific conductance measurements recorded during rain event sampling could be due to dilution associated with increased discharge.

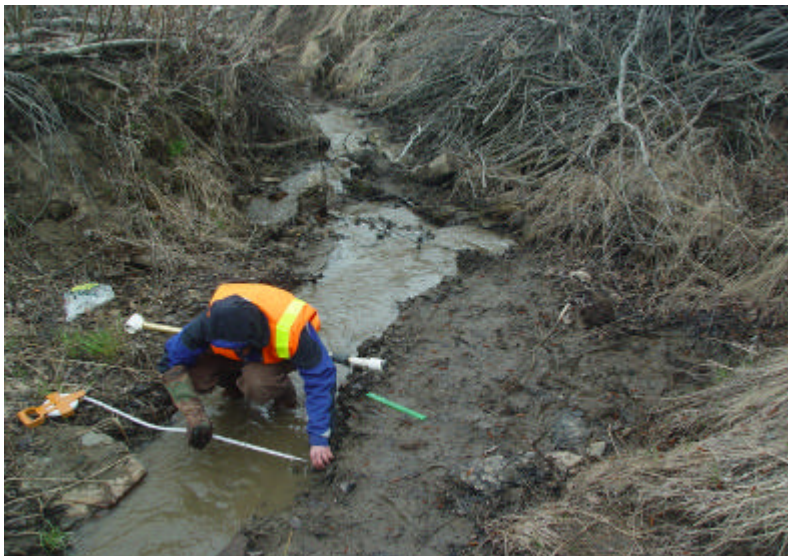
Figure 17. Cook Inletkeeper staff measured discharge at the downstream site on Miller Creek 4/21/05.
