Two Moose Creek

(Anchor River Tributary)

Permit and Habitat Violations

Timeline of Events at Two Moose Creek, a listed King Salmon tributary to the Anchor River - April 2012 to present (December 2013)

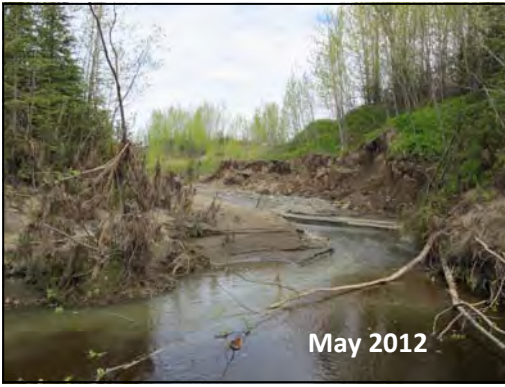
May 2012

We have documented turbidity from gravel pit discharges into Two Moose Creek, approximately 1/4 mile upstream from the confluence with the Anchor River, since May 2012. The inflow channel on the left (see photos) originates from a gravel pit, whose owner has a discharge permit from ADEC stipulating that the discharge cannot introduce muddy water into Two Moose Creek. Between June 2012 and July 2013, Cook Inletkeeper has documented 13 violations of this permit during 15 site visits through water quality monitoring. Additional ground photos and aerial photos clearly show the origins of this discharge and the chronic nature of this illegal discharge.

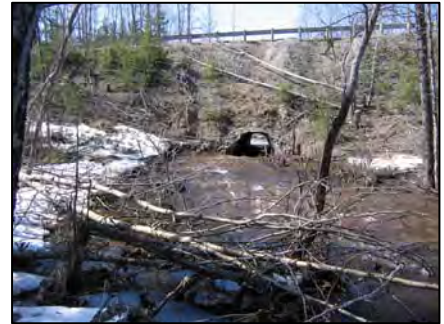
4/30/2012: CEMP Volunteer notes in the site comments: ""Site destroyed! Okay, just messy. It looks like loggers have cleared a wide path off the highway. What a mess. Water very high and fast." Top picture to the right is from this site visit.

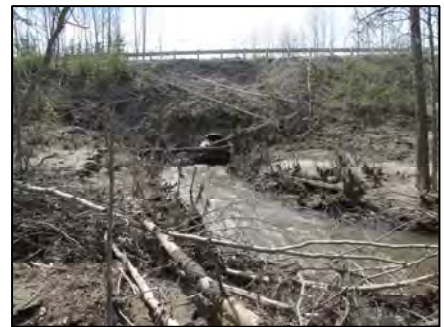
5/14/2012: The same CEMP Volunteer in his next visit wrote, "It looks like the culvert was blocked by the trees that were cut last month and caused a major flood. Mud over 12" deep around site. The bank around the culvert is caved in. Even the parking spot looks like it was flooded." Bottom picture on the right is from this subsequent site visit.

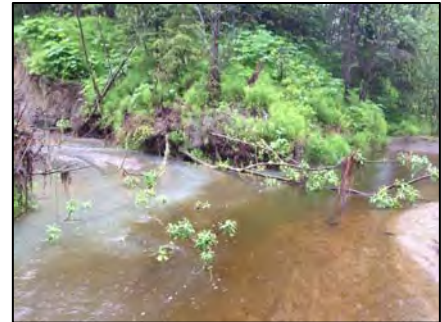
6/25/2012: Began monitoring turbidity weekly at the inflow and above the inflow. Inletkeeper data shows the gravel pit **discharge 14 NTUs over background**. (see photo to right)

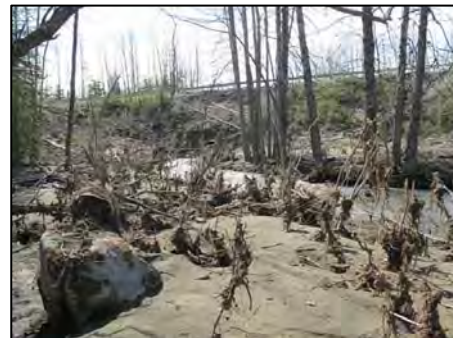
7/16/2012: Inletkeeper sends photos and information to ADF&G Lands and Refuge program staff. They respond asking if ADF&G Habitat is involved as it would be a Fish & Game Title 16 violation. See photo on right as demonstrating the level of sedimentation along the riparian zone.

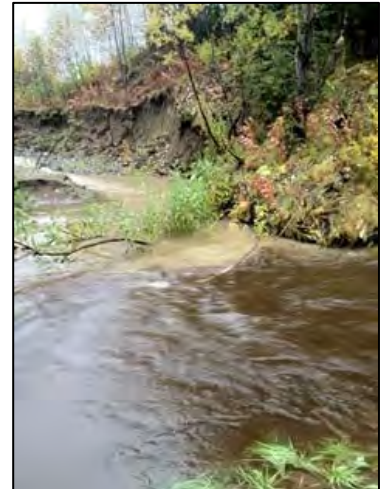
Inletkeeper data shows the gravel pit **discharge 115 NTUs over background**. (see photo to the right)

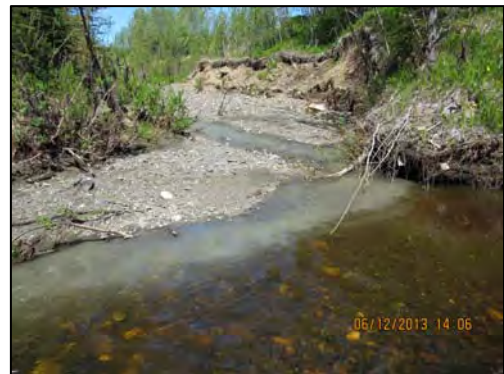
6/12/2013: Inletkeeper staff sends an email to ADEC enforcement after another Inletkeeper site visit that indicates ongoing discharge. (**discharge 59 NTUs over background**, see photo to the right)

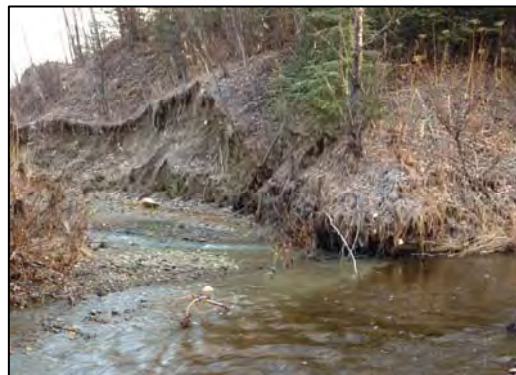
10/25/2013: Inletkeeper staff goes back to the site after the summer. Discharge visibly is continuing with turbidity levels well above background (see photo to the right).

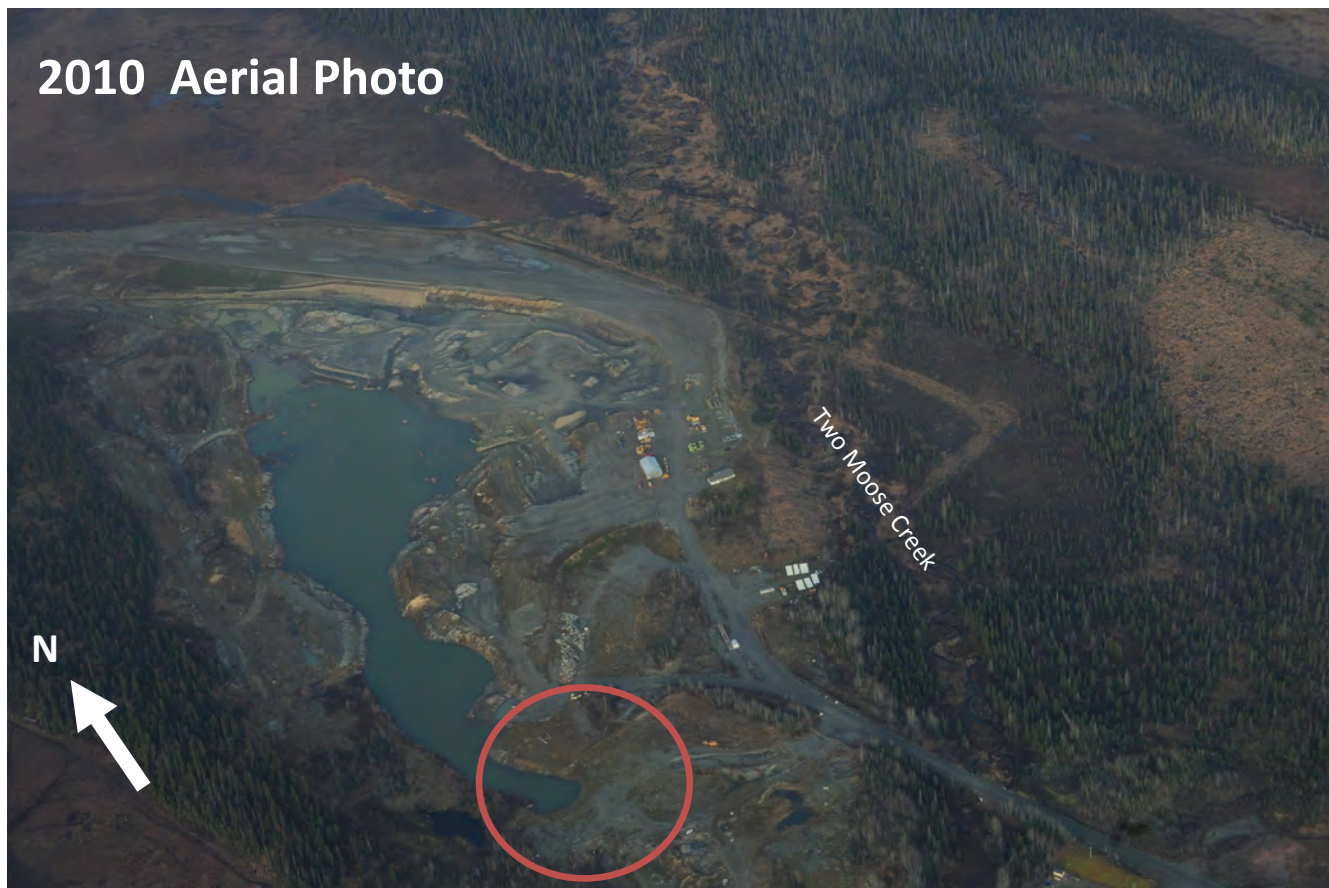
2010 Aerial Photo

A dam is clearly evident in imagery previous to May 2012. The confluence of Two Moose with the Anchor River is just beyond the highway, approximately 1/4 mile from the current gravel pit discharge location.

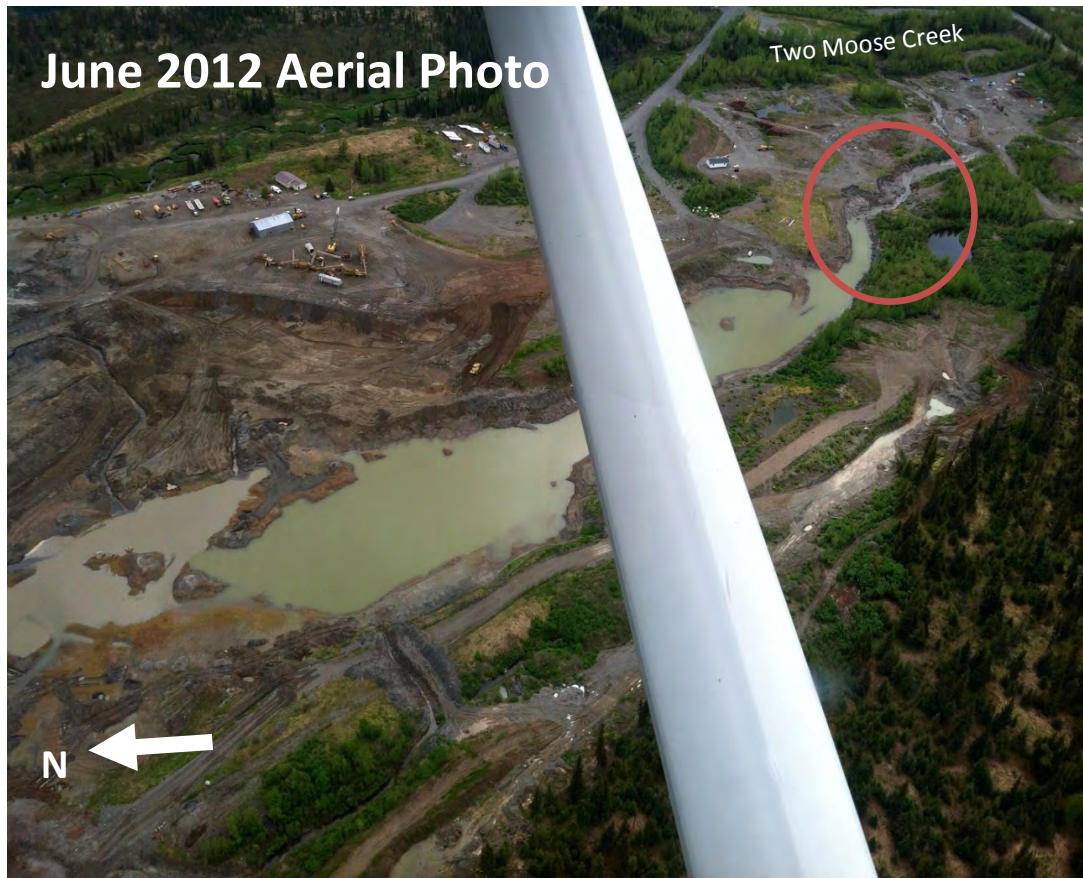
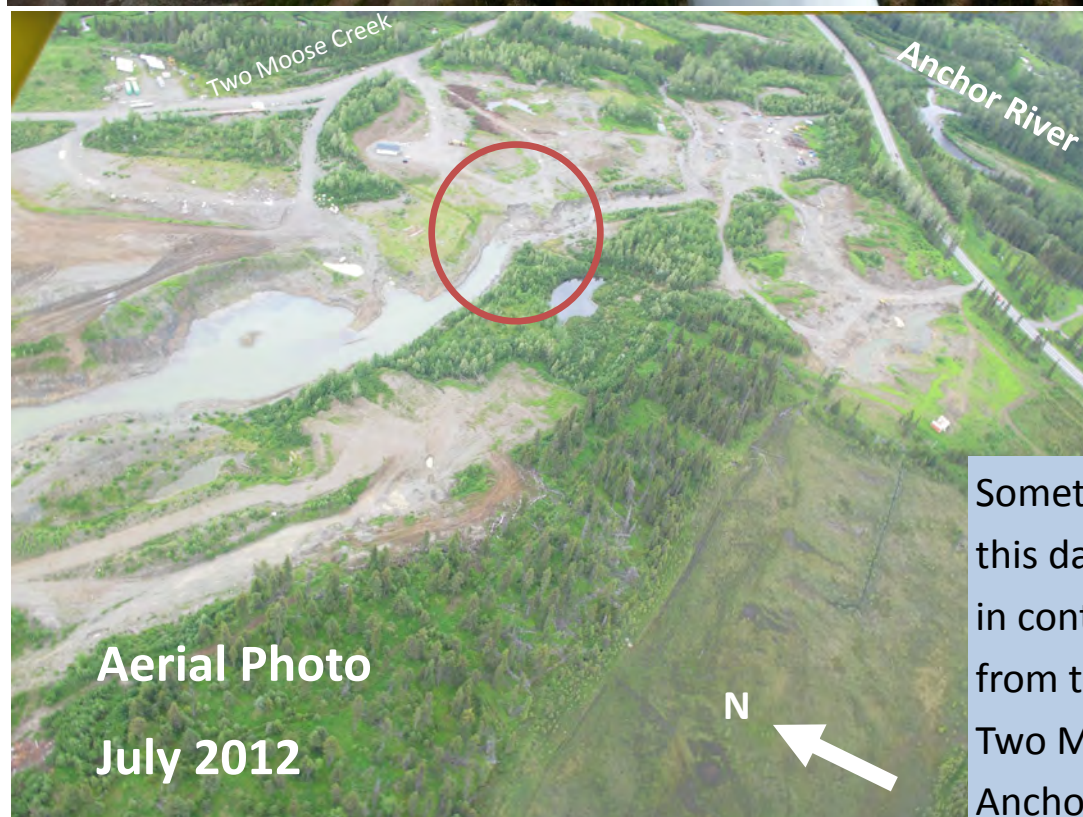
Sometime in May 2012, this dam broke resulting in continuous discharge from this Gravel Pit into Two Moose Creek and the Anchor River.

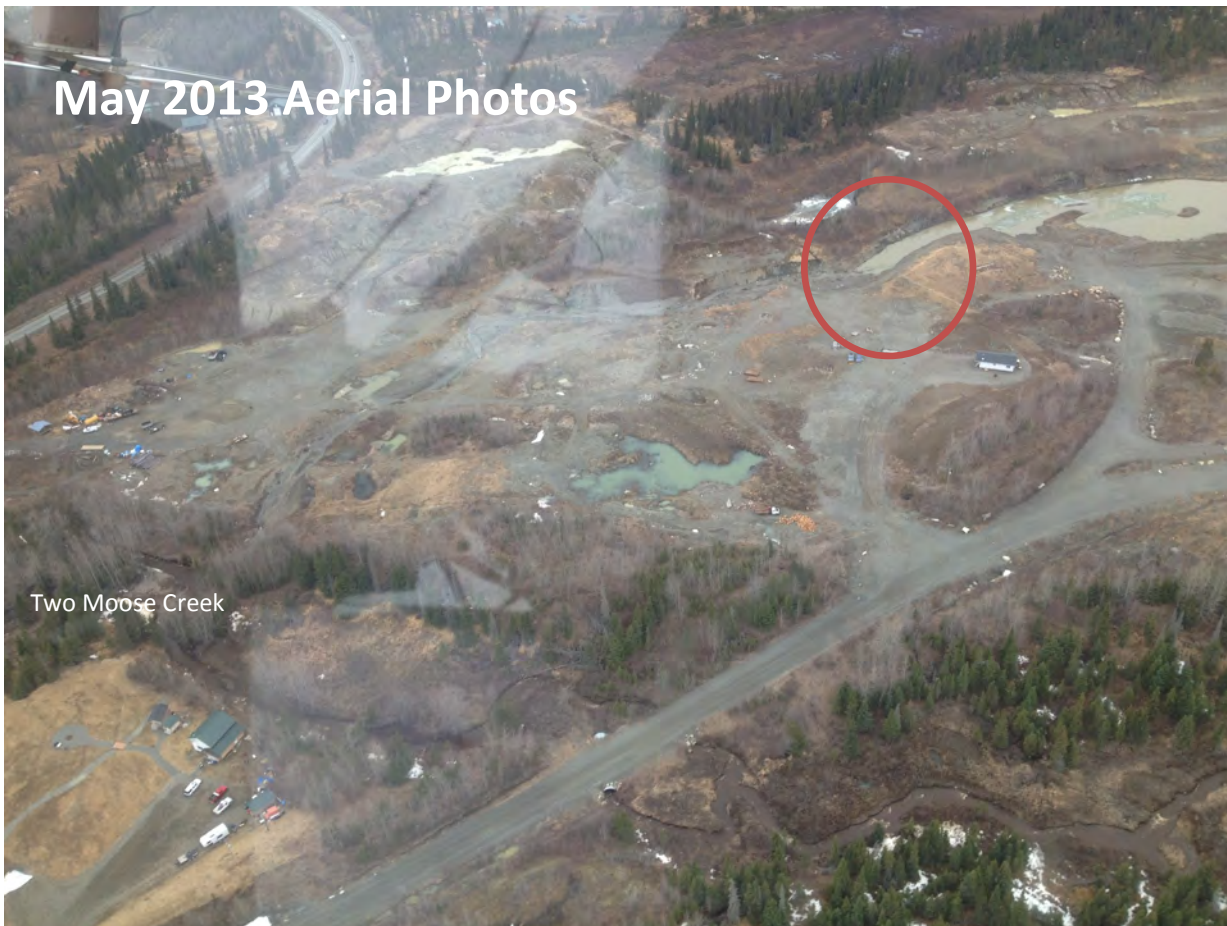
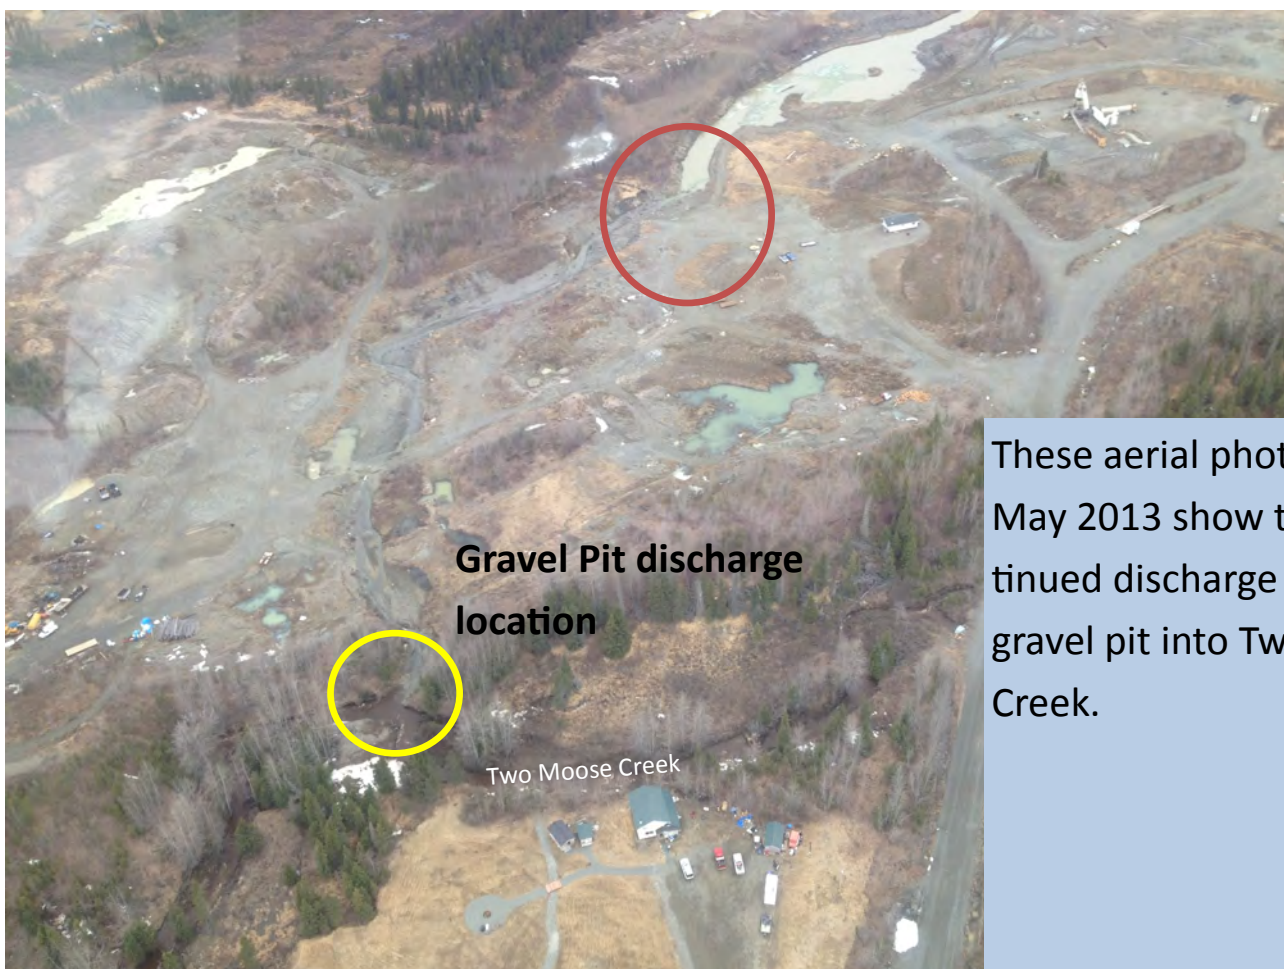
May 2013 Aerial Photos

These aerial photos from May 2013 show the continued discharge from the gravel pit into Two Moose Creek.

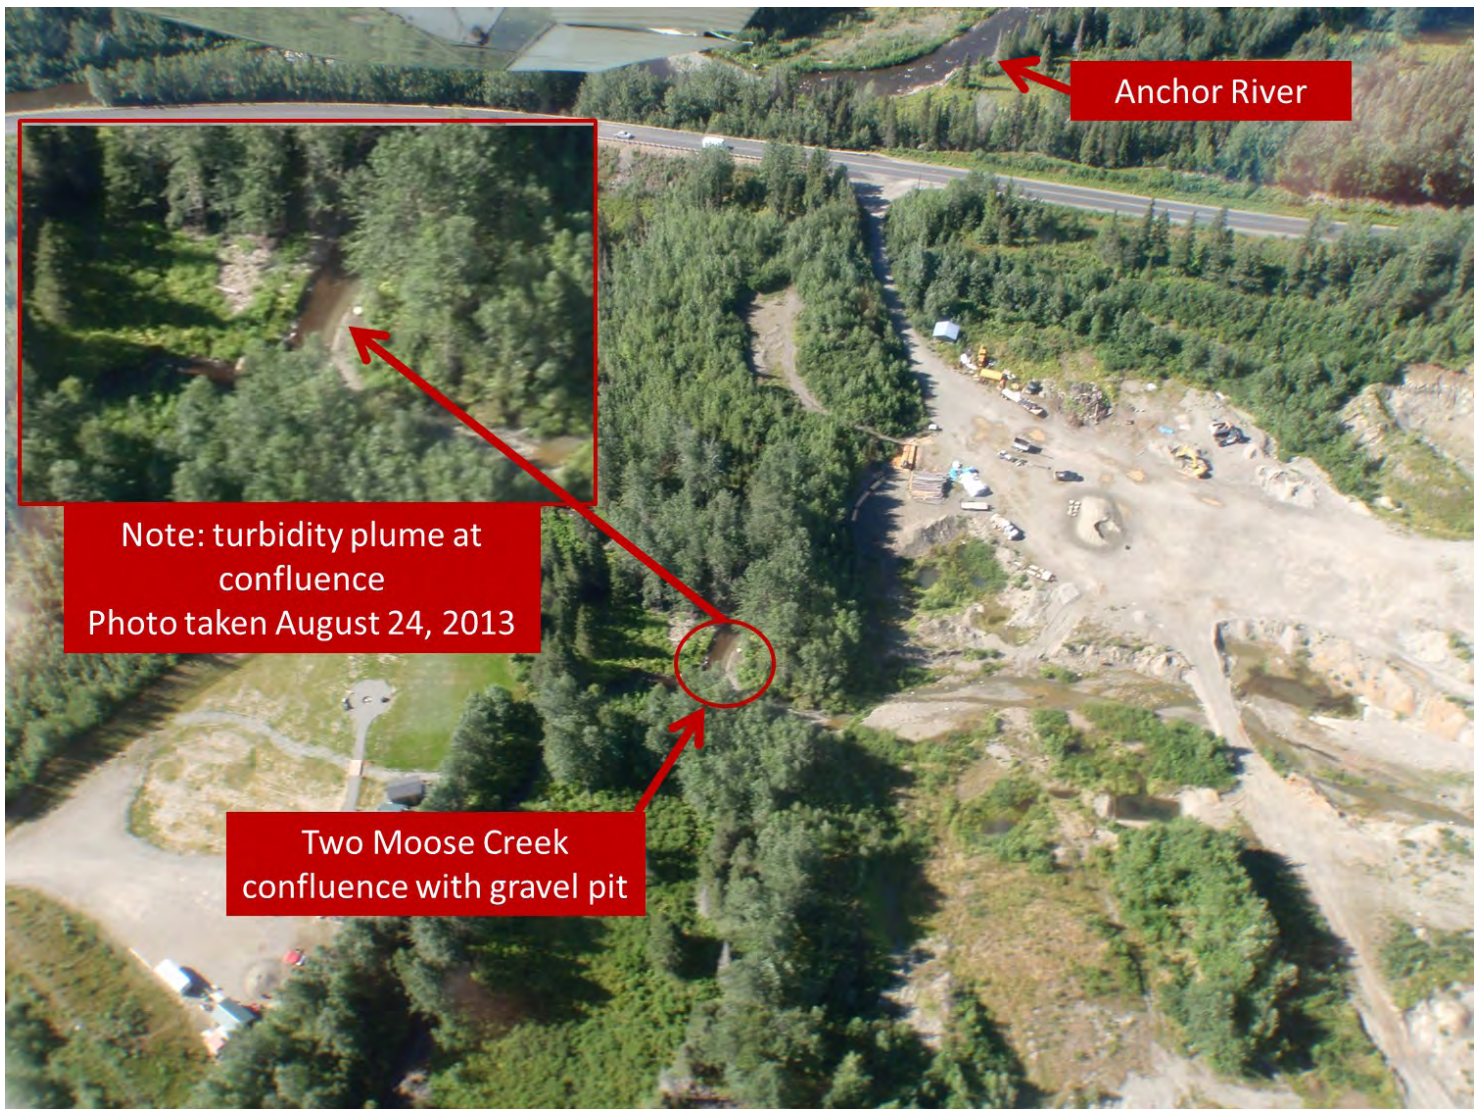
Two Moose Creek
confluence with gravel pit

Note: turbidity plume at
confluence
Photo taken August 24, 2013

This annotated aerial
from August 2013 shows
the continued discharge
from the gravel pit into
Two Moose Creek.

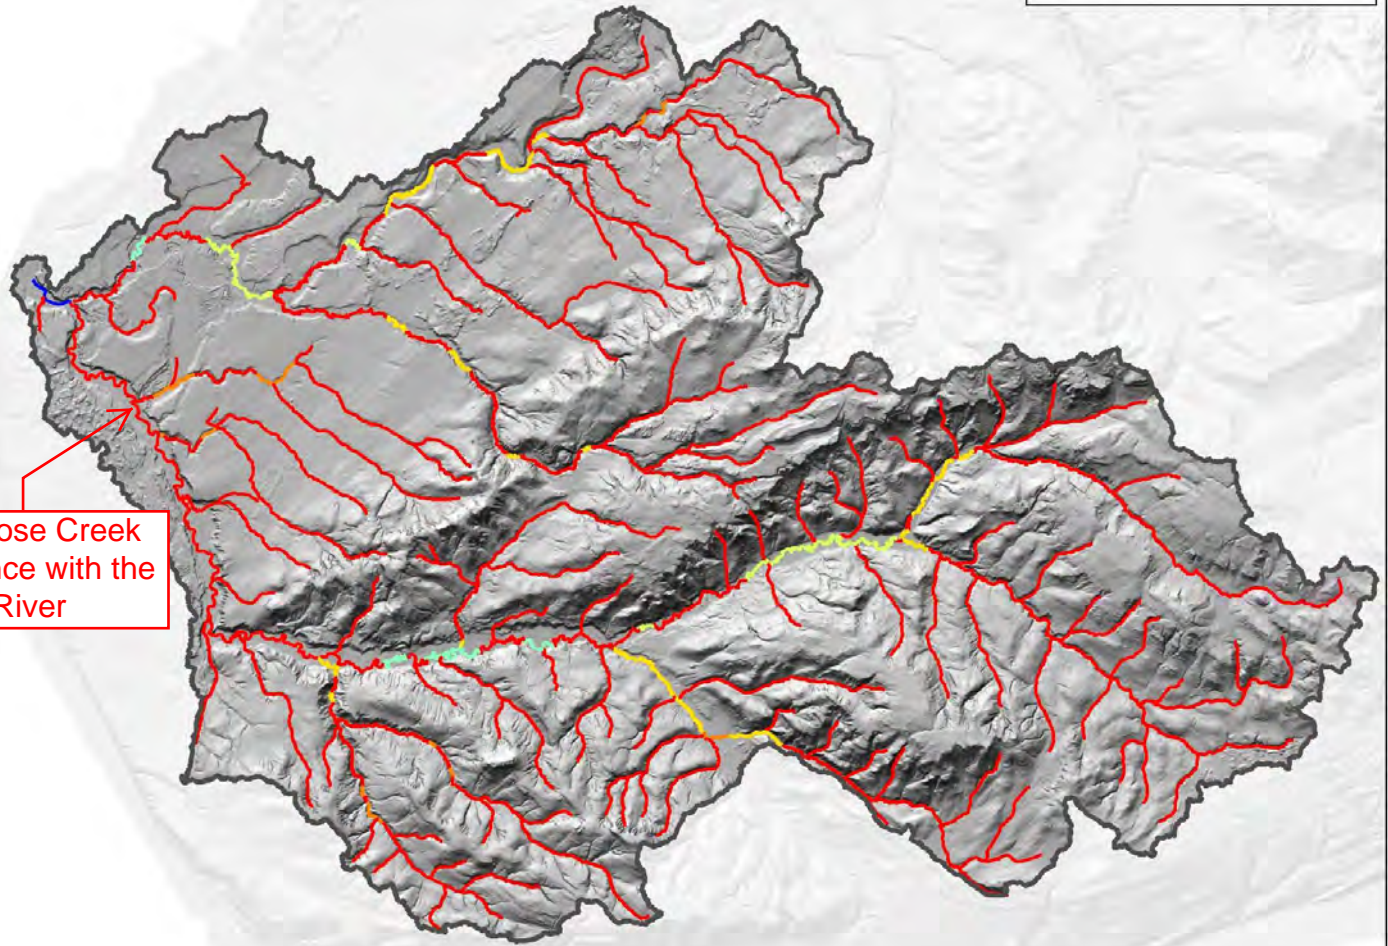
ANCHOR RIVER, AK - CHINOOK SALMON

Stillwater Sciences used RIPPLE, a physically-based population model, to assess factors controlling Chinook and coho salmon population size in the Anchor River. For each freshwater stage, the model estimates reach-specific carrying capacities using predicted physical variables such as channel morphology and substrate size, in conjunction with field measured maximum densities of each life stage for different slope and drainage area combinations and habitat types. RIPPLE then uses these reach-specific carrying capacities in a multistage stock-production model to predict distribution and abundance of each life stage.

Two Moose Creek
confluence with the
Anchor River

Spawner Carrying Capacity

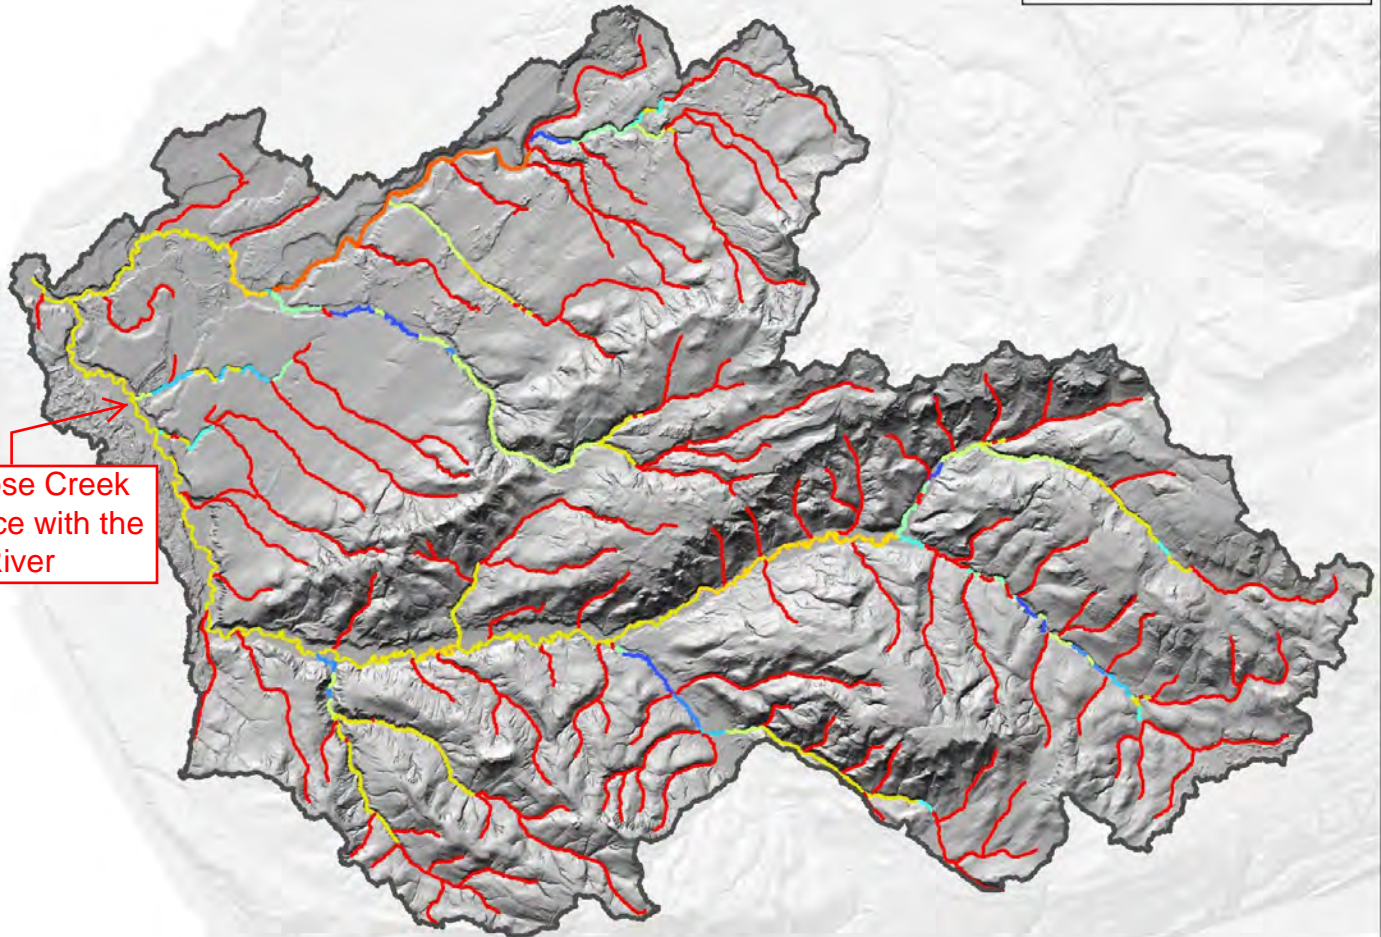
ANCHOR RIVER, AK - CHINOOK SALMON

Two Moose Creek
confluence with the
Anchor River

Summer 0+ Carrying Capacity

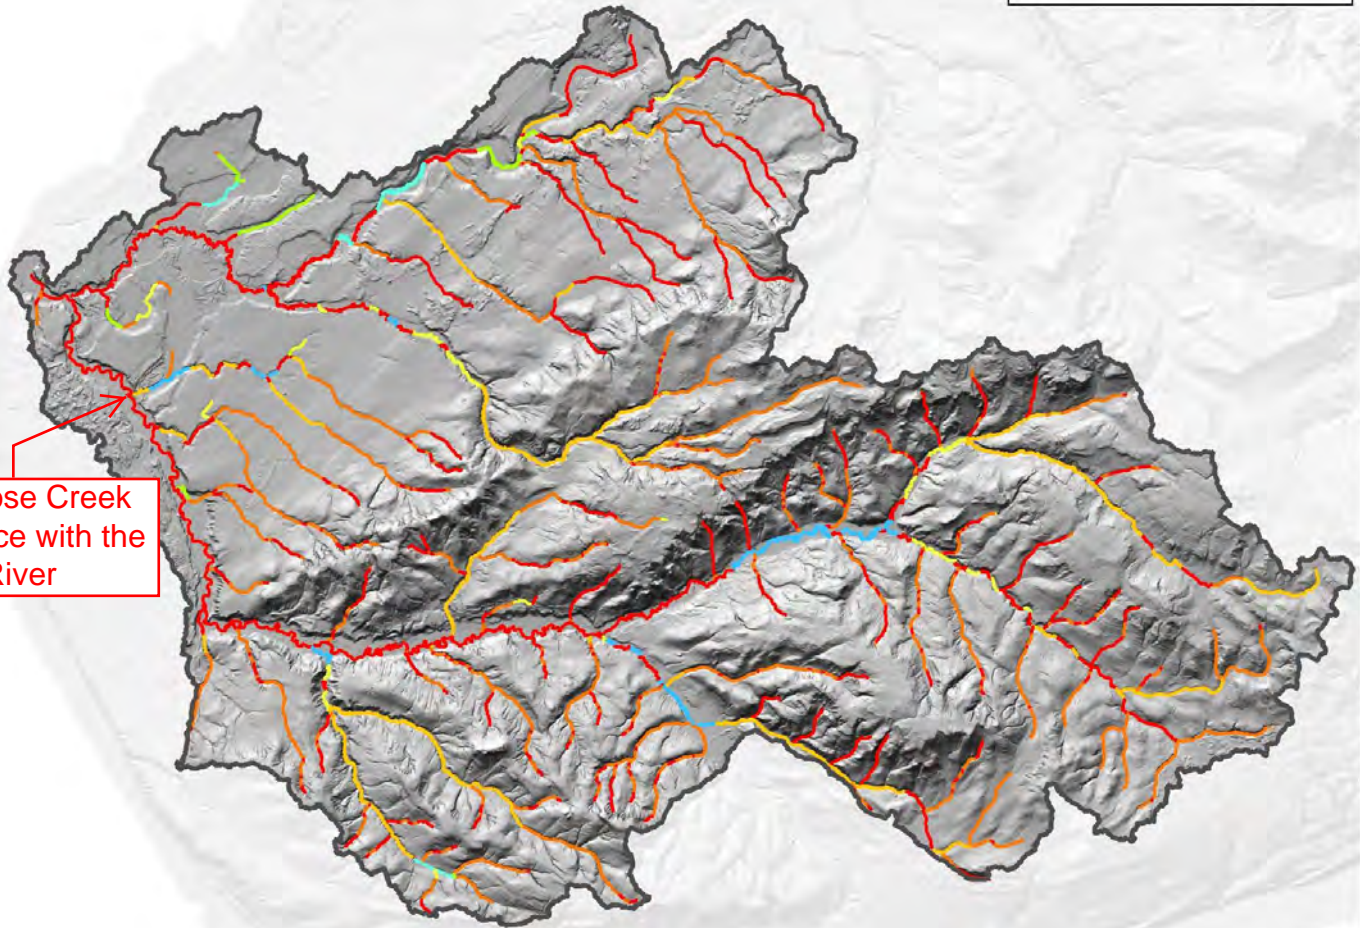
ANCHOR RIVER, AK - COHO SALMON

Two Moose Creek
confluence with the
Anchor River

Spawner Carrying Capacity
