Citizens' Environmental Monitoring Program

Watershed Overview

Woodard Creek

Citizens' Environmental Monitoring Program
Watershed Overview
Woodard Creek
August 2012

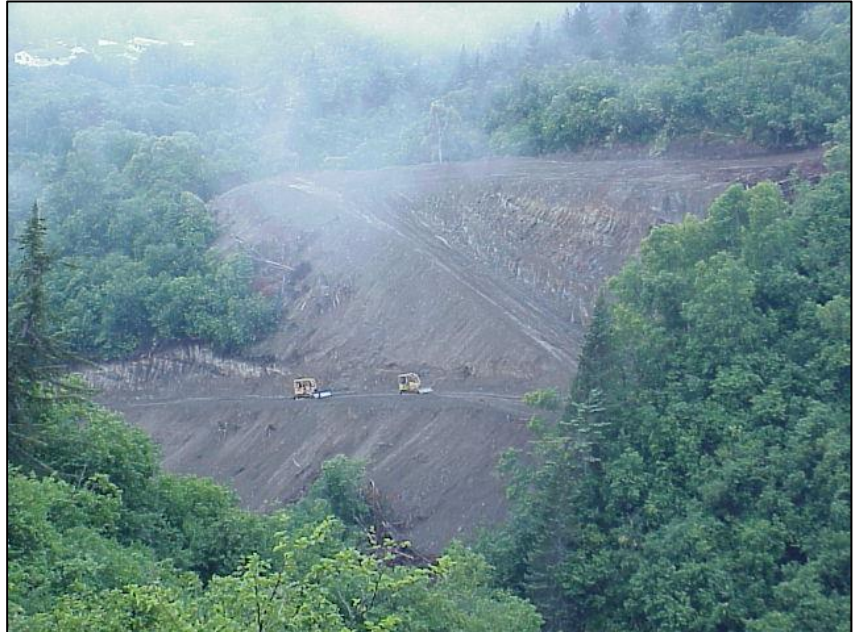
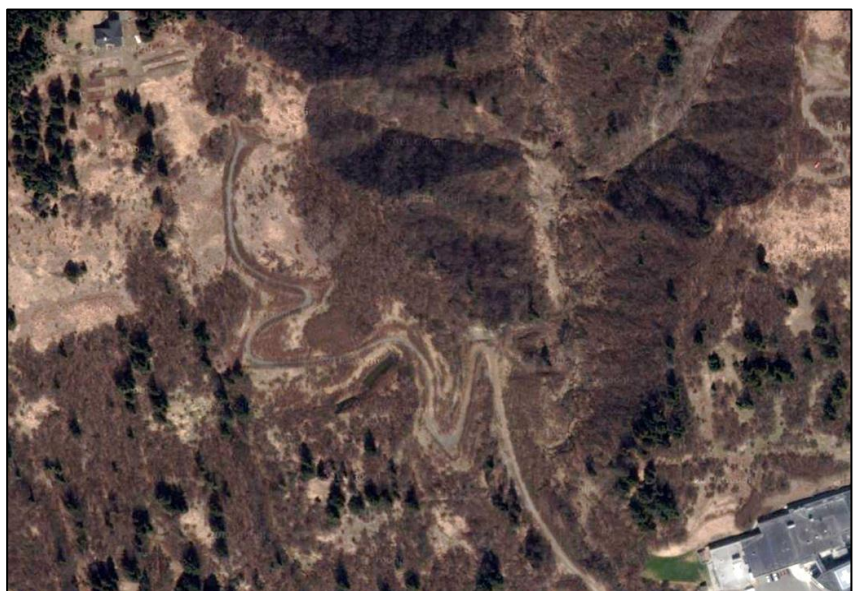
In the early 2000's, Woodard Canyon was repeatedly threatened by fill piles sloughing down the canyon from Karen Hornaday Park and the construction of a private driveway (see photographs at right). Upon site visits, CEMP volunteers observed sediment inputs into Woodard Creek from these piles. Erosion control fences were erected in futile efforts to control the slough material, and are still somewhat intact today.

(Top) Picture taken during private driveway construction in 2000, viewing steep slope and soil sloughing into Woodard Canyon/Woodard Creek; (Bottom) Birds-eye view of driveway, accessed from Google Maps 26 July 2012

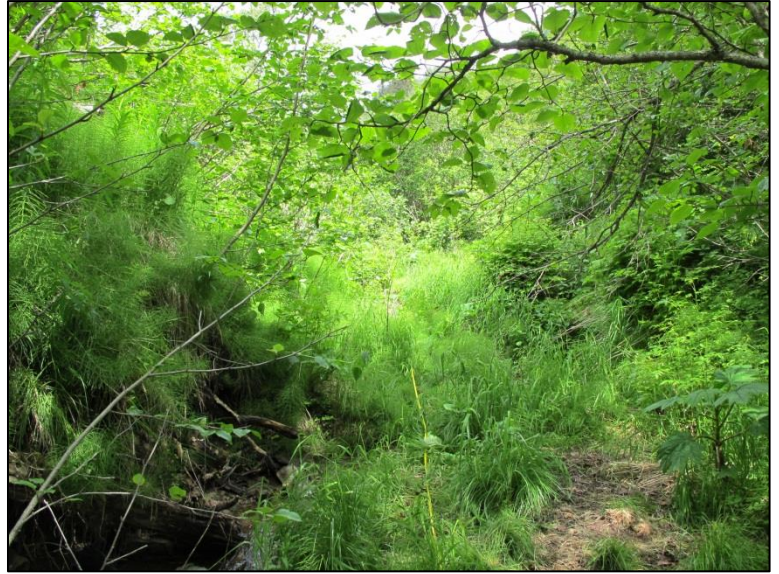
Upstream view along reach at KB-180, June 2012.

The reach began at the CEMP site and continued upstream for 50 meters, following the curves of the creek. Water level was considered to be 90% of bank full, with fairly clear water. About half of the streambed was composed of gravel, and the remainder was split between silt/clay, sand, and cobbles. Boulders present along the reach were mostly reserved to the few short

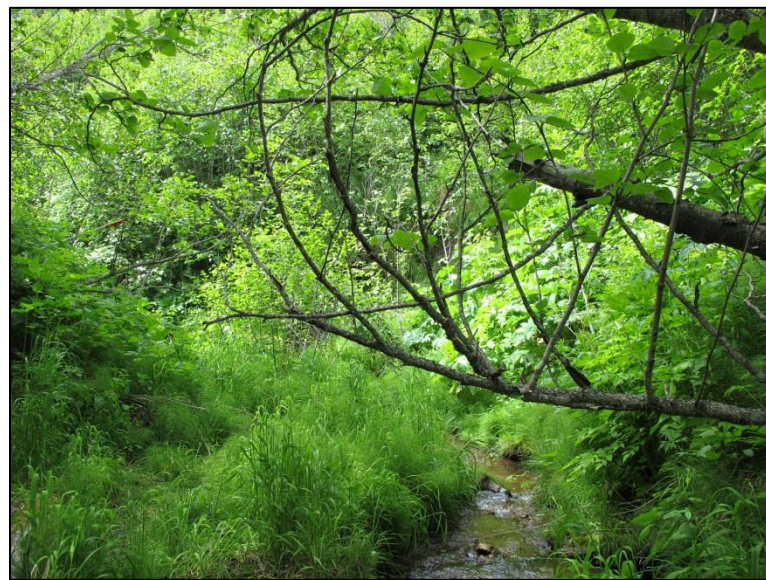
Downstream view along reach at KB-180, June 2012.

cascades. Stream width ranged from 2.6 to 6.3 feet, but was normally 4 feet wide. Depths ranged between 3 and 11 inches, and normally flowed at 5 inches deep.

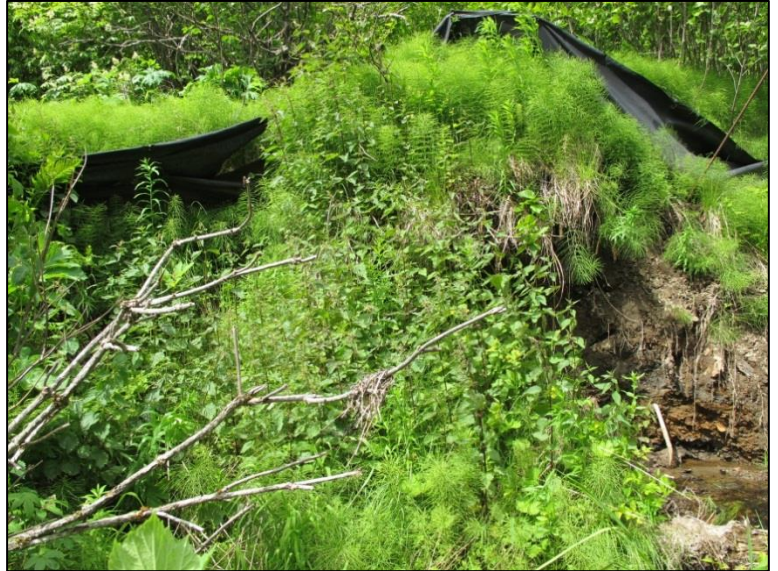
Bank stability was mostly ranked as ‘stable’ for both sides of the reach. Banks were fairly low on the left bank, and both banks were heavily vegetated and secured by root masses. A few areas of bank failure were observed on the right bank, rating about 15% of it as ‘moderate’. Failing erosion controls for the right bank were

observed at the upper end of the reach (see image at right).

Failing erosion controls viewed at upper end of reach at KB-180, right bank, June 2012.

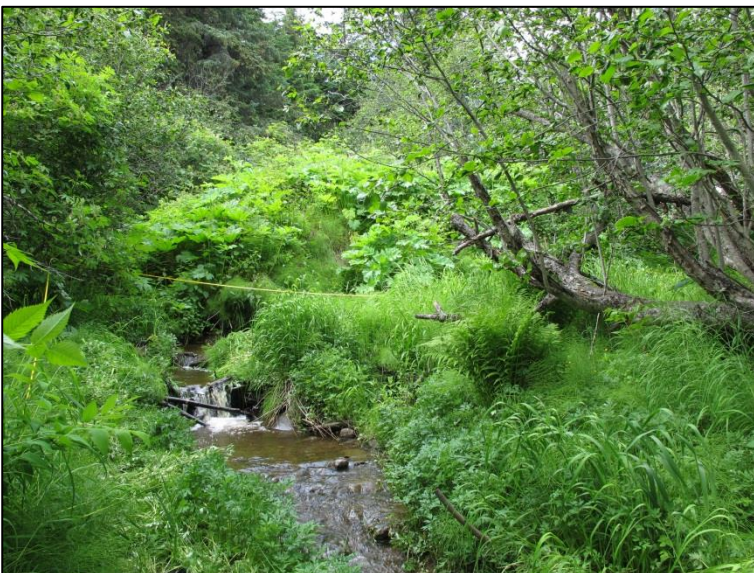
The 50-meter reach began at the CEMP site, just below the culvert at the Pratt Museum parking lot, and continued downstream, following the curves of the creek. Water level was at about 90% bank full, with clear water. Stream bed composition was

mostly made up of sand and gravel, with a greater gravel presence. The remainder was composed of silt/clay and cobbles, with a couple boulders dispersed along the reach. Stream width ranged between 2.1 and 7.5 feet, and normally was 4 feet wide. Depth ranged between 3 inches and 1.4 feet, and normally flowed at 6 inches deep.

Upstream view along reach at KB-150, June 2012.

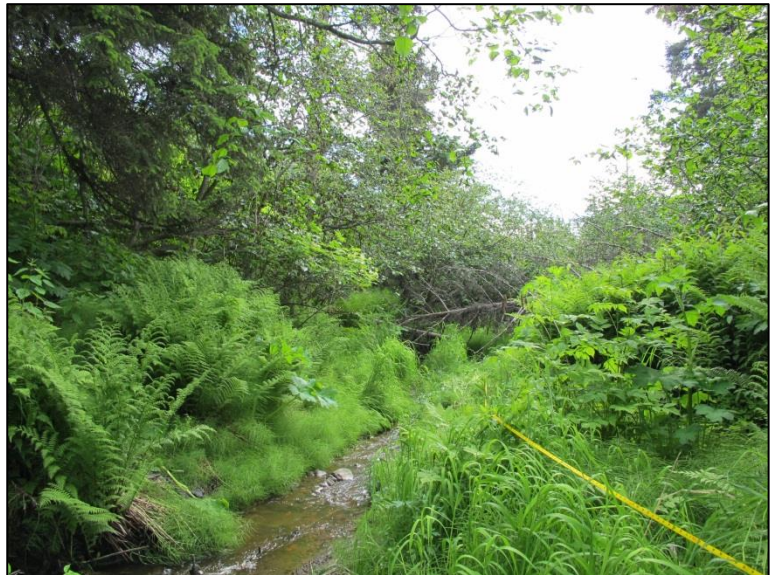
Bank stability was ranked as ‘stable’ for almost the entire reach, with only 10% of the right bank rated as ‘moderate’ for some higher banks. The riparian zone extended to over 60 feet on the right bank. The left bank is closely neighbored by the Pratt Museum parking lot and the Homestead Building, yielding a riparian zone length between 24 and just over 60 feet. The majority of the left riparian zone was at 60 feet along the reach. Riparian vegetation was largely composed of alders, dominating the left

bank. Pushki, horsetail and grasses made up about half of the right bank vegetation, and the remainder of the left. A few spruce trees were present at the end of the reach on the left bank.

Downstream view along reach at KB-150, June 2012.

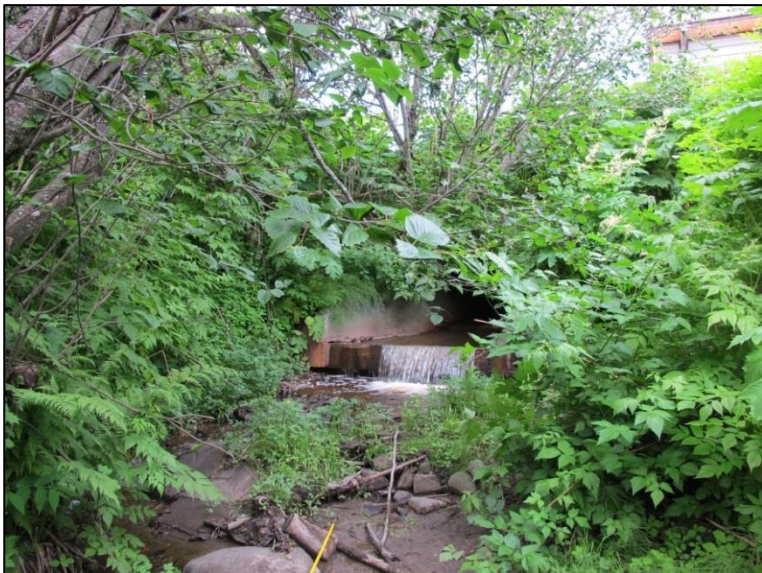
This reach is located within a Homer Society of Natural History parcel. The culvert under the Pratt Museum parking lot appeared intact with no damage or blockages. There is no apparent human activity within this reach of the stream.

Culvert under Pratt Museum parking lot at head of KB-150 reach, June 2012.

During future site visits, culvert assessments should be made to monitor for any damage, blockages, or other threatening issues.
