**Hilcorp MGS Pipeline
Leak Investigation & Repair
Project Plan**

Hilcorp MGS Pipeline Leak Investigation & Repair Project Overview

- Leak investigation for the identified 8-inch undersea pipeline located near Platform A in Middle Ground Shoal (MGS) for Hilcorp Alaska, LLC
- *DSV Shamrock* has been de-winterized and will be mobilized and utilized as the marine dive platform in support of the pipeline leak investigation

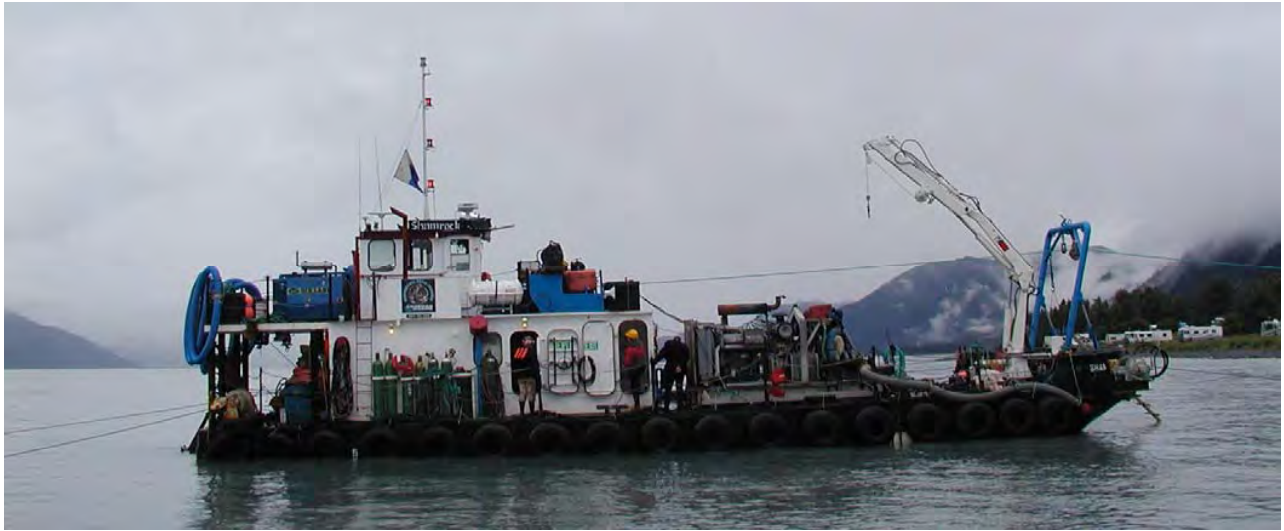
Dive Support Vessel Shamrock

<i>Home Port:</i>	Homer, Alaska	
<i>Dimensions:</i>	70' x 24' x 7'	
<i>Main Propulsion:</i>	Twin Detroit Diesel 6-71 (175 hp each) w/Twin Disc MG-509 Marine Gear	
<i>Reduction Gears:</i>	Twin Disc-509 Marine	
<i>Hull:</i>	Welded steel w/screw tunnel and semi-flat bottom for going dry and ice operations	
<i>Speed:</i>	8 knots	
<i>Fuel Capacity:</i>	6,000 Gallons	<i>Water Capacity:</i> 2,000 Gallons
<i>Electrical:</i>	John Deere 75 kw main with 20kw auxiliary	
<i>Engine Cooling:</i>	Keel coolers and compartment unit radiators	
<i>Electronics:</i>	Loran C, VHF Radio, Single Side Band Radio, Sperry Auto Pilot, Depth Sounder Multi Receiver DGPS/GPS Units, CCTV System, Deck Comms and Hailing System Workhorse Sentinel 600 kHz ADCP / Bottom Tracking / KVH Digital Fluxgate Compass	
<i>Diver Support:</i>	48" Double Lock Decompression Chamber, Bauer and Quincy Breathing Air Compressor, and Dive Equipment Spread for 200+ fsw
